Wissenschaftliche Berichte
FZKA 7307

Results of the QUENCH-12 Experiment on Reflood of a VVER-type Bundle

**J. Stuckert, A. Goryachev, M. Große,
M. Heck, I. Ivanova, G. Schanz, L. Sepold,
U. Stegmaier, M. Steinbrück**

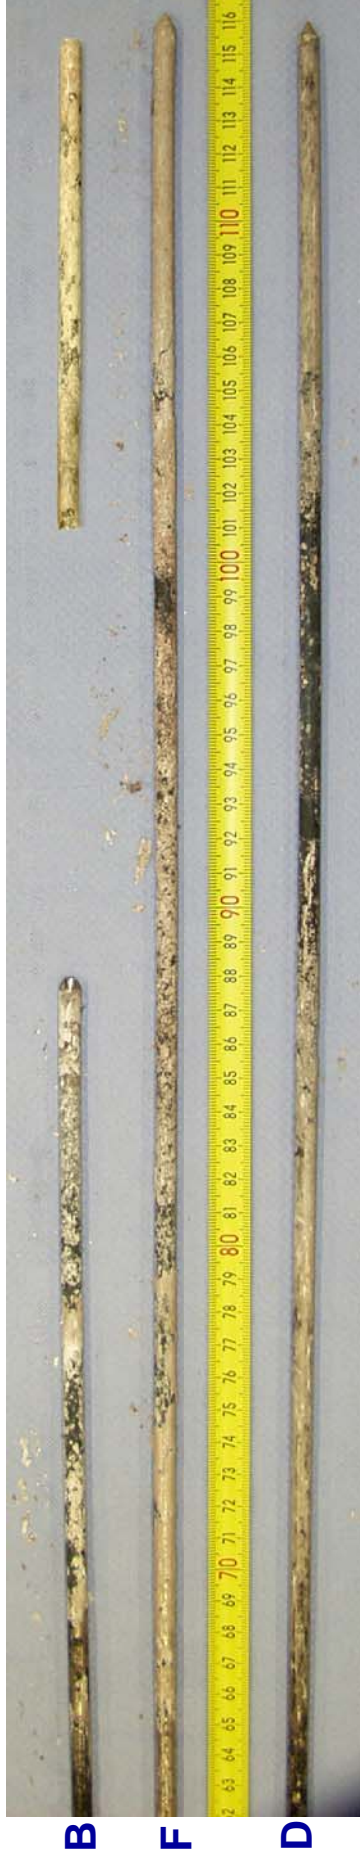
Fig. 23: QUENCH-12; Spalling of outer scales of oxide layers at corner rods D, F, and B.

corner rod B after pre-test
(800 °C, oxide layer thickness < 5 µm, measured with eddy-current technique)

Corner rods withdrawn during the main test:
D – after pre-oxidation,
F – before reflow,
B – after test.

The third corner rod, i.e. rod B, was withdrawn after the test, again to check oxide levels and hydrogen absorption. All corner rods showed break-away oxidation effects, i.e. strong spalling of oxide scales (see [Fig. 23](#)). Corner rod B could only be withdrawn in two pieces with rod rupture at the bundle elevation of 880 mm. Besides the solid corner rods the entire test bundle resulted in severe damage of the surfaces of cladding and shroud due to breakaway oxidation. Spalling of the ZrO_2 scales of the rod claddings, however, is less pronounced than at the corner rods. Possible reasons could be (a) different mechanical properties of tube and solid rod; (b) different surface quality of cladding and rods.

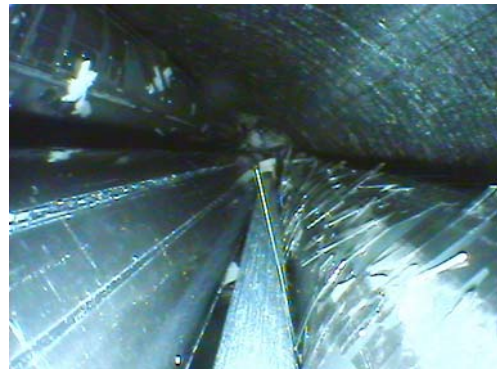
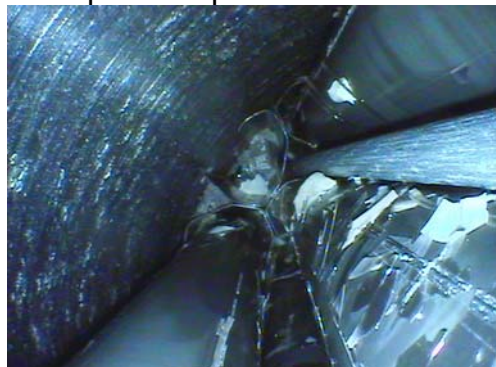
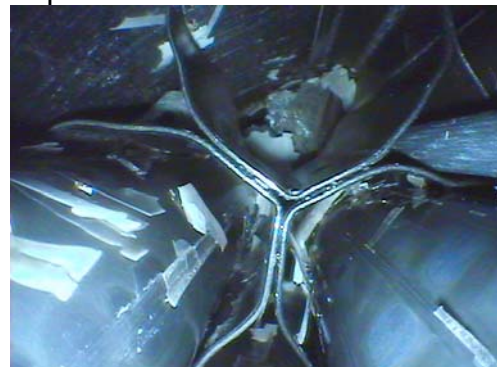
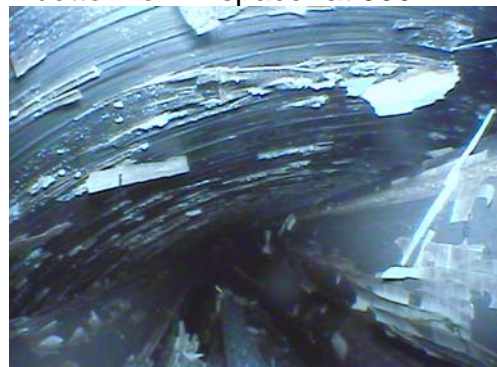
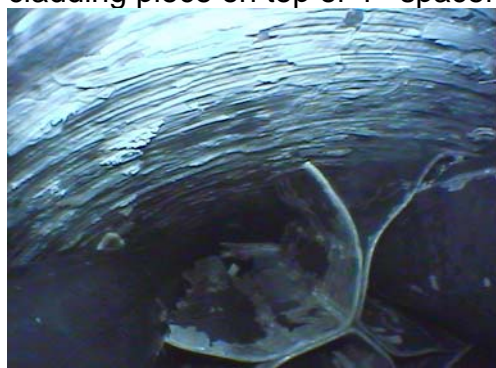
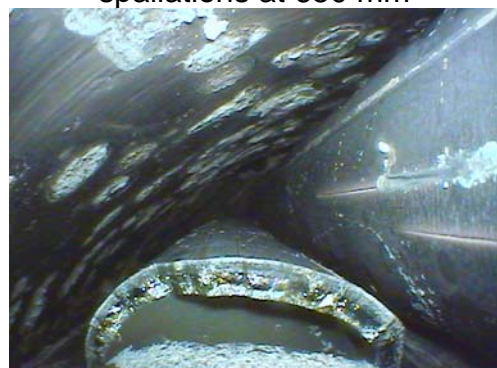
Fig. 35: QUENCH-12; Videoscope monitoring at empty position of the withdrawn corner rod D, viewed from bottom to top; cont'd.

top of 3rd spacer at 320mm

spallations at rod 27 at 450 mm

spallations at rod 16 at 500 mm

cladding piece on top of 4th spacer

spallations at 650 mm

bottom of 5th spacer at 800 mm

Spallation of the oxide scale was also observed with help of a videoscope (OLYMPUS IPLEX) inserted at the empty positions of the three withdrawn corner rods. Spalled oxide scales were even partially removed by pull-out of the videoscope from the bundle. [Figs. 34-36](#) show photographs of typical structures from different bundle elevations taken at the empty position of the withdrawn rod D. The lowest elevation where breakaway oxidation of cladding surface took place was at ~400 mm. The maximum temperature at this bundle position was about 1123 K. No spallation of oxide layer was observed at hottest bundle elevations between 800 and 1000 mm. However the shroud surface at these elevations was exposed to nodular breakaway oxidation. The majority of debris from claddings and shroud accumulated at the bottom of the bundle and upper edge of grid spacers. Particularly, the grid spacer at 550 mm elevation acted as a debris catcher. The initially coarse shroud surface revealed thicker spalled oxide scales, when compared to the simulator rod cladding.

cladding cracks were found in the hot bundle zone between 700 and 1000 mm (last photos in Figures 35 and 36).

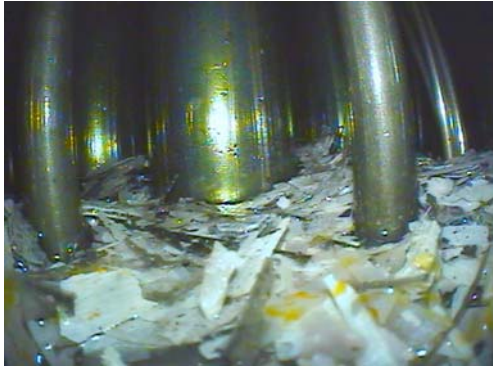
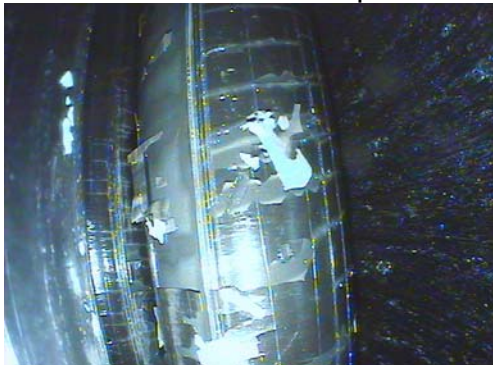
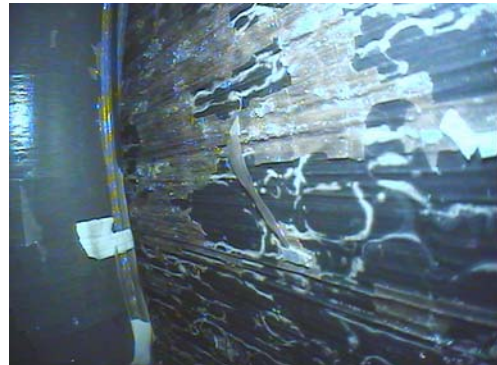
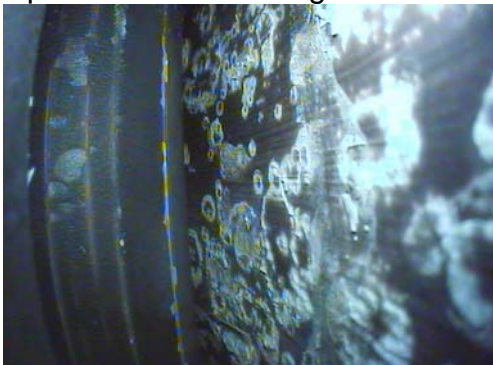
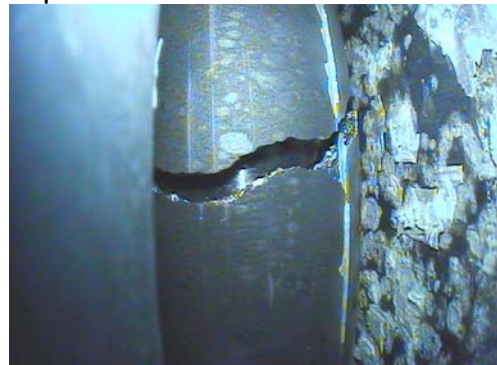
Fig. 36: QUENCH-12; Videoscope monitoring (side view) at the empty position of the withdrawn corner rod D.

debris on bottom of separator

bottom of unheated rod

spallations at cladding at 400 mm

spallations at shroud at 400 mm

spallations at shroud at 850 mm

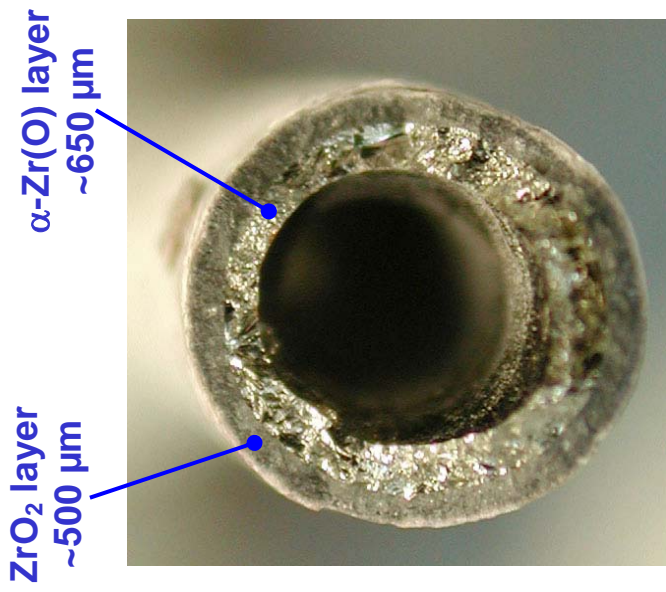
Upper part of the broken rod with central part lost due to melting of β-Zr at T>2130 K

Melt formations inside the bundle were observed only at some local positions, i.e. no massive melt had formed. An interesting effect was observed at the position of the corner rod B at an elevation above 850 mm. The neutron radiograph of the upper end of the lower withdrawn part of this rod is shown in [Fig. 37](#). It is comparable to the lower end of the upper part of this rod (both rod parts are to be seen in [Fig. 23](#)). The deep hole is clearly visible. The formation of these holes can be explained by the α - β phase composition of Zry-4. The α -Zr(O) phase at the outer regions and the β -Zr phase in the bulk of the rod formed during oxidation. Due to the lower melting temperature of the β -Zr phase (2128 K) compared to the oxygen stabilized α -Zr(O) phase (2248 K) a partial melting of the bulk occurs whereas the outer regions remain solid. After solidification, stresses and micro-cracks can be formed at the interface and the rod breaks along this interface.

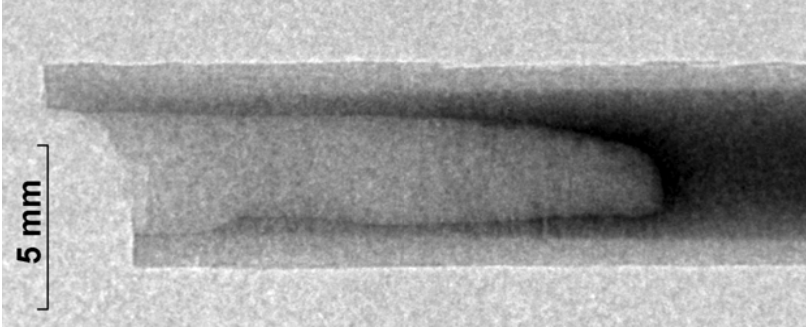
Neutron radiography shows deep hole with irregular diameter

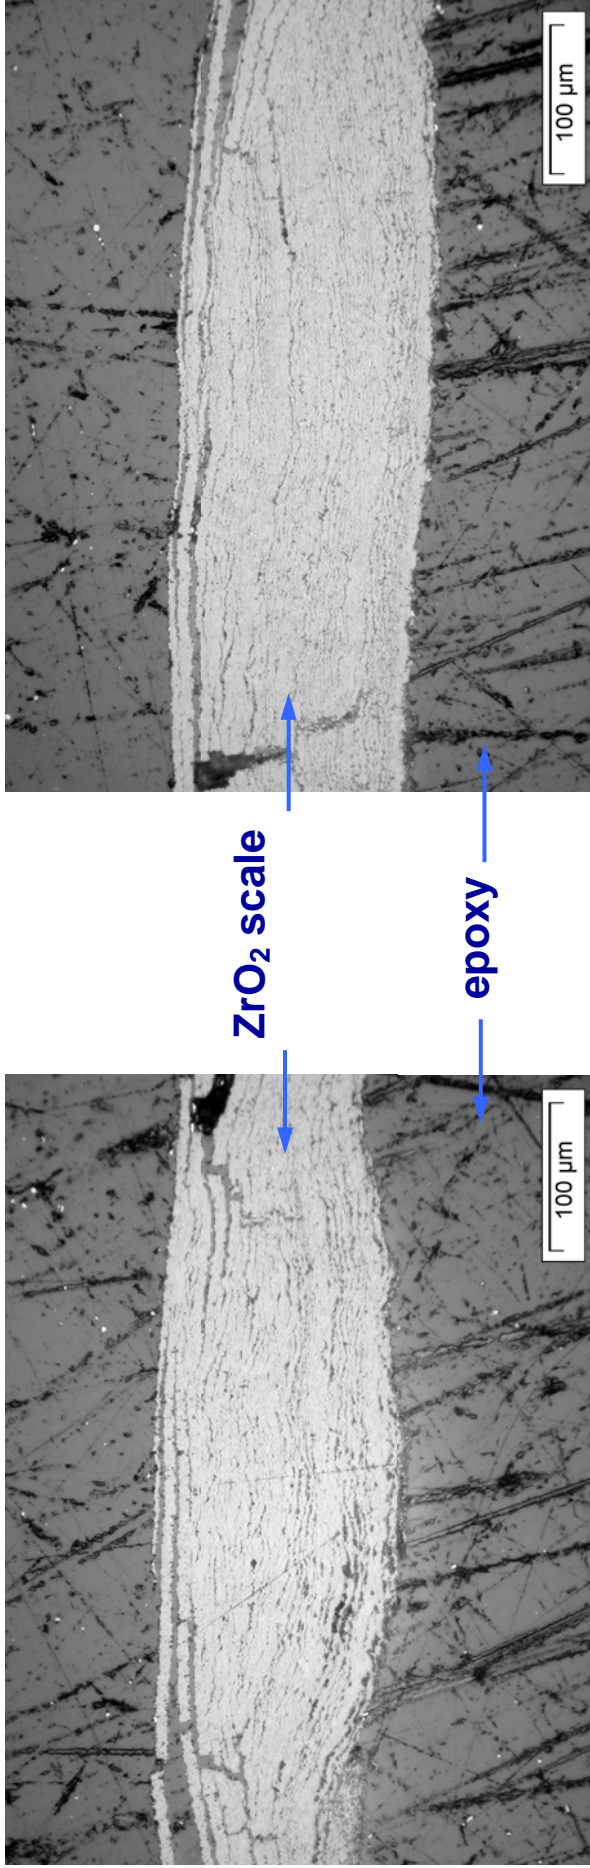
Fig. 46: QUENCH-12; Typical morphology of spalled oxide scale of corner rod (laminated structure).

During the withdrawal and subsequent handling of the corner rods a certain amount of oxide scales fell off. This has to be taken into account with regard to the complete oxide layer thickness. Some of the thicker pieces were epoxied and ground, and [Fig. 46](#) shows their cross-sections. It illustrates how easy oxide scales can fall off during handling and that 100 μm in spalled oxide scale thickness is quite typical for the corner rod material.

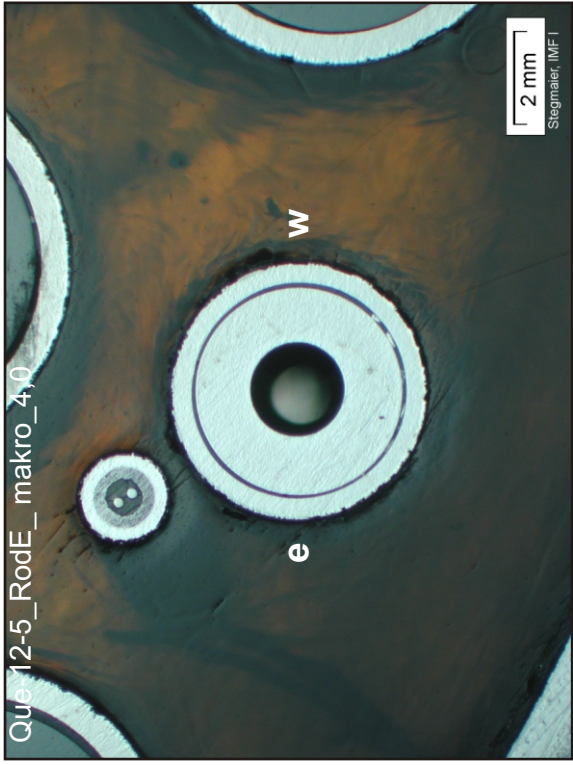
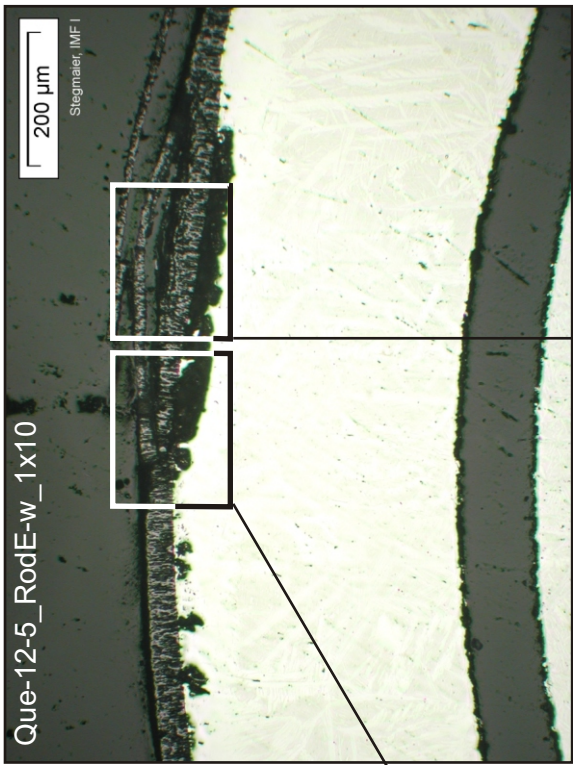
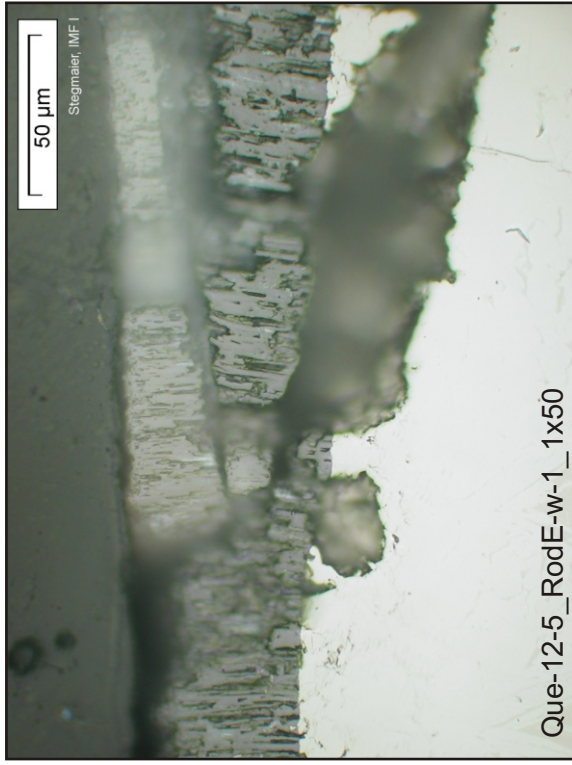
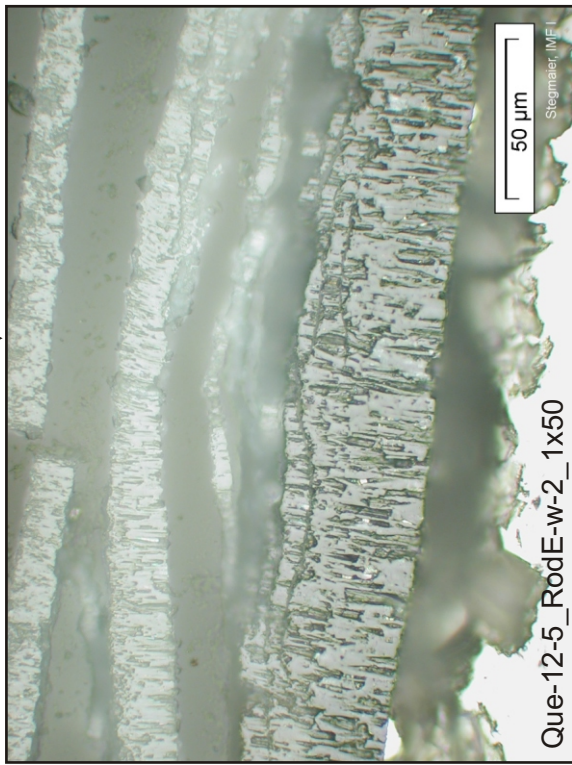
**Intact scale and regions
with sublayer spalling**

Fig. 76: QUE-12-5, level 750 mm; oxidation state of corner rod E towards west.

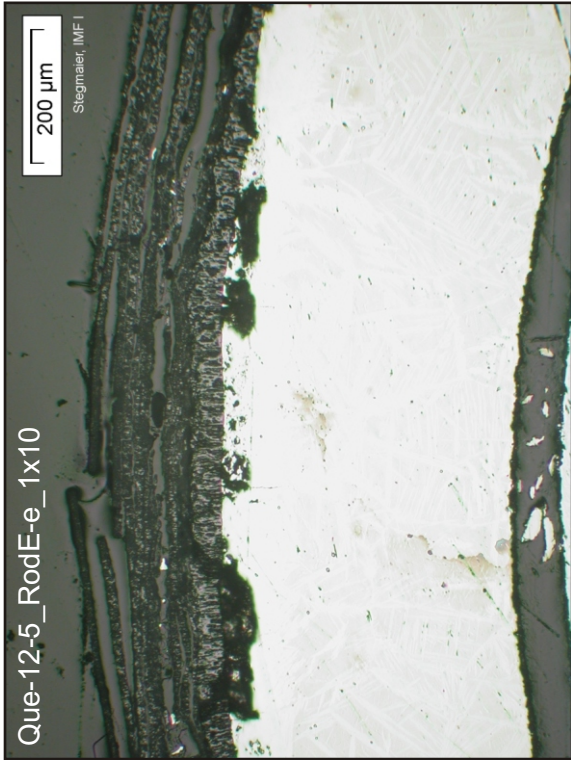
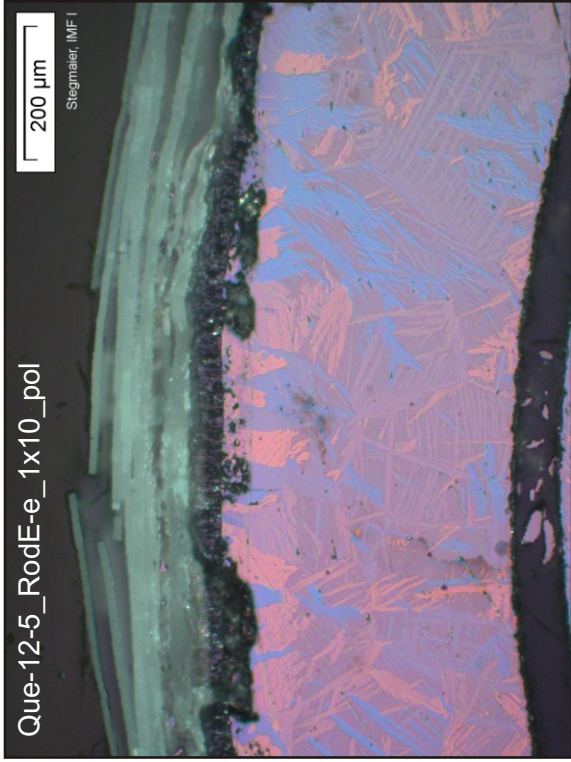
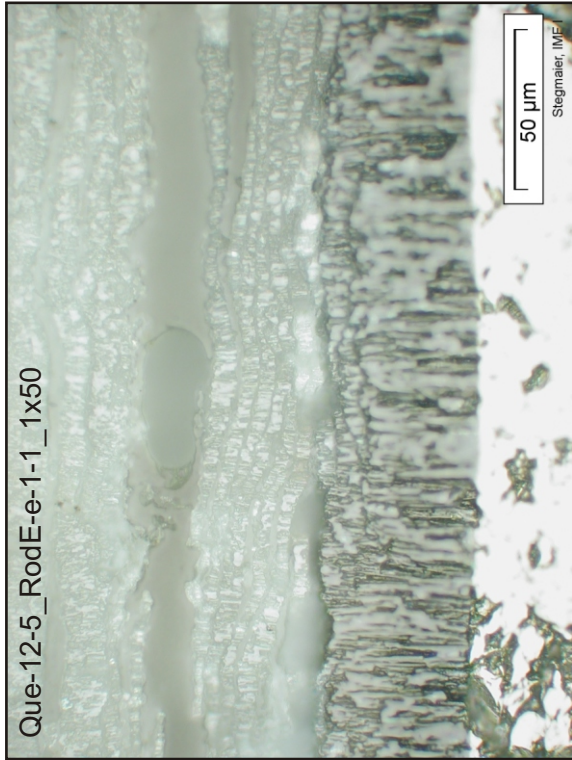
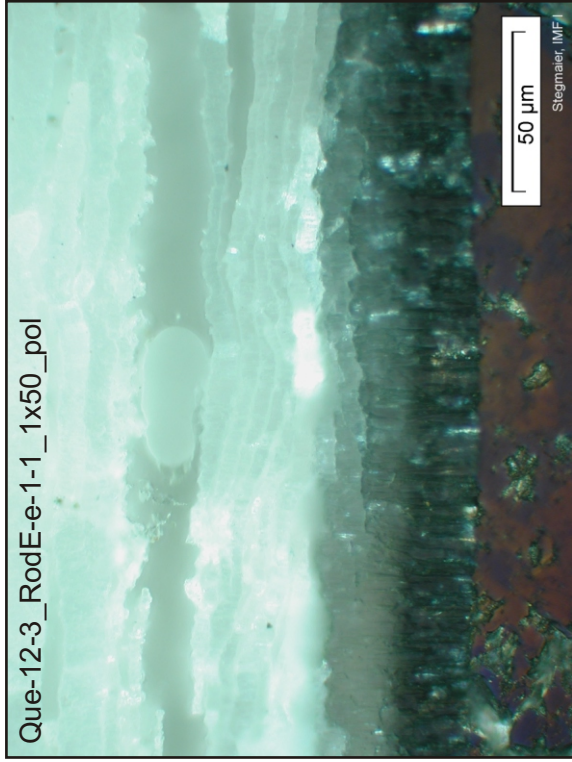
Spalling of many sub-layers from the compact inner part of the scale

Fig. 77: QUE-12-5, level 750 mm; oxidation state of corner rod E towards east.

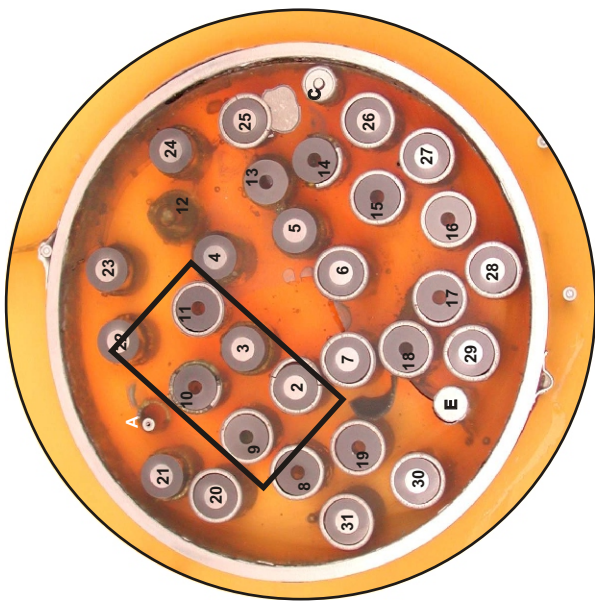
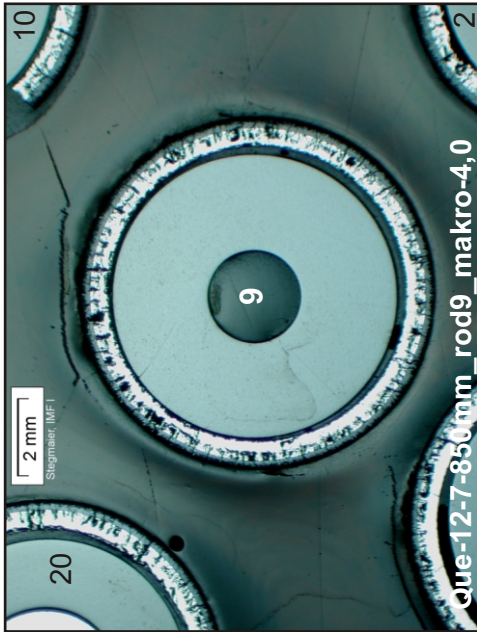
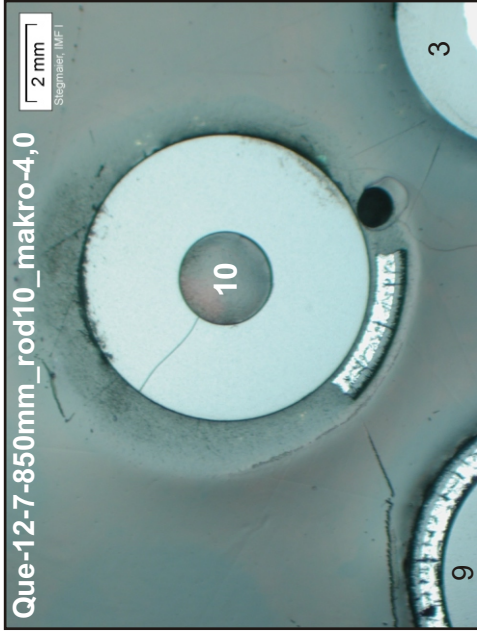
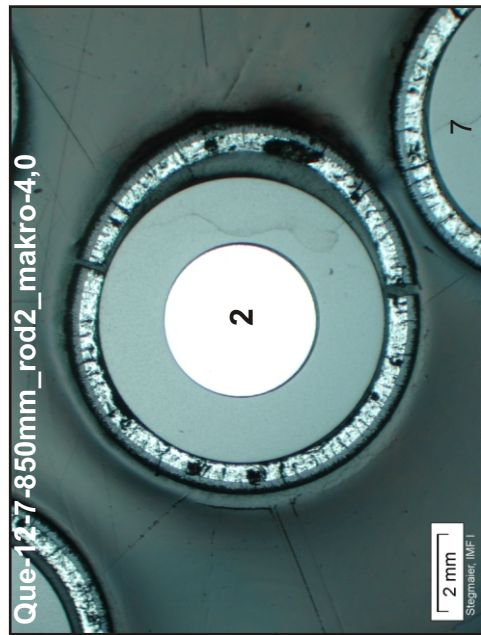
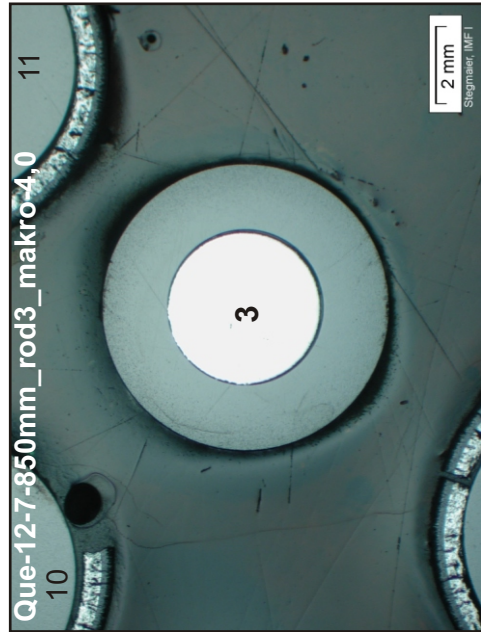
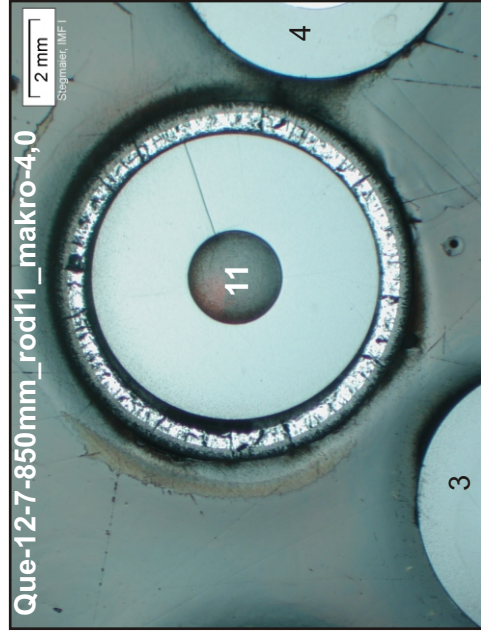
Fig. 79: QUE-12-7, level 850 mm; macrographs of rods towards SE, illustrating advanced oxidation and losses of cladding due to fracture.

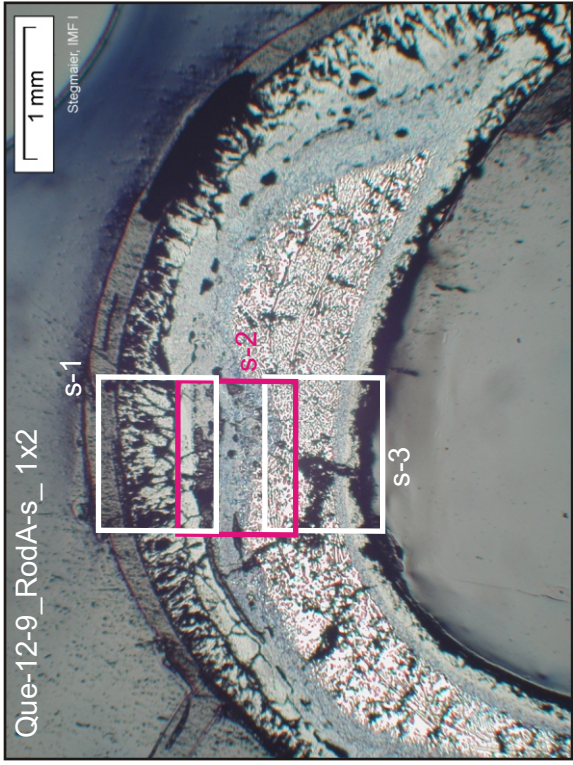
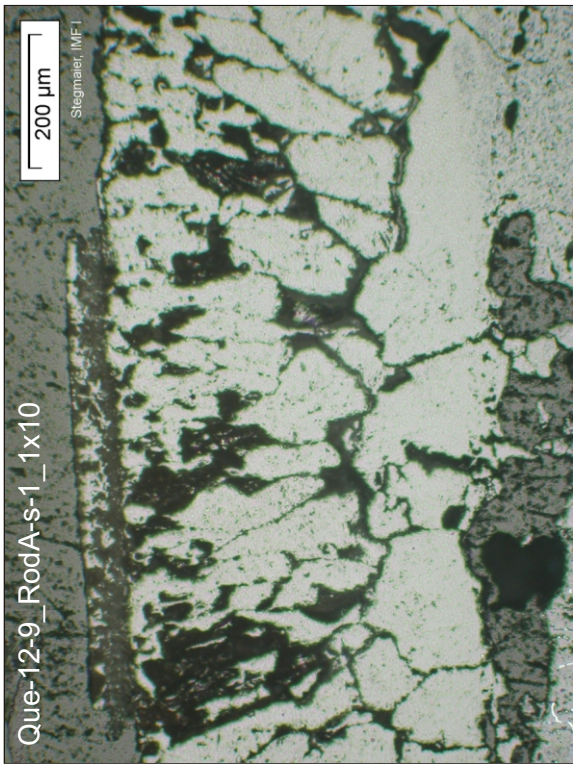
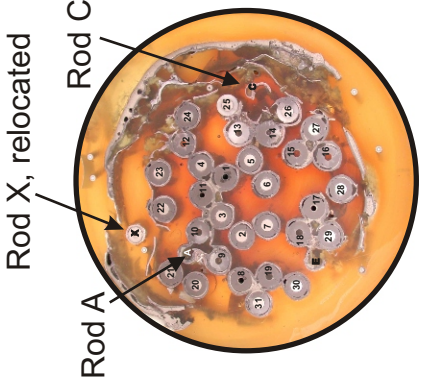
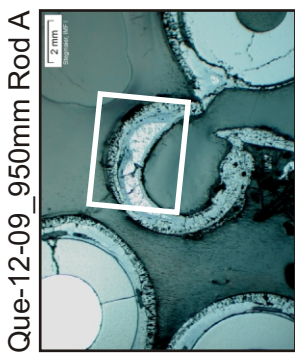
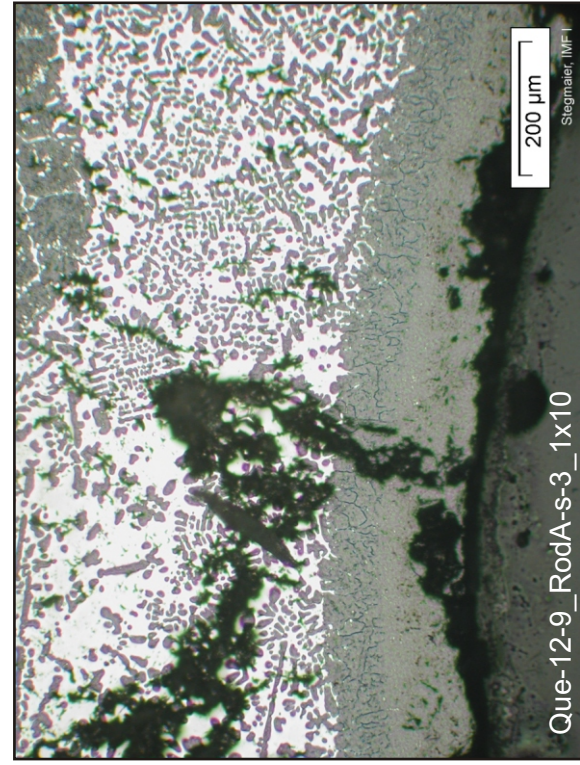
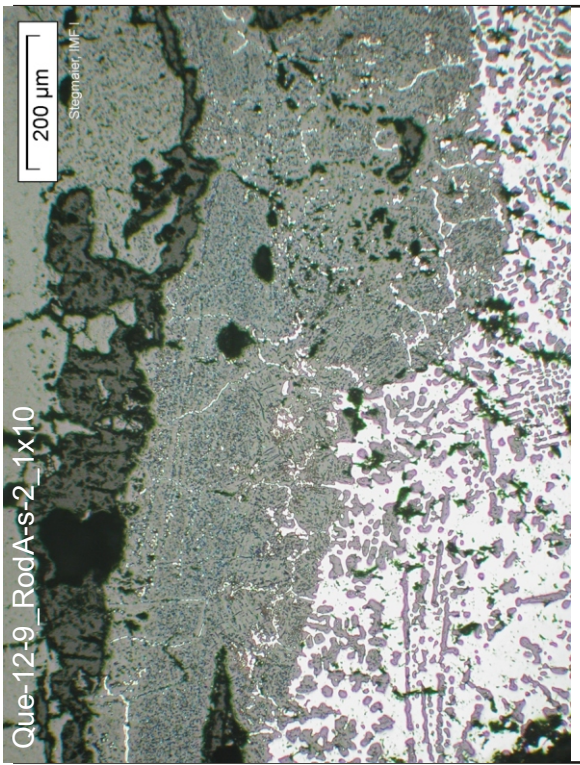
Fig. 96: QUE-12-9, level 950 mm; oxidation state of corner rod A, showing massive oxide and duplex melt microstructure.

The oxidation state of corner rod A towards south is described with [Fig. 96](#). Accordingly, the outer part of the scale shows the coarse microstructure of high-temperature oxide (top/right), the following part seems to be disturbed, eventually due to interrupted presence of metallic melt (bottom/right), and the internal scale (bottom/left) indicates the access of steam into the split tube remnant. In comparison, rod X, interpreted according to its position as a relocated stub of the same rod A, shows a rather strange scale microstructure, which has to be explained by its history at changed elevation: As shown in [Fig. 97](#), the outermost part is a double layer of coarse grained oxide (top/right), next follows a series of partial layers of breakaway type (left, not depicted in more detail), and finally an again compact and protective oxide with variable layer thickness, formed at high temperature (bottom/right). Such composed oxide as depicted was found at the whole circumference of the rod according to archived photos. [Fig. 98](#) describes rod C towards west as fully oxidized tube, for which the external scale can be distinguished from the remnants of internal scale which was formed when metallic melt at the inner side came into contact with steam. It is mentioned without presenting an illustration that remnants of corner rod E are rather similar and fully oxidized as well.

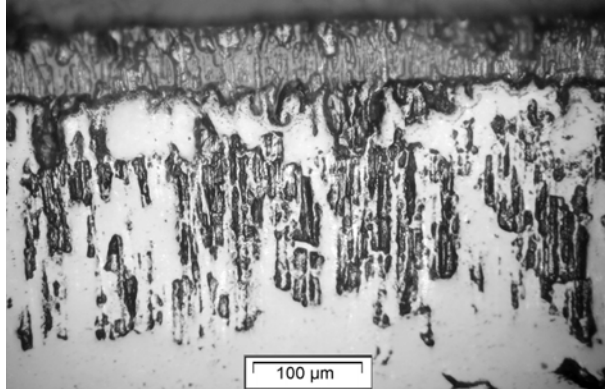
rod 1: external oxide scale spalling

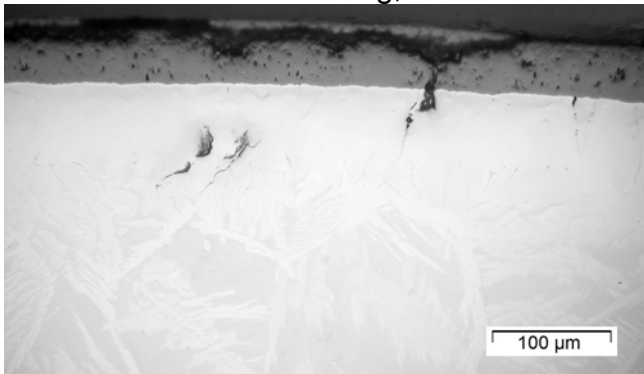
rod 12, 225°: external oxide scale spalling

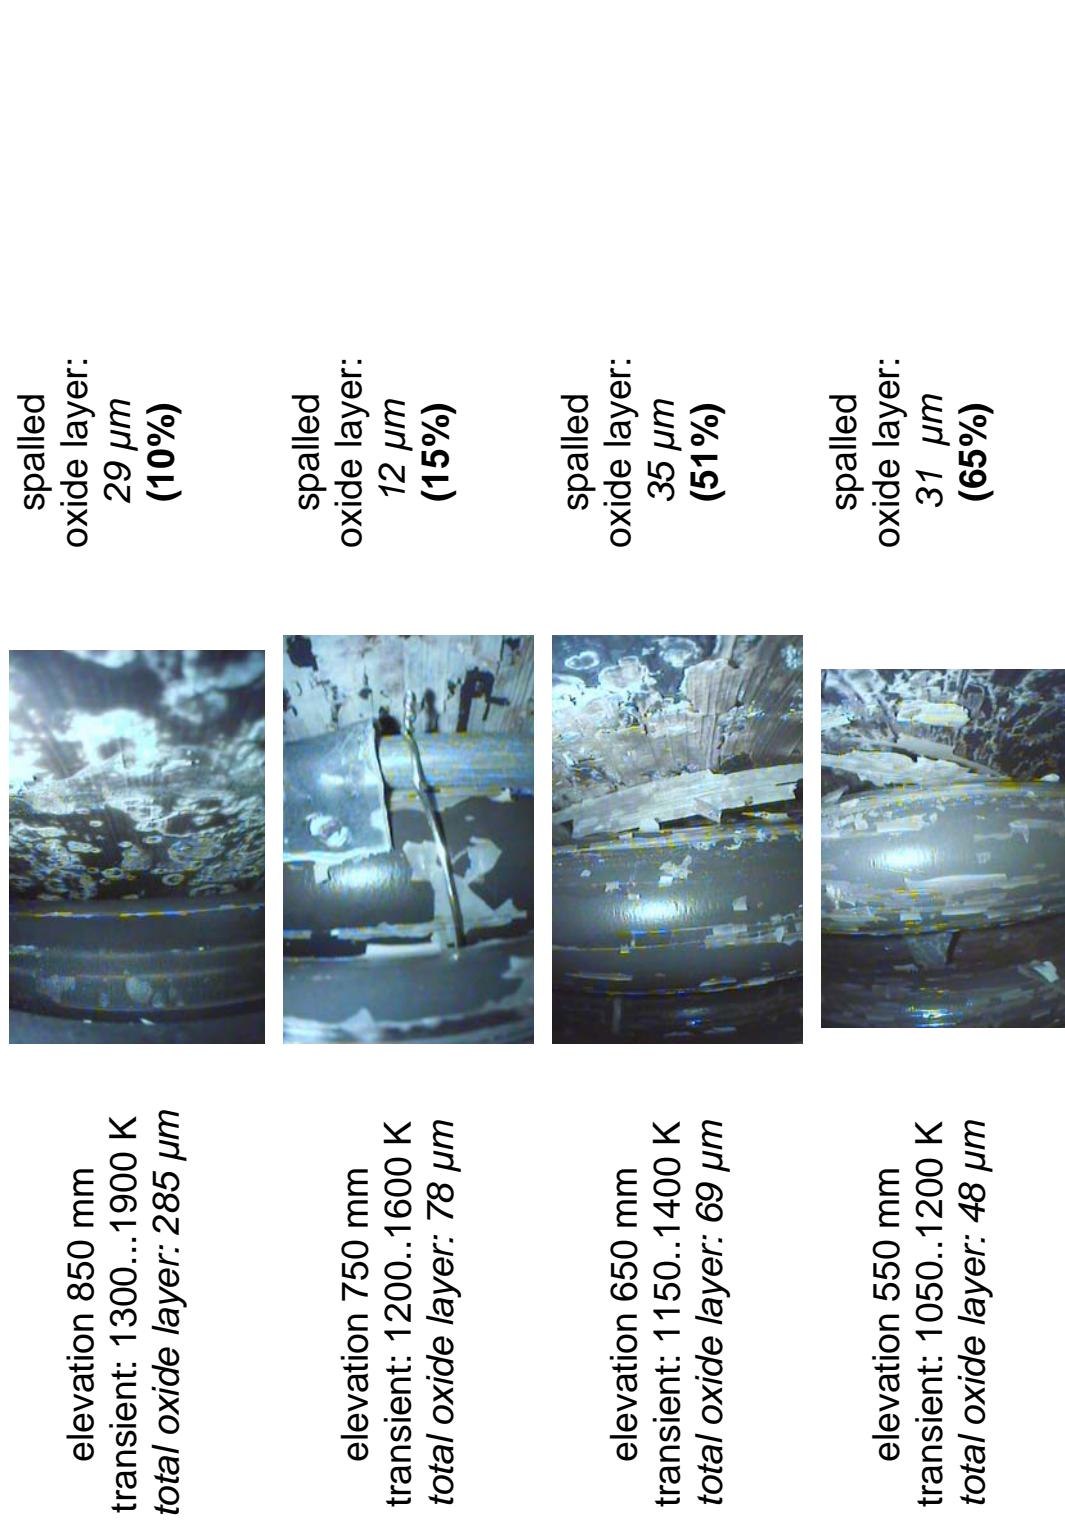
Fig. 133: QUENCH-12; degree of cladding oxide layer spalling for different bundle elevations, total oxide layer calculated on the base of residual metal.
