Erosion and redeposition pattern on the W7-X graphite test divertor unit tile

A set of plasma-facing components was retrieved from the W7-X vessel after OP1.2b campaign with an inertially cooled Test Divertor Unit (TDU) and analyzed postmortem to provide data on the plasma-surface interactions processes in the complex device geometry. In the present study, the lower TDU horizontal target (HT) graphite tile HM19TM400hTE2 exposed to the plasma during both OP 1.2 campaigns was examined. The surface modification of the material caused by the plasma-wall interactions was determined. The study employed several microscopy methods including SEM, FIB, STEM, TEM, EDX, and optical profilometry which showed that (i) distinct erosion zone was located at the inner HT strike line position, (ii) the area covered by a pronounced deposit was located adjacent the erosion zone, (iii) the target finger substructures positioned close to the outboard side was unaltered, and (iv) significant changes to surface roughness values along the length of the plate occurred.

In the presented study, the fine graphite horizontal target tile designated as HM19TM400hTE2 from the lower TDU module 1, which was subject

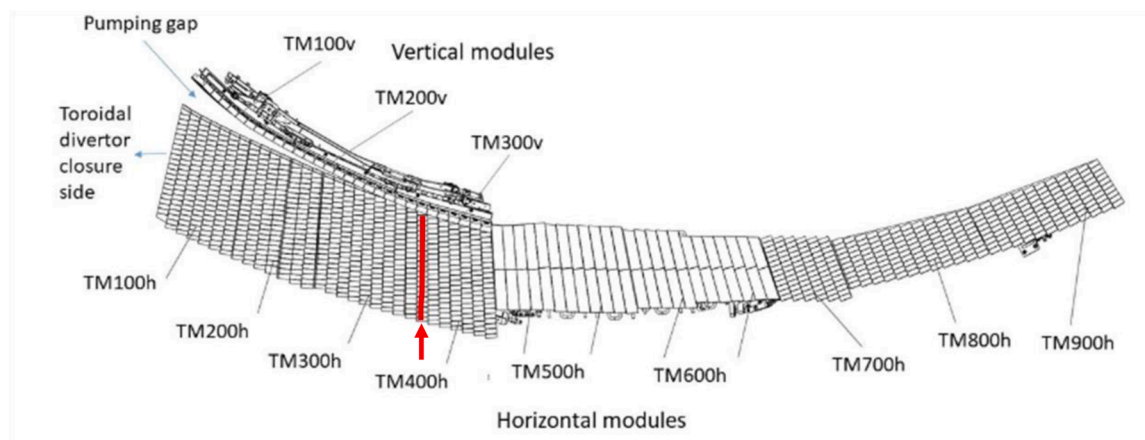
Fig. 1. Drawing of TDU modules (horizontal 9 modules + vertical 3 modules) based on the Max-Planck-Institut für Plasmaphysik's internal document 1-ACT00AC-Z0001. Examined tile position of TDU modules is marked by a thick red line and indicated with a thick red arrow in target module TM400h.

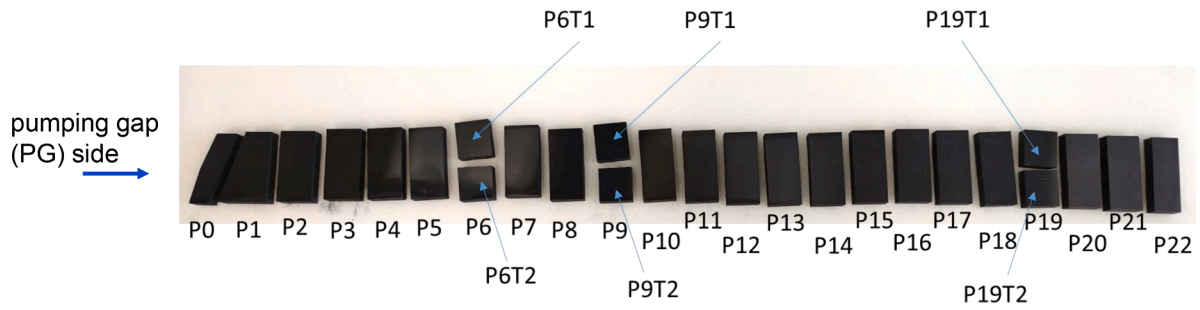
Samples were cut with a blade. First, the target element was cut along the length into two parts, i.e. plasma-facing part and back-side part, to reach the plasma-facing part's thickness of 10 mm. Then the plasma-facing part was cut into the pieces shown in Fig. 2 along the existing grooves in the tile. The size of samples P2–P22 was 25 mm x 55 mm. During the cutting process, dedicated vacuum cleaning was employed to minimize contamination of the plasma-facing surface with cutting debris. No additional cleaning was performed.

Fig. 2. Image of tile HM19TM400hTE2 cut into 23 samples named P0, P1 ...P22. Three samples P6, P9, and P19 were further cut into two pieces each and named P6T1, P6T2, P9T1, P9T2, P19T1, and P19T2, respectively.
