Tube failure during long-term exposure to flowing lead-bismuth eutectic (LBE)

Carsten Schroer, Olaf Wedemeyer, Aleksandr Skrypnik, Josef Novotny, Jürgen Konys

INSTITUTE FOR APPLIED MATERIALS – MATERIAL PROCESS TECHNOLOGY (IAM-WPT)

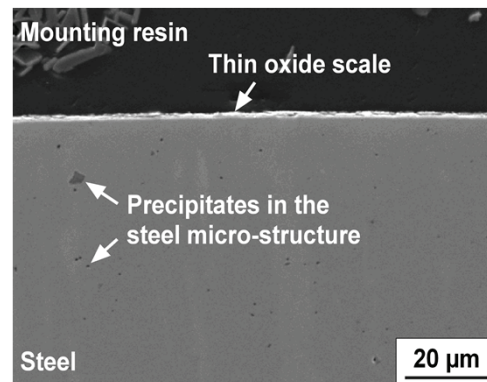
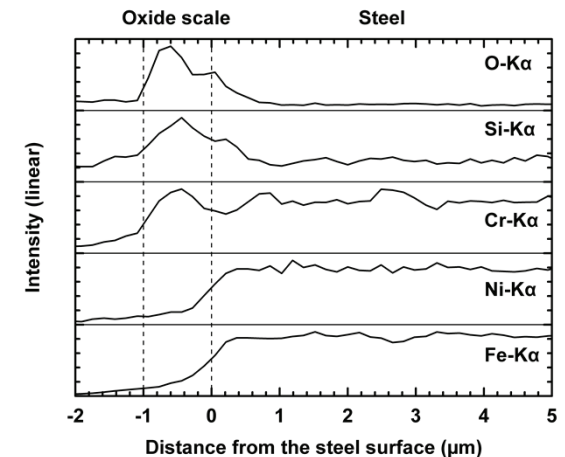
- Thin oxide scale ($< 1 \mu\text{m}$) consisting of Cr- or Si-rich oxide layers
- Might have evolved from thin films already existing on the steel surface before exposure
- Similar to the scale formed by pre-oxidation in dry gas (Ar)
- Locally long-lasting phenomenon on specimens exposed at $450/550^\circ\text{C}$, 10^{-6} mass% O in the test-sections of the loop
- Not observed on tube samples taken from the hot leg of the loop; effect of long exposure time and varying c_{O} (?)

1.4571 specimen in the test-section of the loop after exposure for 3495 h to oxygen-containing flowing LBE at 550°C and $c_{\text{O}} \approx 10^{-6}$ mass%

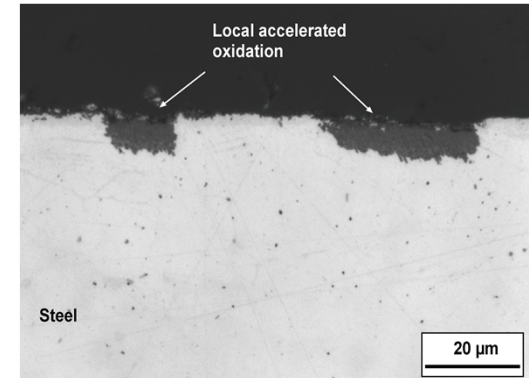
- Starts locally where the thin oxide scale lost integrity or did not form
- Formation of $\text{Fe}(\text{Fe}_x\text{Cr}_{1-x})_2\text{O}_4$, Fe_3O_4 and an internal oxidation zone; the latter two depending on oxygen content, temperature (or flow velocity)
- The thicker scale spreads on the steel surface with time and becomes partially continuous
- Varying c_{O} (mostly lower than 10^{-6} mass%) seems to promote accelerated oxidation

After exposure for 3495 h at 550°C and $c_{\text{O}} \approx 10^{-6}$ mass%

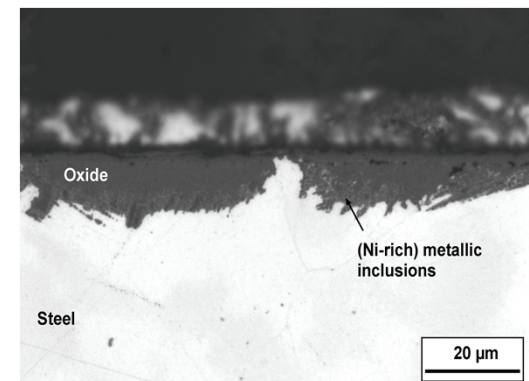
After exposure for 10,006 h at 550°C and varying c_{O}

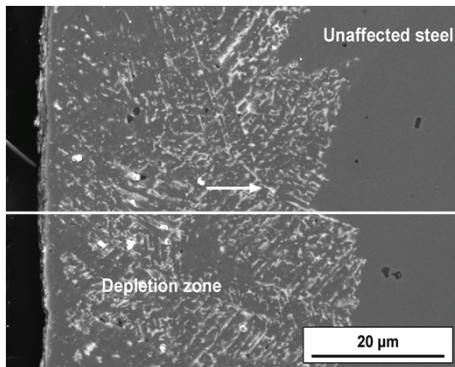
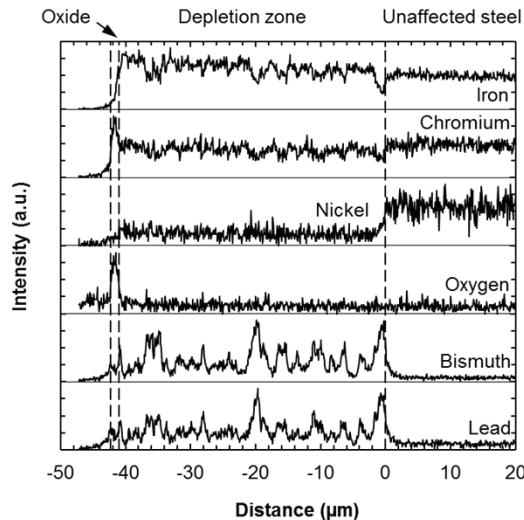
1.4571 after exposure for 5012 h at 550°C and $c_O \approx 10^{-6}$ mass%

- Starts locally with preferential dissolution of Ni and penetration of Pb and Bi into the depletion zone
- Phase transition from austenite into ferrite resulting from Ni depletion
- Dissolution of Cr after oxygen depletion in the liquid metal penetrating the steel (critical penetration depth)
- In general, insignificant amounts of Cr oxide inside or on the surface of the depletion zone
- Removal of loosened steel grains by the liquid-metal flow in a later stage of severe selective leaching

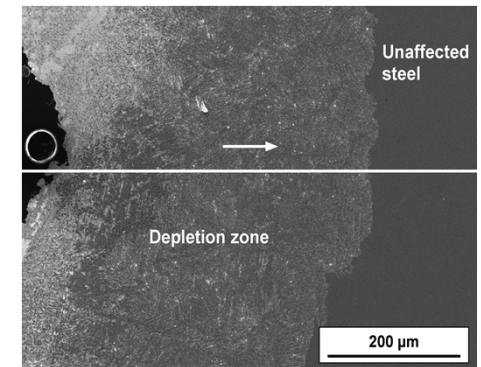
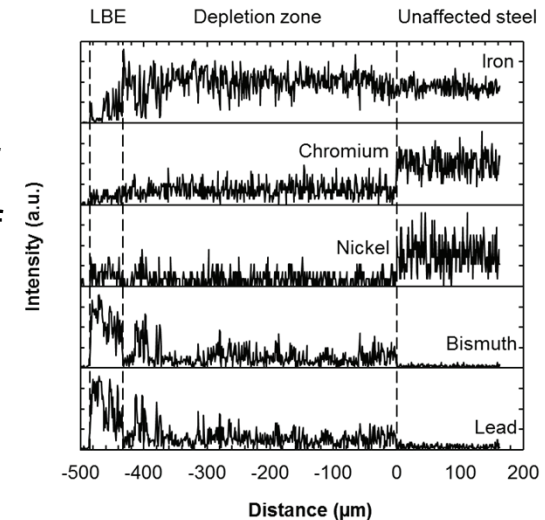
1.4571 after exposure for 5012 h at 550°C and $c_O \approx 10^{-6}$ mass%

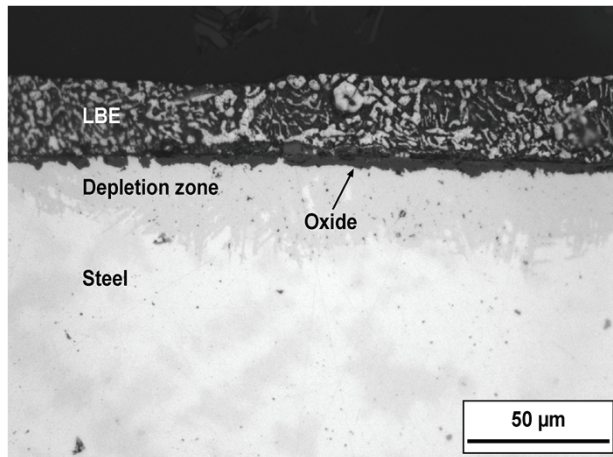
- Depletion zone penetrated by Pb and Bi underneath an oxide scale
- Oxide is Cr-rich in comparison to the $\text{Fe}(\text{Fe}_x\text{Cr}_{1-x})_2\text{O}_4$ layer formed by accelerated oxidation
- Result of the transition from selective leaching to oxidation (?)
- Formation of Cr-rich oxide scale can stop selective leaching (?)

- Typical scale observed for some of the tube samples from the CORRIDA loop

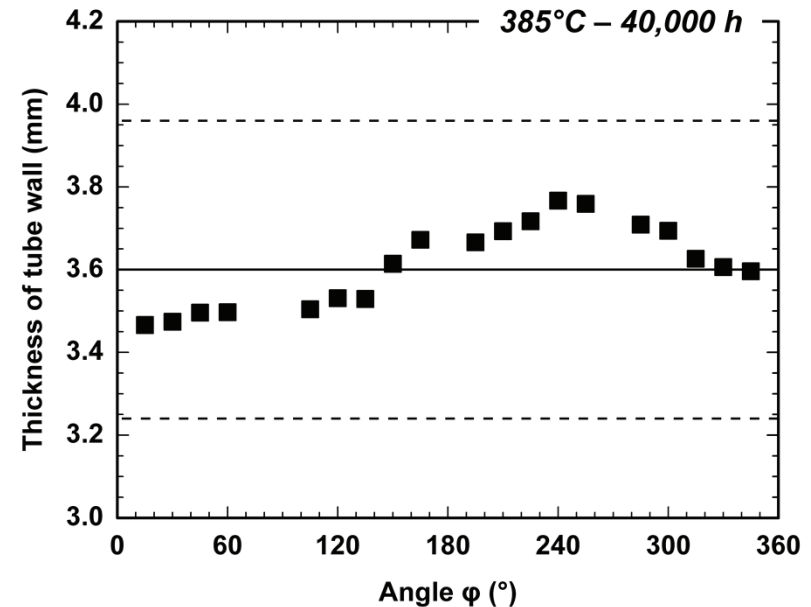
- Position after the cooler, before magnetic trap
- No significant change in wall thickness after the long-term exposure
- Oxide deposits in adherent solidified LBE, but only in some distance from the tube wall
- Neither deposits nor significant amounts of oxide on the surface

Electron-optical micrograph (BSE)

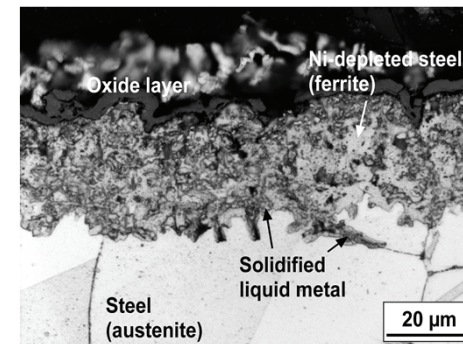
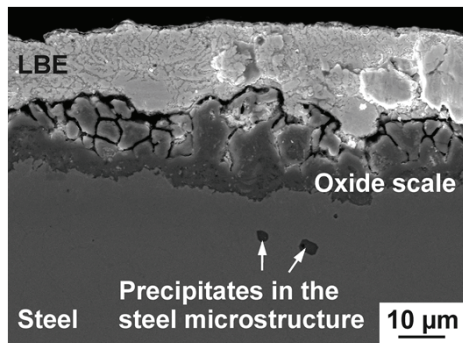
Oxide scale on T4

- T3 (6000 h) and T4 (40,000 h) mainly show oxidation; T3 was not pre-oxidised
- T1 (23,000 h) and T2 (29,000 h) show significant selective leaching

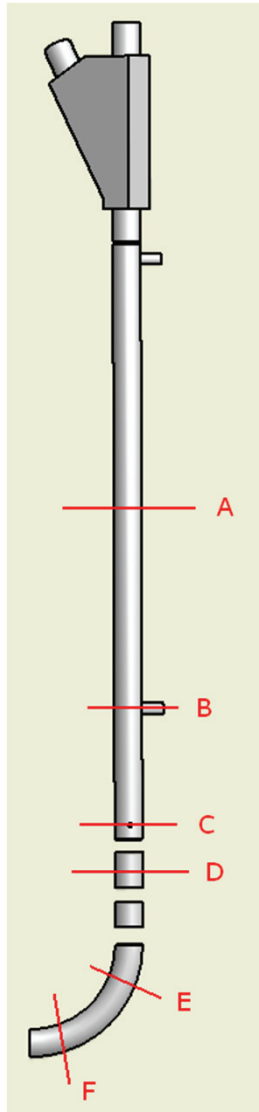
❑ Tubing of the first test-section after 66,000 h

- ❑ During experiment at 550°C/10⁻⁷ mass% O
- ❑ Prior to that, experiments at 450°C and 550°C/10⁻⁶ mass% O and pre-conditioning for 550°C/10⁻⁷ mass% O
- ❑ Ø10 mm leak in Position C that corresponds to the bottom end of the specimen rod
- ❑ **The particular specimen in this position (9Cr steel) was heavily corroded!**
- ❑ Up- and down-stream specimens inconspicuous
- ❑ Oxygen sensors did not indicate excessive oxygen consumption in the test-sections
- ❑ Problems with maintaining constant flow and sudden release of oxygen into the LBE

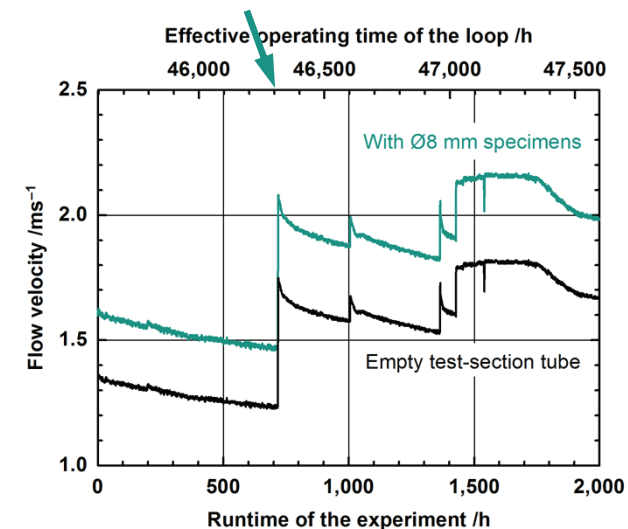
Tube failure after 715 h of the experiment at 550°C/10⁻⁷ mass% O

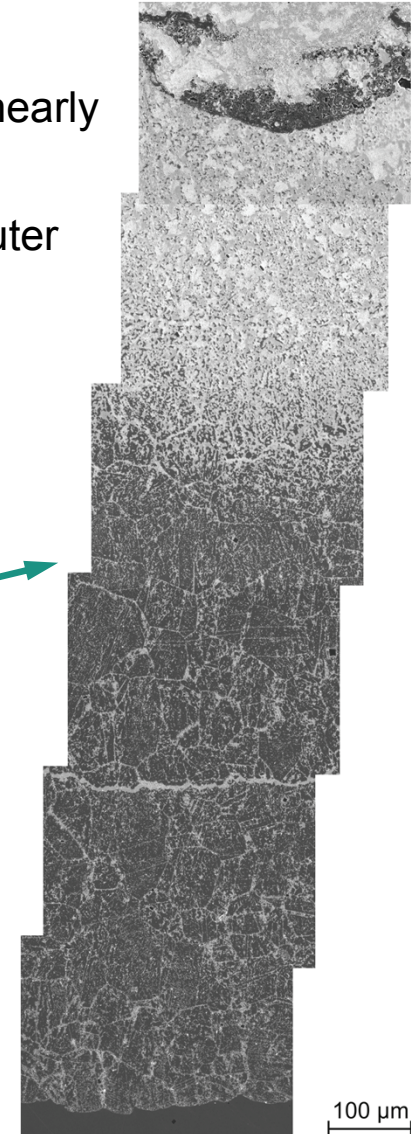
- Severe selective leaching along nearly the complete inner tube surface
- Depletion zone locally reaches outer tube surface
- Cracking of the mechanically unstable depletion zone probably is the ultimate cause of failure in Position C

In a cross-section nearby the site of failure
