KfK 3769
August 1986

Post Test Investigation of the Bundle Test ESBU-1

**On Temperature Escalation in PWR Fuel
Rod Simulator Bundles due to
the Zircaloy/Steam Reaction**

**S. Hagen, H. Kapulla, H. Malauschek,
K. P. Wallenfels, B. J. Buescher**
**Hauptabteilung Ingenieurtechnik
Projekt Nukleare Sicherheit**

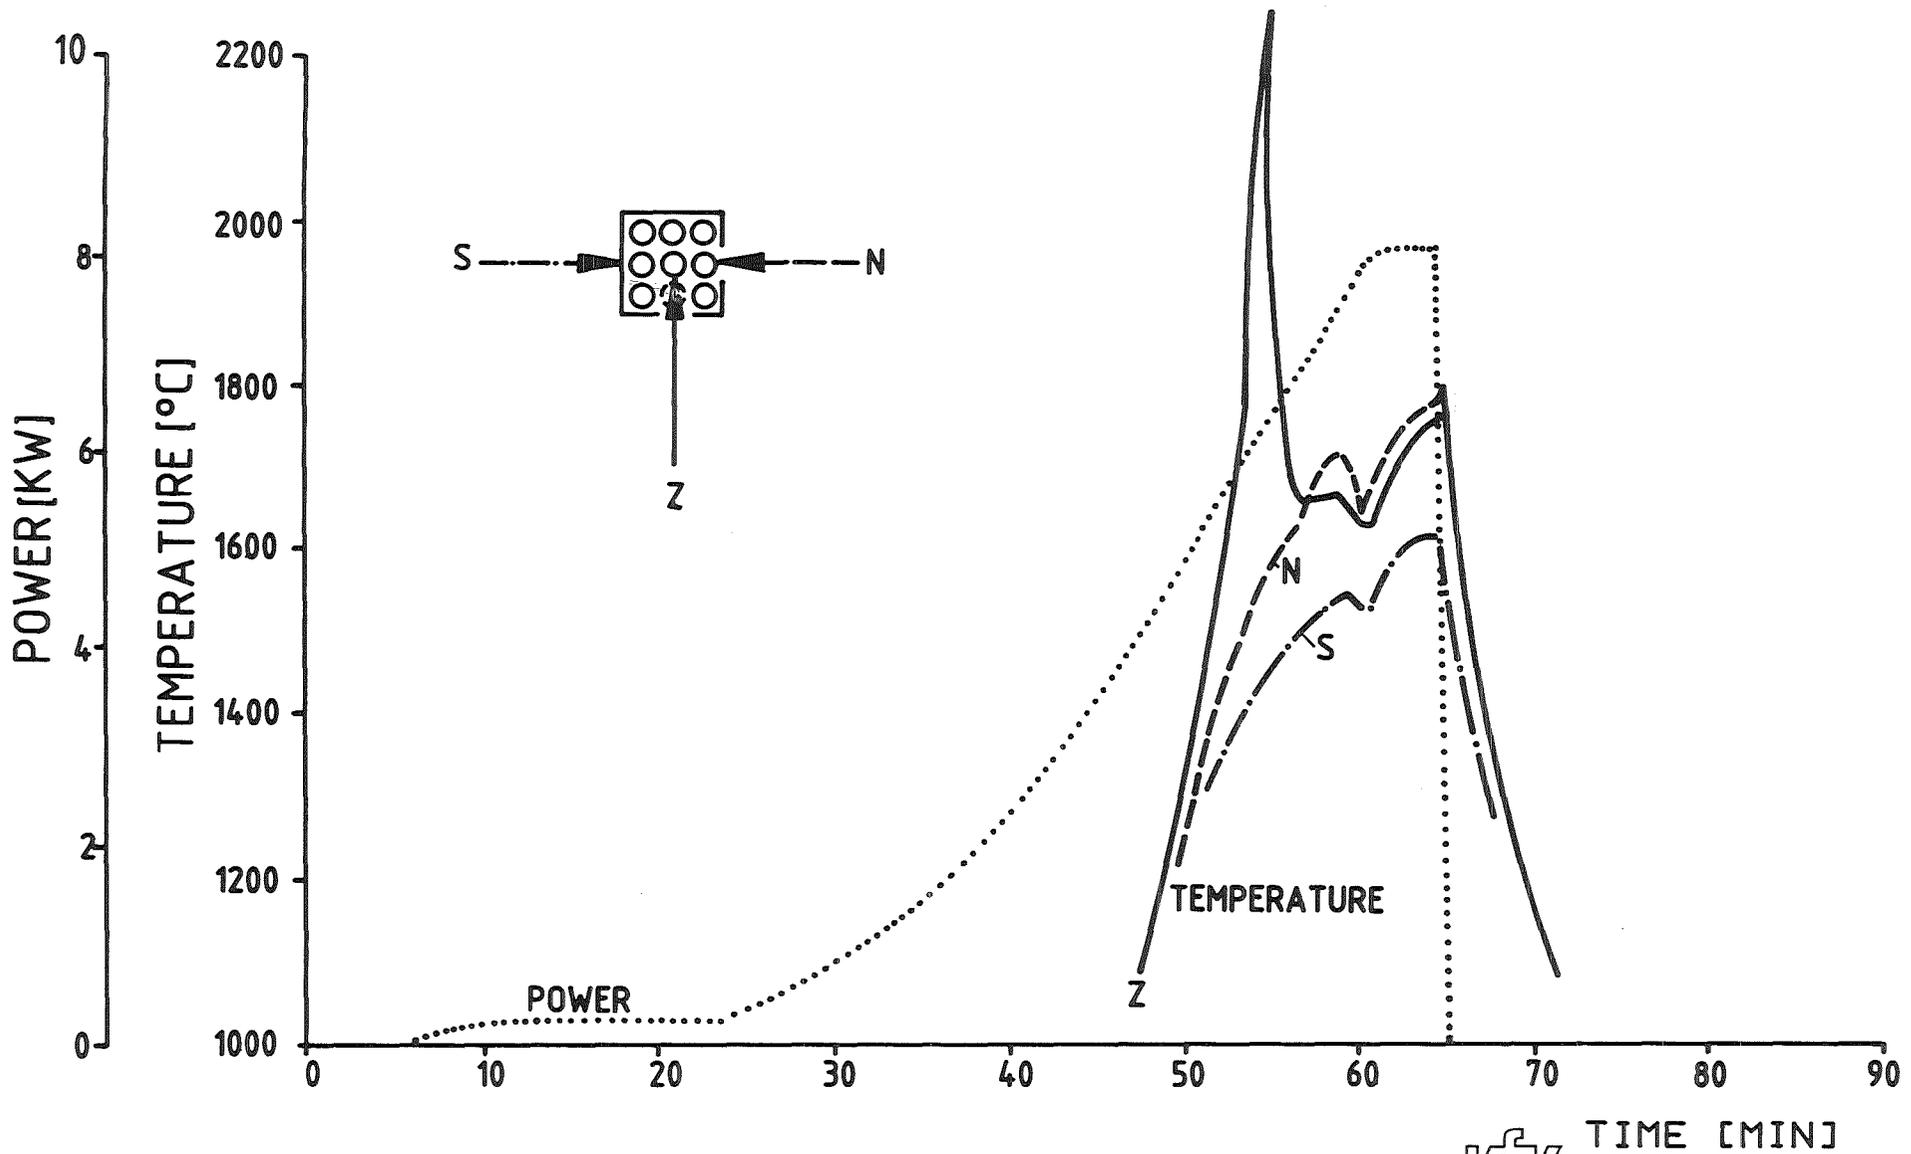
As seen in Figure 2 the surface temperature of the central rod increases at a rate of about 2 °C/s until about 1700 °C is reached. After reaching this temperature, the influence of zircaloy oxidation increases the heatup rate to about 6 °C/s, the temperature escalates to a peak of 2250 °C and then falls rapidly. On the outer rods and the shroud, the initial temperature peaking occurs somewhat later and is much lower in temperature. At 60 minutes into the test all three temperatures show a minimum. During the transient the electric power increases continuously up

FIG.2 : TEMPERATURES ON THE CENTRAL ROD (Z), SIDE ROD (N) AND SHROUD (S) 145 MM FROM THE UPPER END OF CLADDING COMPARED TO THE ELECTRIC POWER INPUT FOR ESBU-1

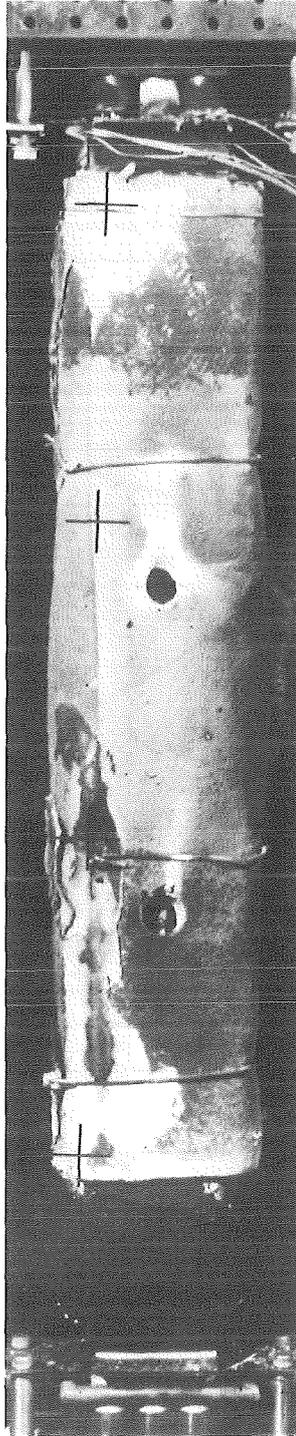
The appearance of the test assembly following the test with the insulation and shroud still in place is shown in Figure 3. The insulation and shroud were intact following the test. However, both were severely embrittled, as seen during the removal of the insulation from the shroud. The insulation, originally a flexible mat, broke into many pieces. Even though removal of the insulation was done carefully, pieces of the shroud broke off as is seen in Figure 4. The shroud was severely oxidized over the center region of the bundle and broke away in several places revealing the fuel rod simulators.

FIGURE 3: BUNDLE ESBU-1 WITH INSULATION AFTER THE TEST

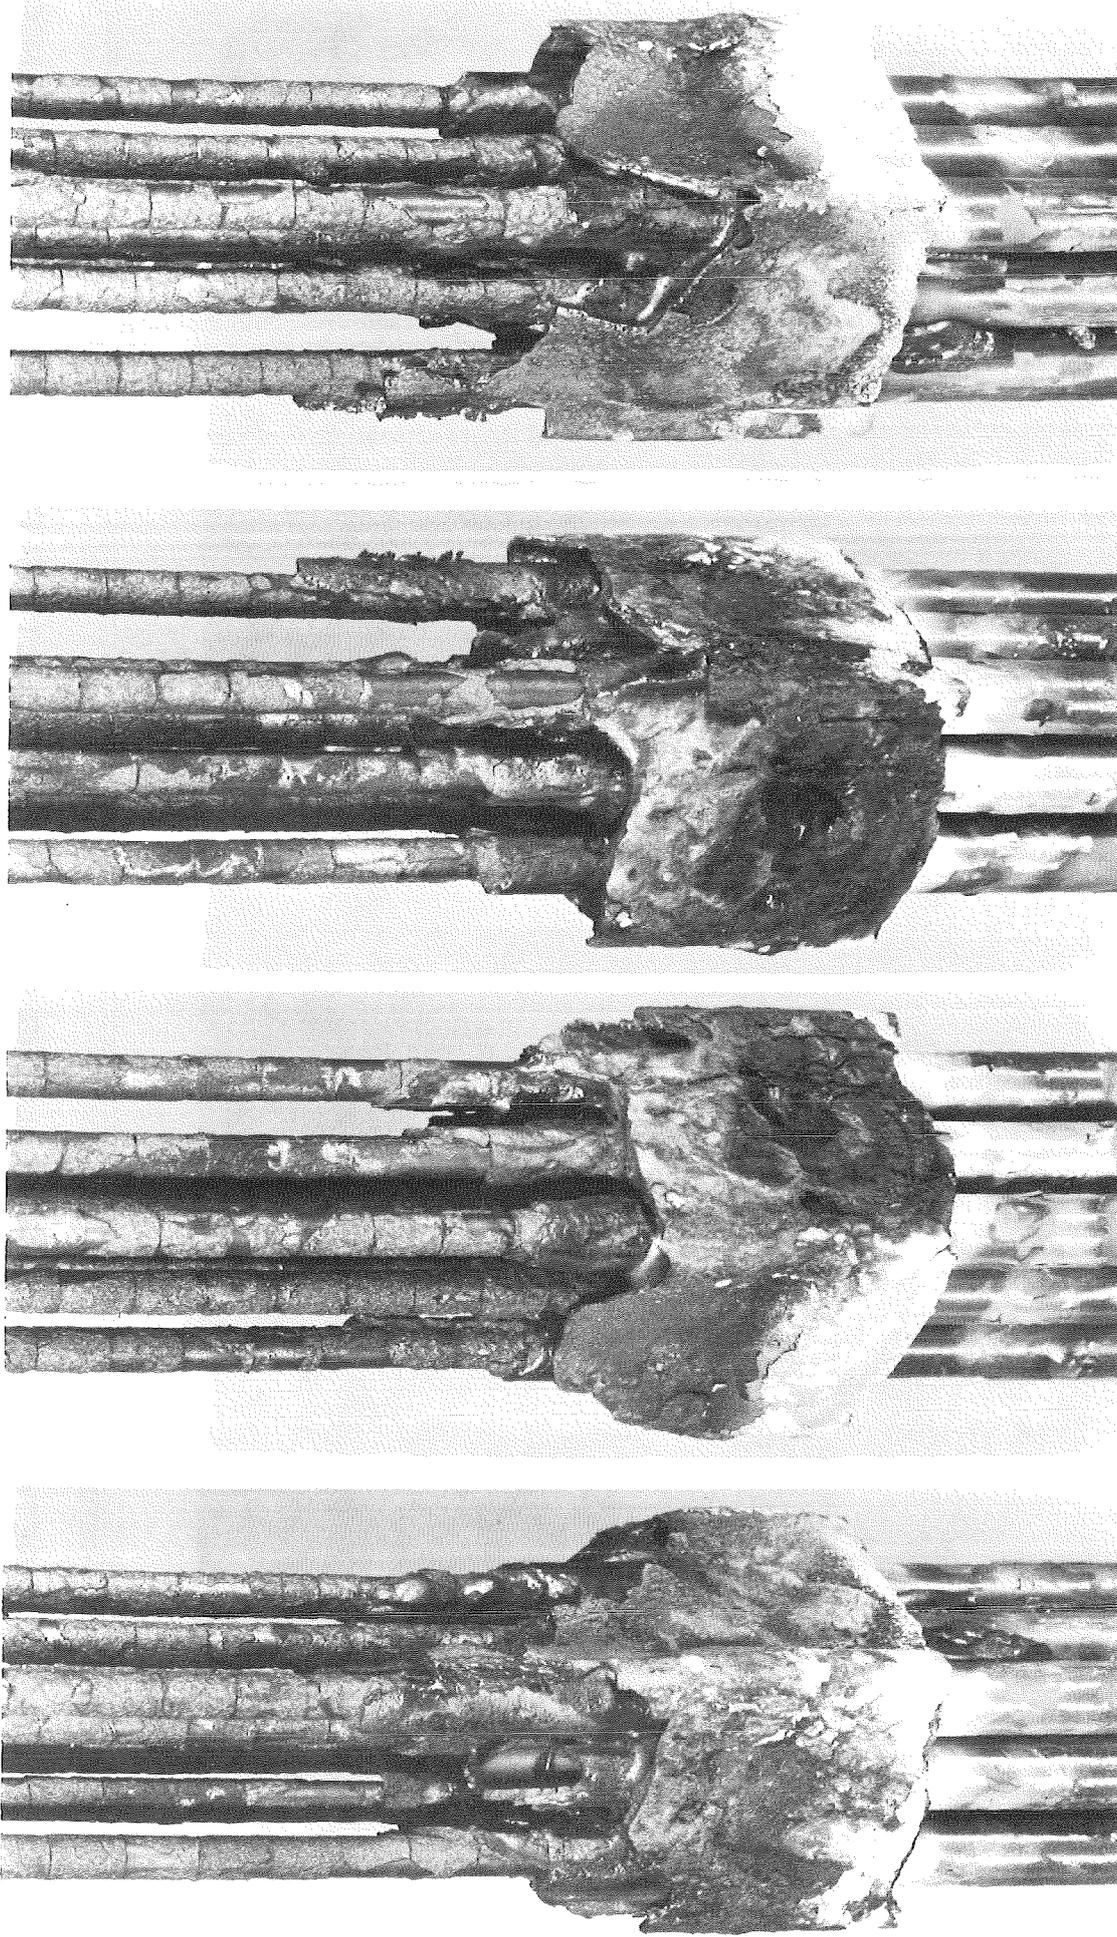
FIGURE 9: APPEARANCE OF THE BLOCKED REGION OF ESBU-1 AS SEEN FROM ABOVE

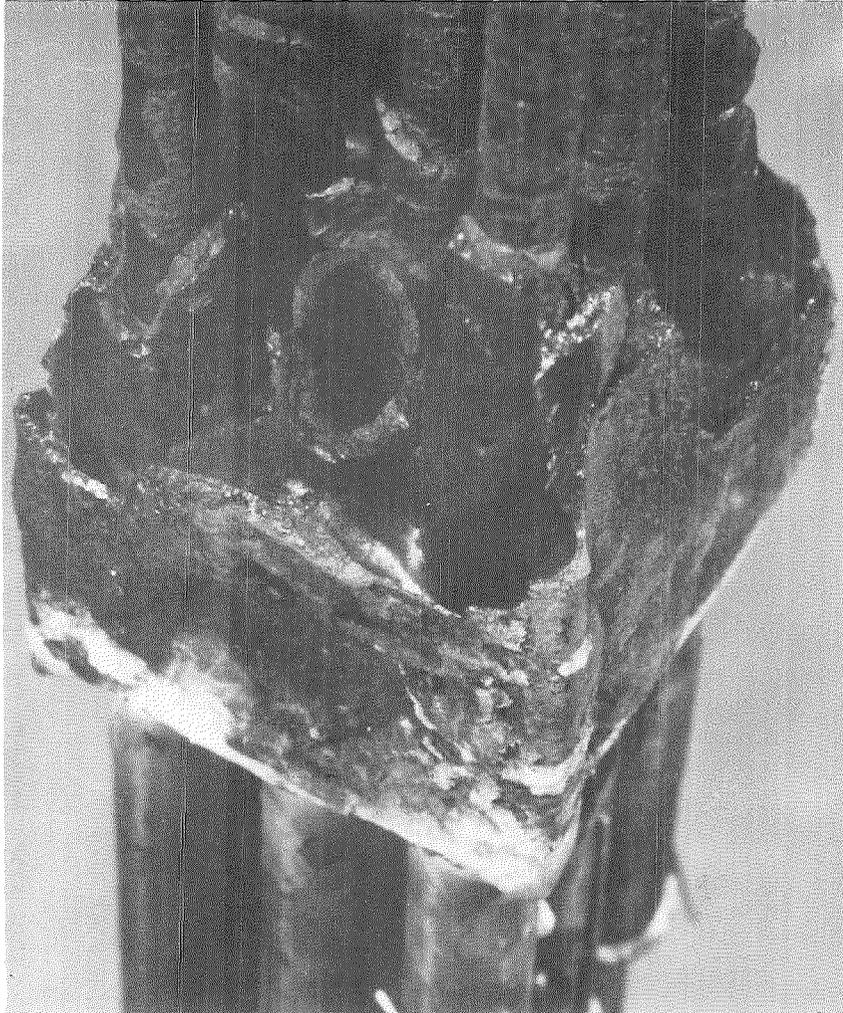
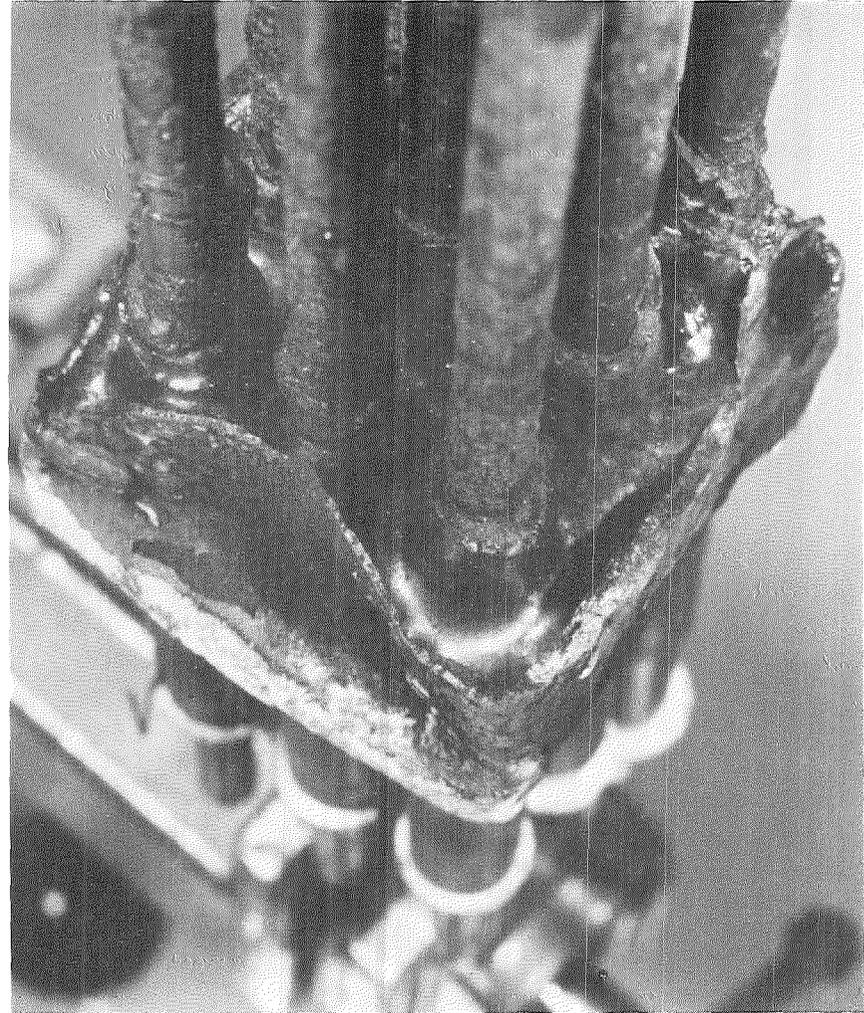
FIGURE 10: DETAILS OF BLOCKED REGION OF ESBU-1 SHOWING THE REFROZEN MELT FROM ABOVE

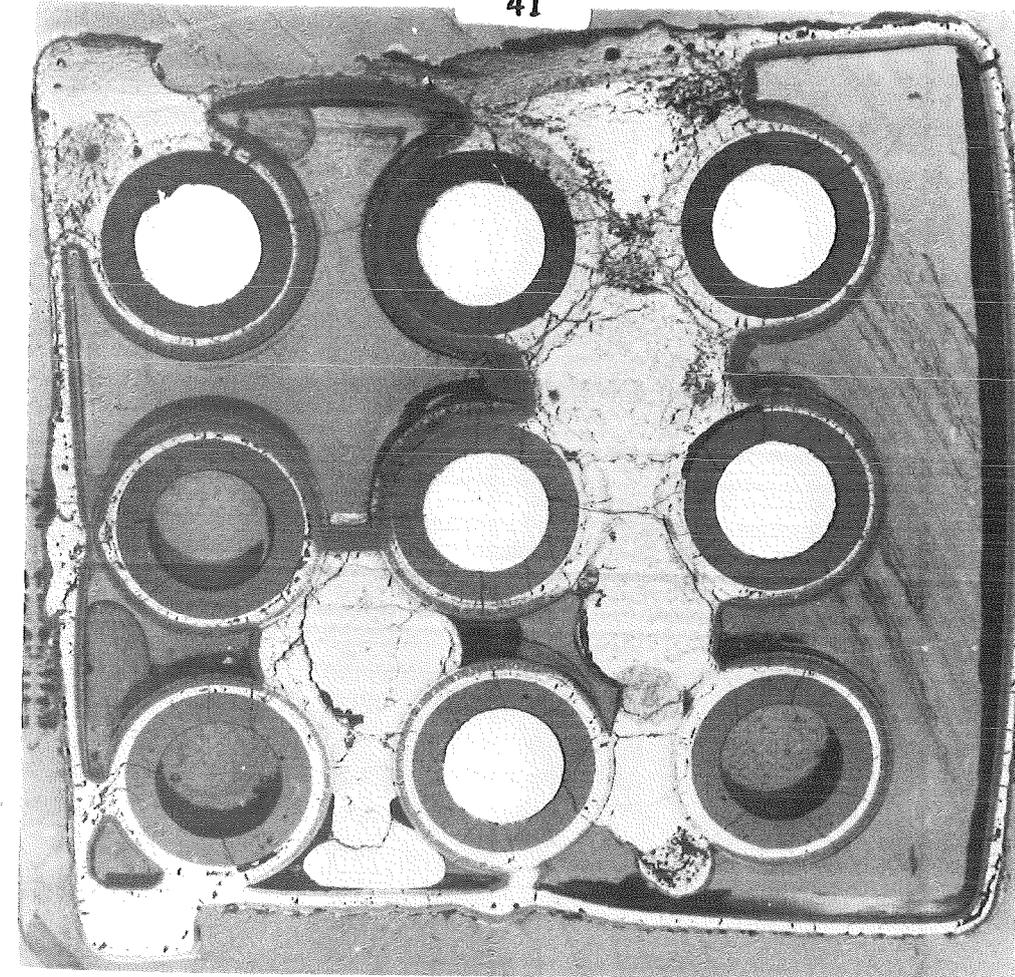
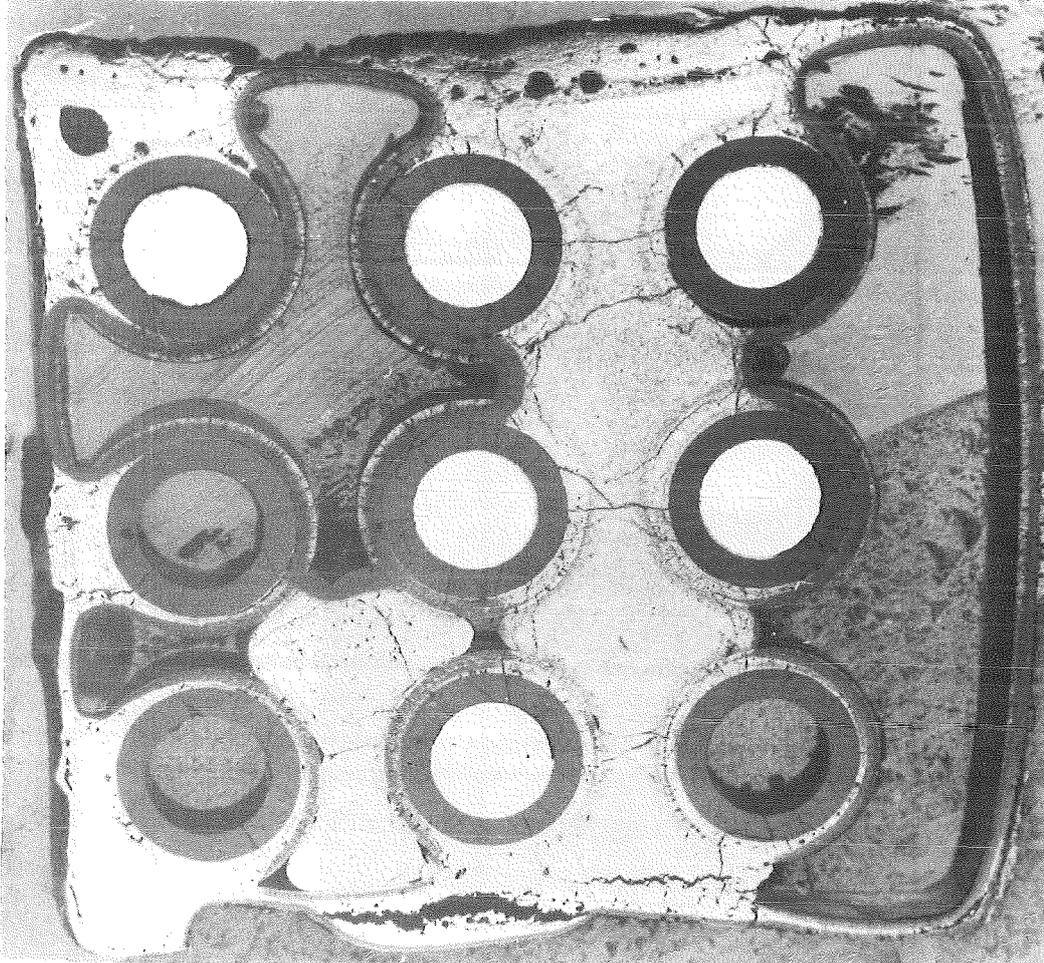
FIGURE 17: CROSS SECTIONS OF ESBU-1 AT 96 AND 86 MM ABOVE THE BOTTOM OF THE BUNDLE

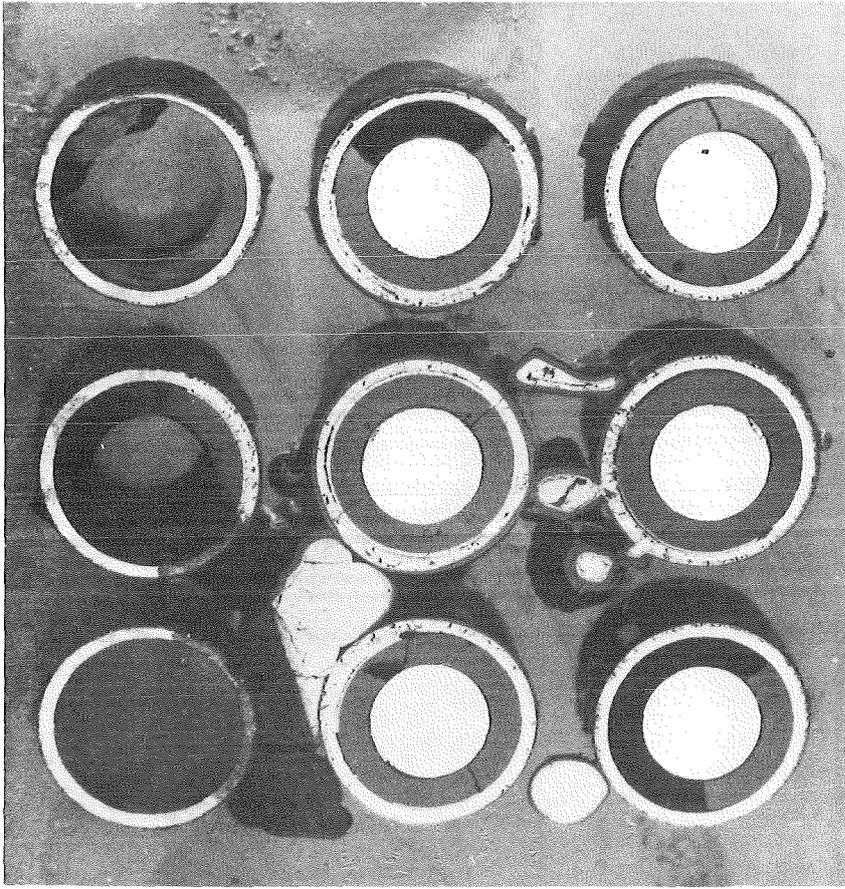
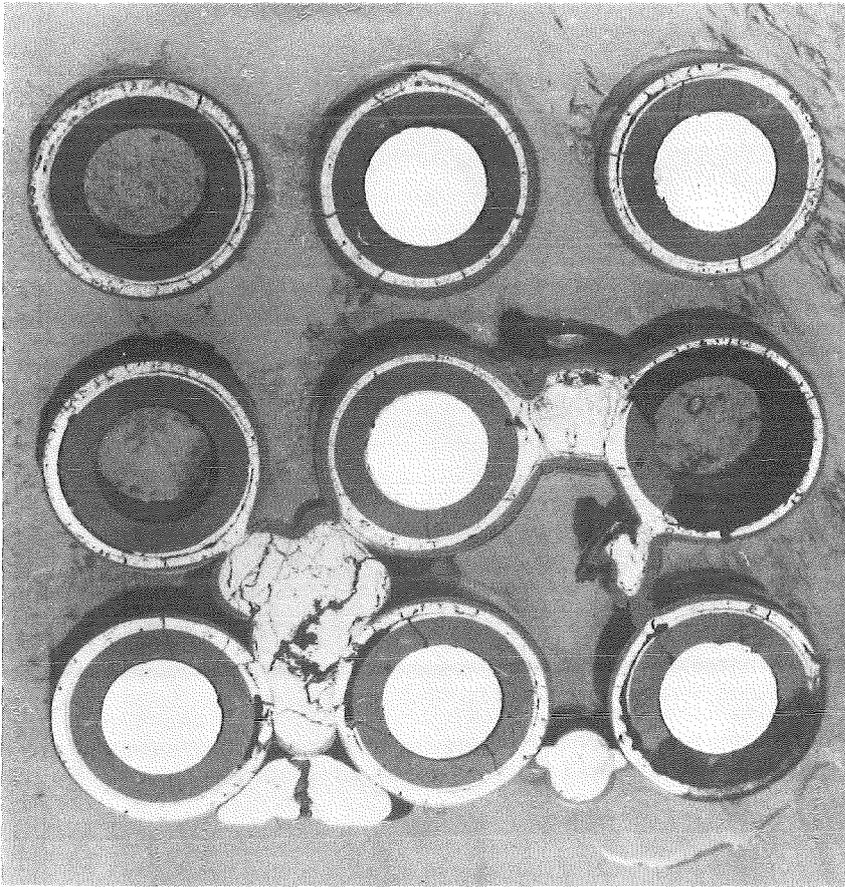
FIGURE 18: CROSS SECTIONS OF ESBU-1 AT 76 AND 66 MM ABOVE THE BOTTOM OF THE BUNDLE

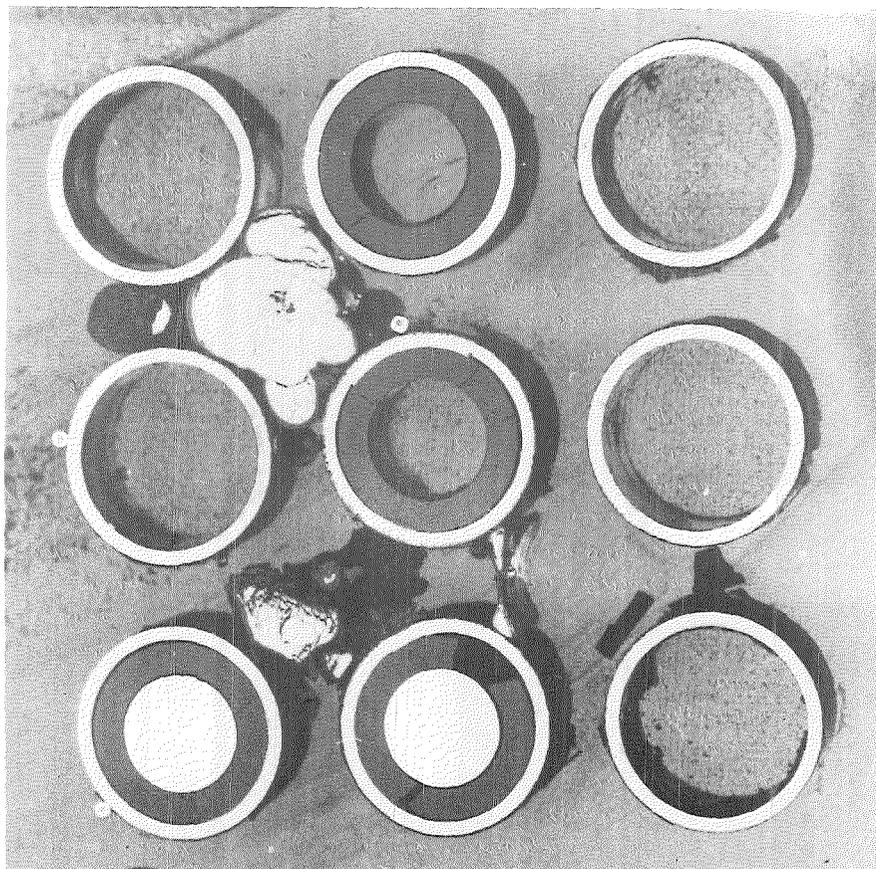
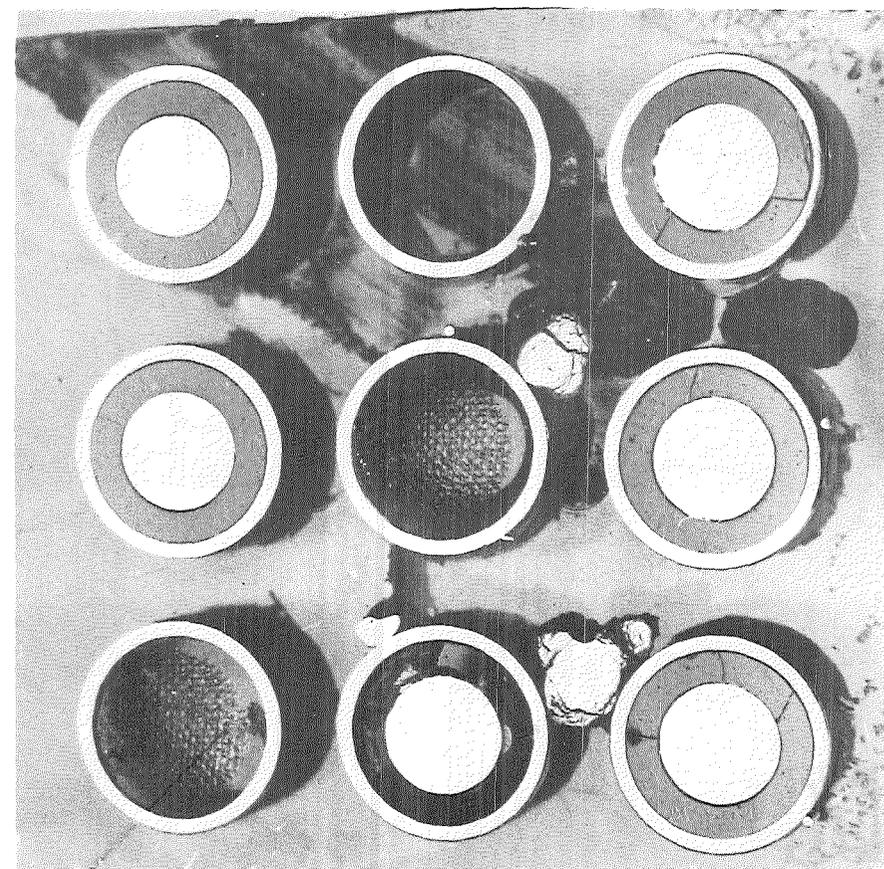
FIGURE 19: CROSS SECTIONS OF ESBU-1 AT 51 AND 15 MM ABOVE THE BOTTOM OF THE BUNDLE

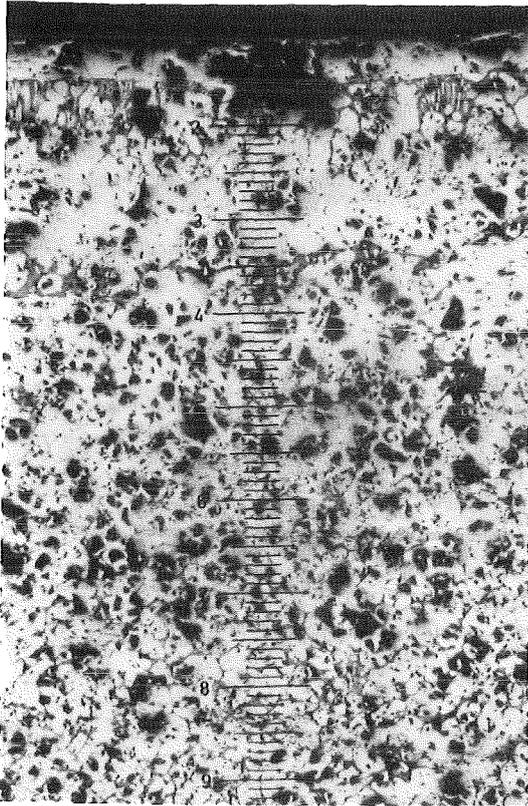
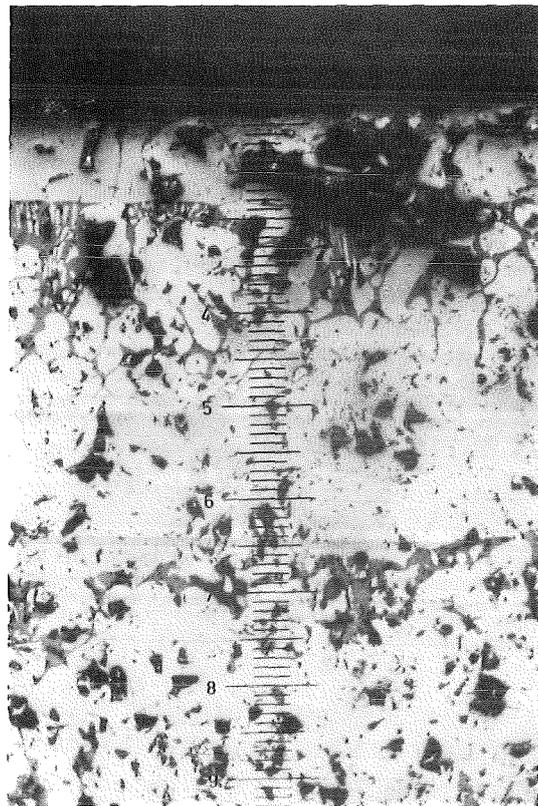
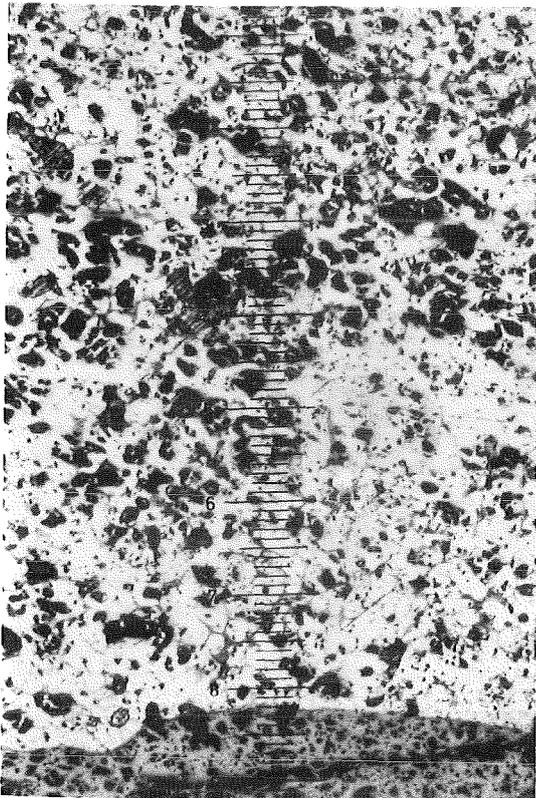
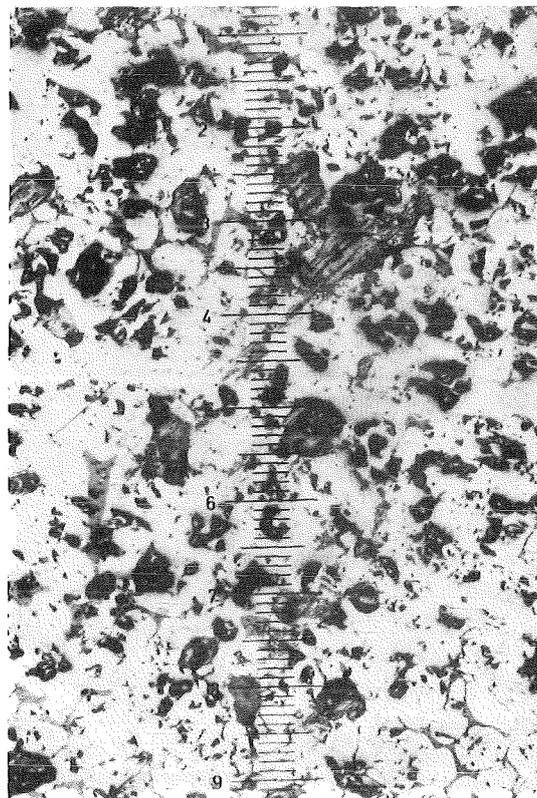
FIG. 27 DETAILS OF THE CROSS SECTION AT 116 MM AT POS. SHOWN IN THE OVERVIEW FIG. 20 (ESBU-1)

The micrographs of the cross section at 116 mm are given in figures 27 to 31. As one can see in figure 13 the cross section at 119 mm is the surface above the saw cut and the cross section at 116 mm is the surface below the saw cut. This means that the overview pictures from the cross section 119 mm are left-right reversed to the overview pictures of the cross section at 116 mm.

Location 1 is the region containing the former shroud. On this side of the bundle much less oxidation is found than on the other side 3 mm higher. The frozen melt in areas 2, 3, 4, 5 and 6 is shown in figures 27 to 29.

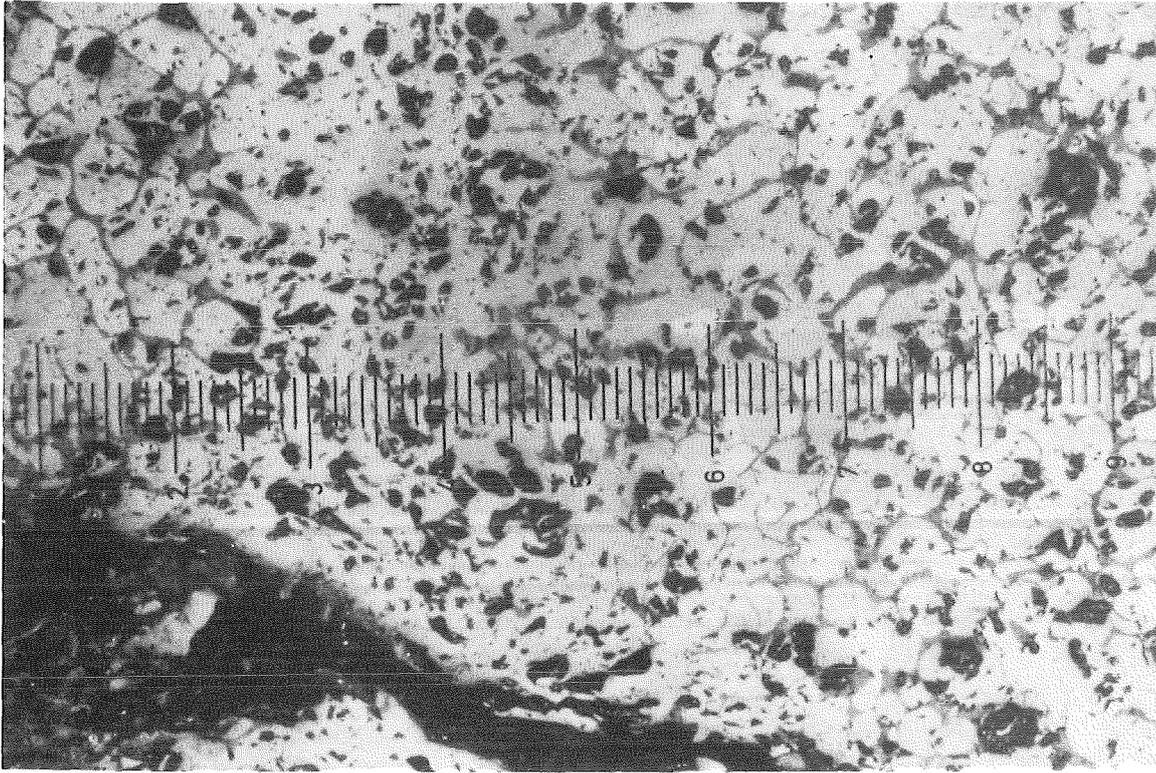
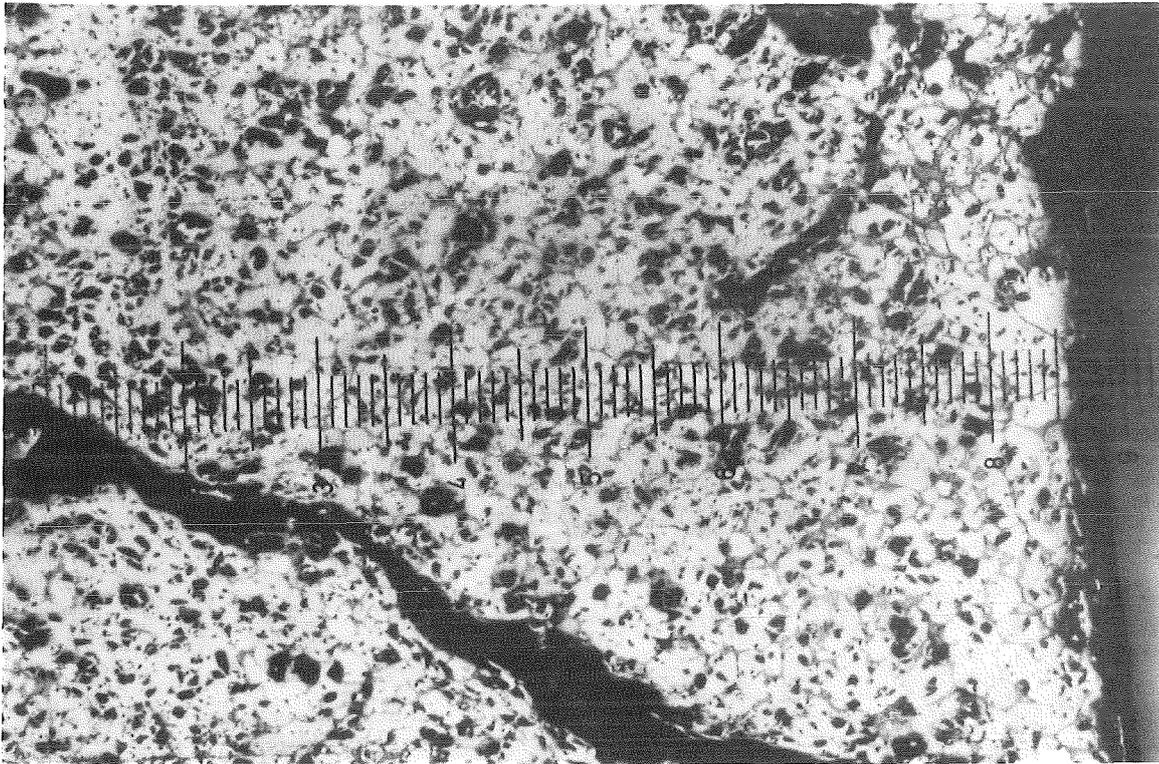
FIG. 30 DETAILS OF THE CROSS SECTION AT 116 MM AT POS. SHOWN IN THE OVERVIEW FIG. 20 (ESBU-1)

Figure 30 shows two micrographs taken from location 7. At this location and elevation, the UO₂ ring pellet is missing. The test rod here was not heated and extended only part way up the bundle to allow temperature measurements of the central rod with the two color pyrometer. The test rod contained a part length tungsten rod to position the test rod. During the high temperature transient, the cladding melted and filled the gap at this elevation between the cladding and the tungsten rod. The piece of tungsten fell out of the section during cutting and the hole left by the tungsten rod is filled with epoxy.

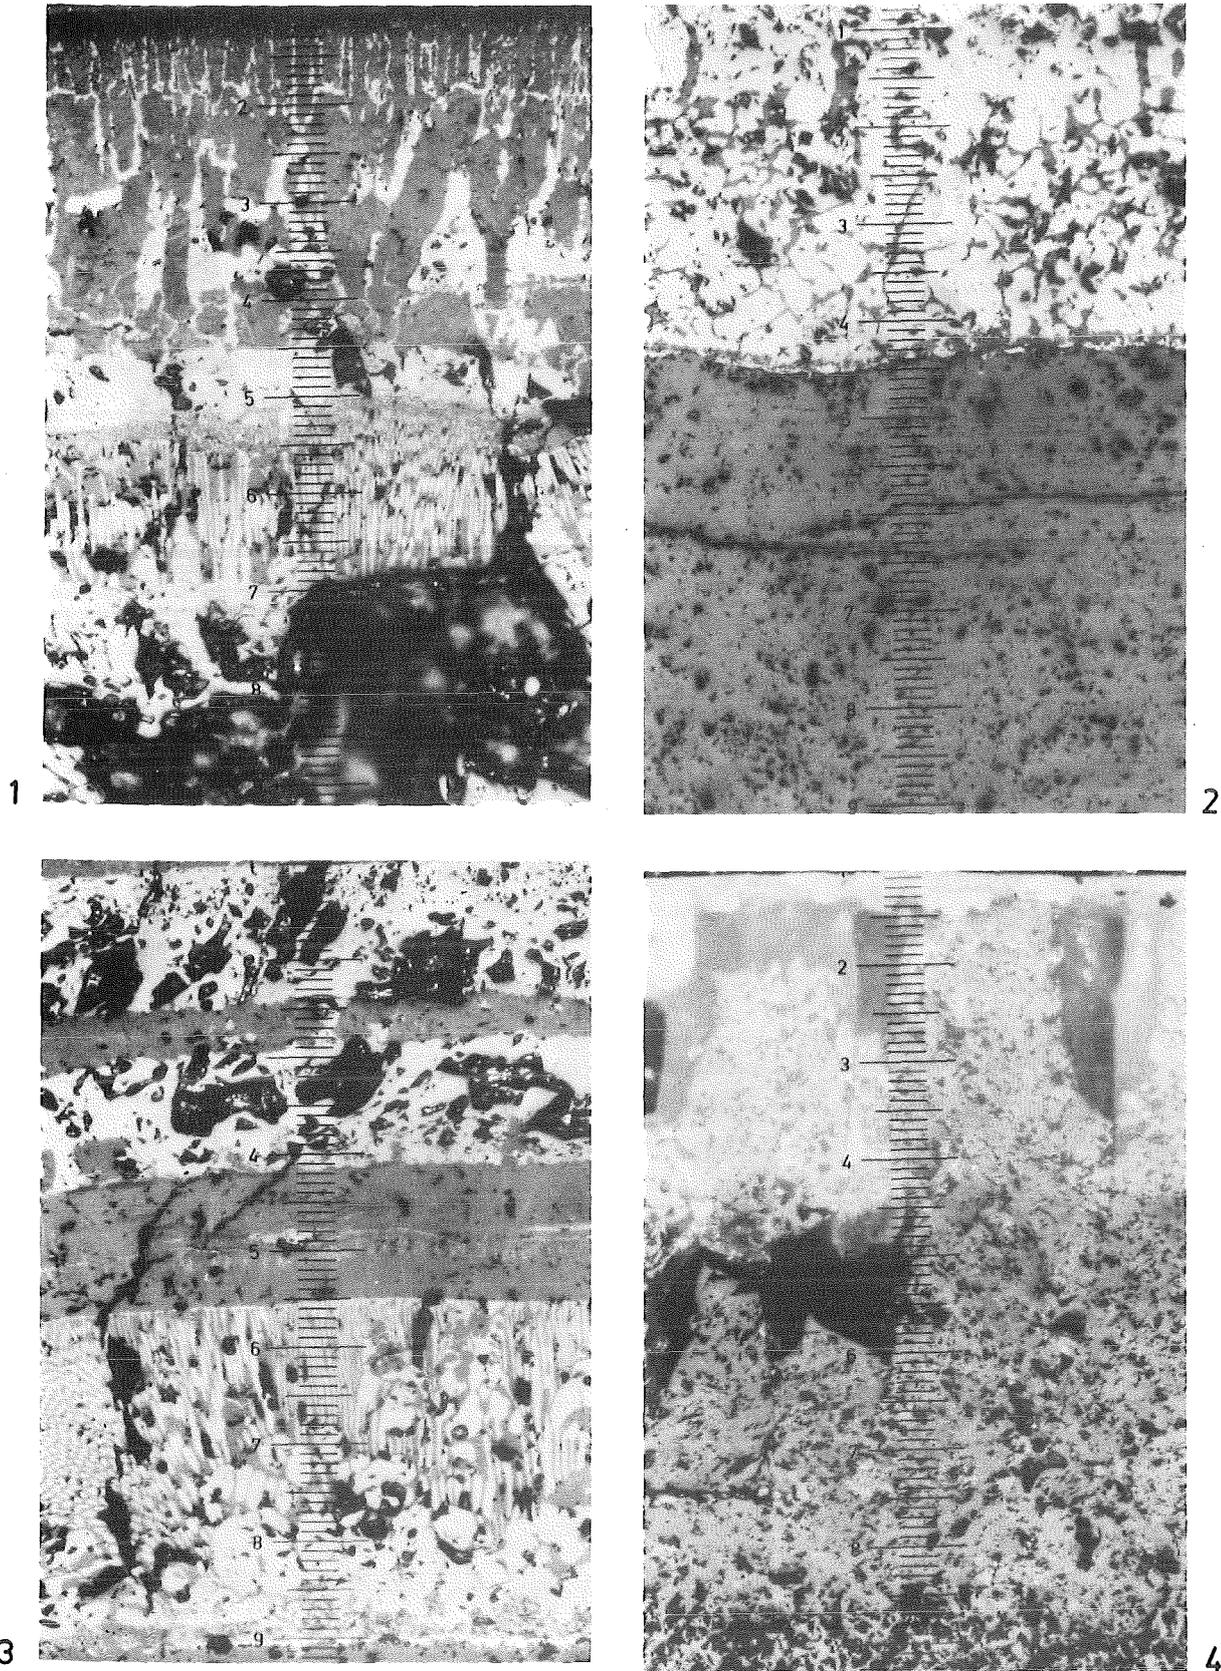
FIG. 32 DETAILS OF THE CROSS SECTION AT 106 MM AT POS. SHOWN IN THE OVERVIEW FIG.20 (ESBU-1)

The micrographs of cross section 4 at 106 mm elevation are given in Figures 32 to 37. This cross section corresponds to the upper surface of segment 4 and it is equivalent to the cross section from 119 mm elevation. The shroud is located at position a in these cross sections. Due to the fact that the melt had not covered the inner surface of the shroud at this elevation we find much more oxidation of the zircaloy than is observed in the cross section 30 mm higher.

In Figure 32, location 1 shows the region of former cladding which was not covered by melt. The outer highly oxidized surface of the cladding is seen in the upper part of the picture. Location 2 shows the opposite side of the test rod. Here the cladding is completely covered with melt and has been completely dissolved. Section 2 shown on Figure 32 is the region where the UO_2 and melt are in contact.

The micrographs taken of locations 3 b and c in Figures 32, 34 and 35 respectively show areas of previously oxidized cladding which were not completely dissolved by the melt at the end of the test. One can see here how the zirconium is attacked by the melt through cracks in the oxide layer. This attack of the melt on the oxidized zircaloy is discussed in a later chapter. Figures 69 to 71 show enlarged views of the same regions.

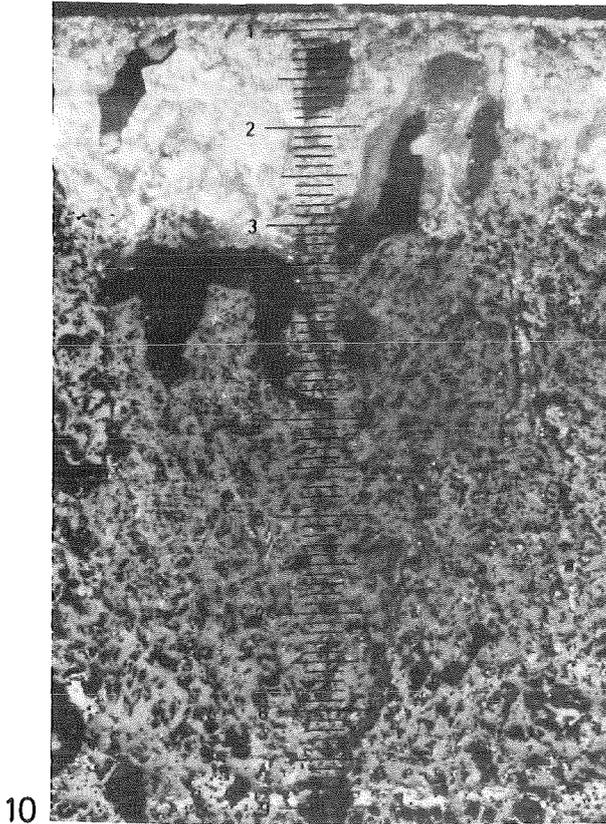
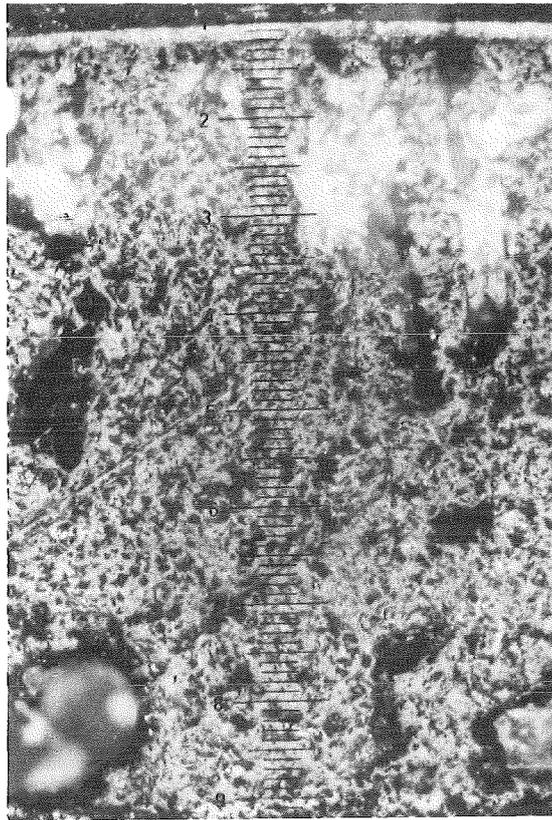
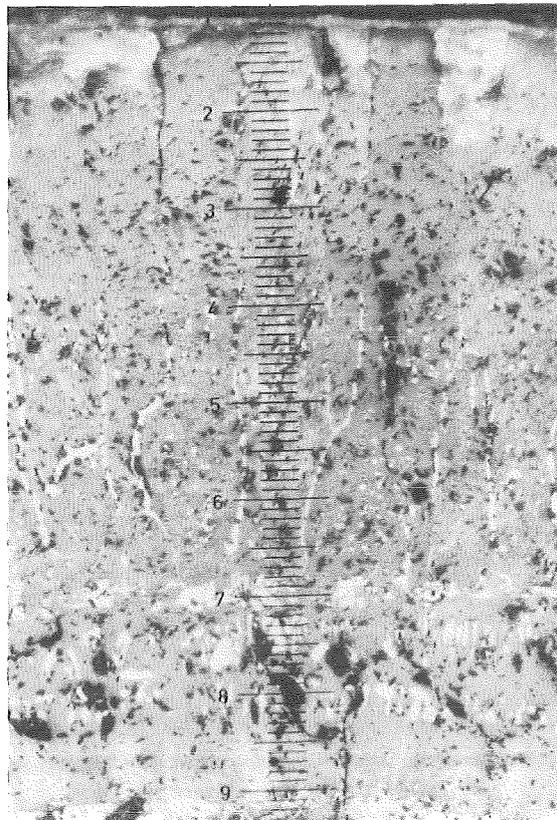
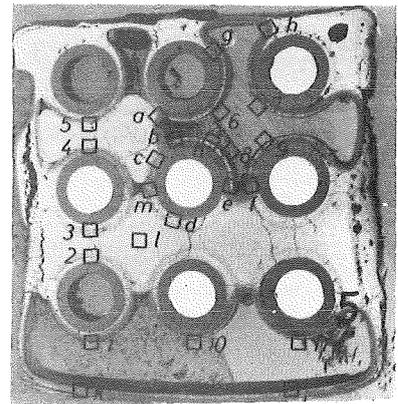
FIG. 38 DETAILS OF THE CROSS SECTION AT 96 MM AT POSITIONS SHOWN IN THE OVERVIEW FIG.20 (ESBU-1)

The micrographs of cross section 5 at 69 mm elevation are given in Figures 38 to 50. Locations 1, 10 and 11 in Figure 38 show oxidized cladding in direct contact with steam which has been nearly completely oxidized. In Figure 39 locations 2, 3, 4 and 5 show regions of former cladding which are covered by melt.

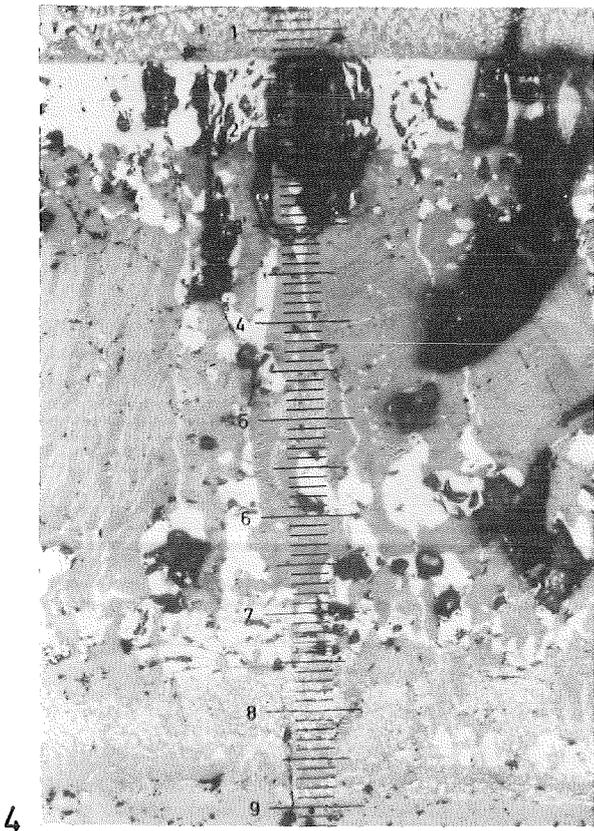
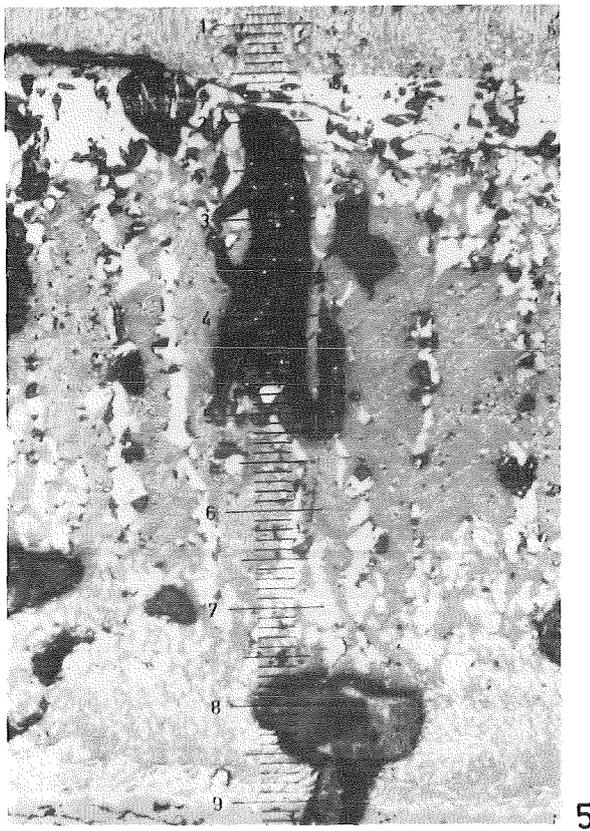
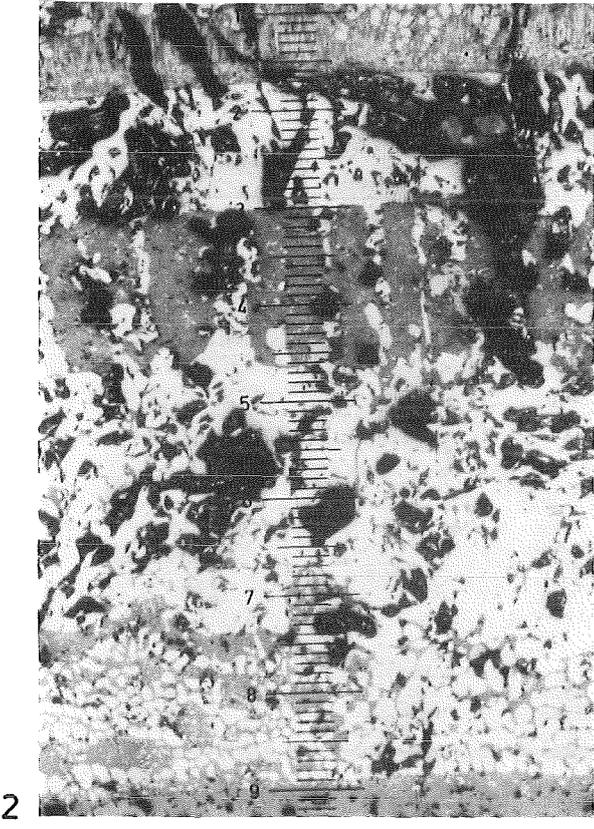
FIG. 39 DETAILS OF THE CROSS SECTION AT 96 MM AT POS. SHOWN IN THE OVERVIEW FIG.20 (ESBU-1)

The melt between locations 2 and 3 appears to have run down much earlier than the melt between location 4 and 5 for much less zirconium oxide is found in areas 2 and 3. In Figure 40 locations 6, 7, 8 and 9 show cladding which has had direct access to the steam channel. In comparison to the oxidized cladding in Figure 38 which reacted under the conditions of stagnant steam, a quite different oxide structure is found. In Figure 40 typical large grains of zirconium oxide are found. Location a, c and d in Figures 41, 43 and 44 respectively show regions of oxidized cladding on the same rods which are covered by melt. Here one can clearly see the reaction of the melt with the zirconium oxide as well as the sharp boundary line between the outside surface of the oxidized cladding and the region of the melt. In all the micrographs one can see a high concentration of oxide phases. This appears as a seam around the former boundary of the cladding. Location b in Figure 42, location e in Figure 45 and location f in Figure 46 shows the melt next to the fuel rod and in direct contact with the steam channel. Here the melt adjacent to the UO_2 pellets is in direct contact with the steam and is completely oxidized. In Figure 42 on the right side of the lower picture one can see the UO_2 pellet. On the lower side of the picture, one sees completely oxidized melt which is in direct contact with the steam channel. And in the upper photograph a mixture of zircaloy and oxidized inclusions is seen. In Figure 45, the UO_2 pellet is again seen on the right side, but in this picture the completely oxidized melt is at the top. In Figure 46, the UO_2 pellet once again is on the right side, but the fully oxidized region appears in the lower part of the picture. In Figure 47 position g shows a region of former cladding in direct contact with the steam. The cladding is nearly completely oxidized. Position h on Figure 48 gives the melt in direct contact to the steam. One can see here how the oxidation forms a layer on the surface of the melt. Positions i and k in Figures 49 and 50 show the oxidized shroud.
