KfK 3769
August 1986

Post Test Investigation of the Bundle Test ESBU-1

**On Temperature Escalation in PWR Fuel
Rod Simulator Bundles due to
the Zircaloy/Steam Reaction**

**S. Hagen, H. Kapulla, H. Malauschek,
K. P. Wallenfels, B. J. Buescher**
**Hauptabteilung Ingenieurtechnik
Projekt Nukleare Sicherheit**

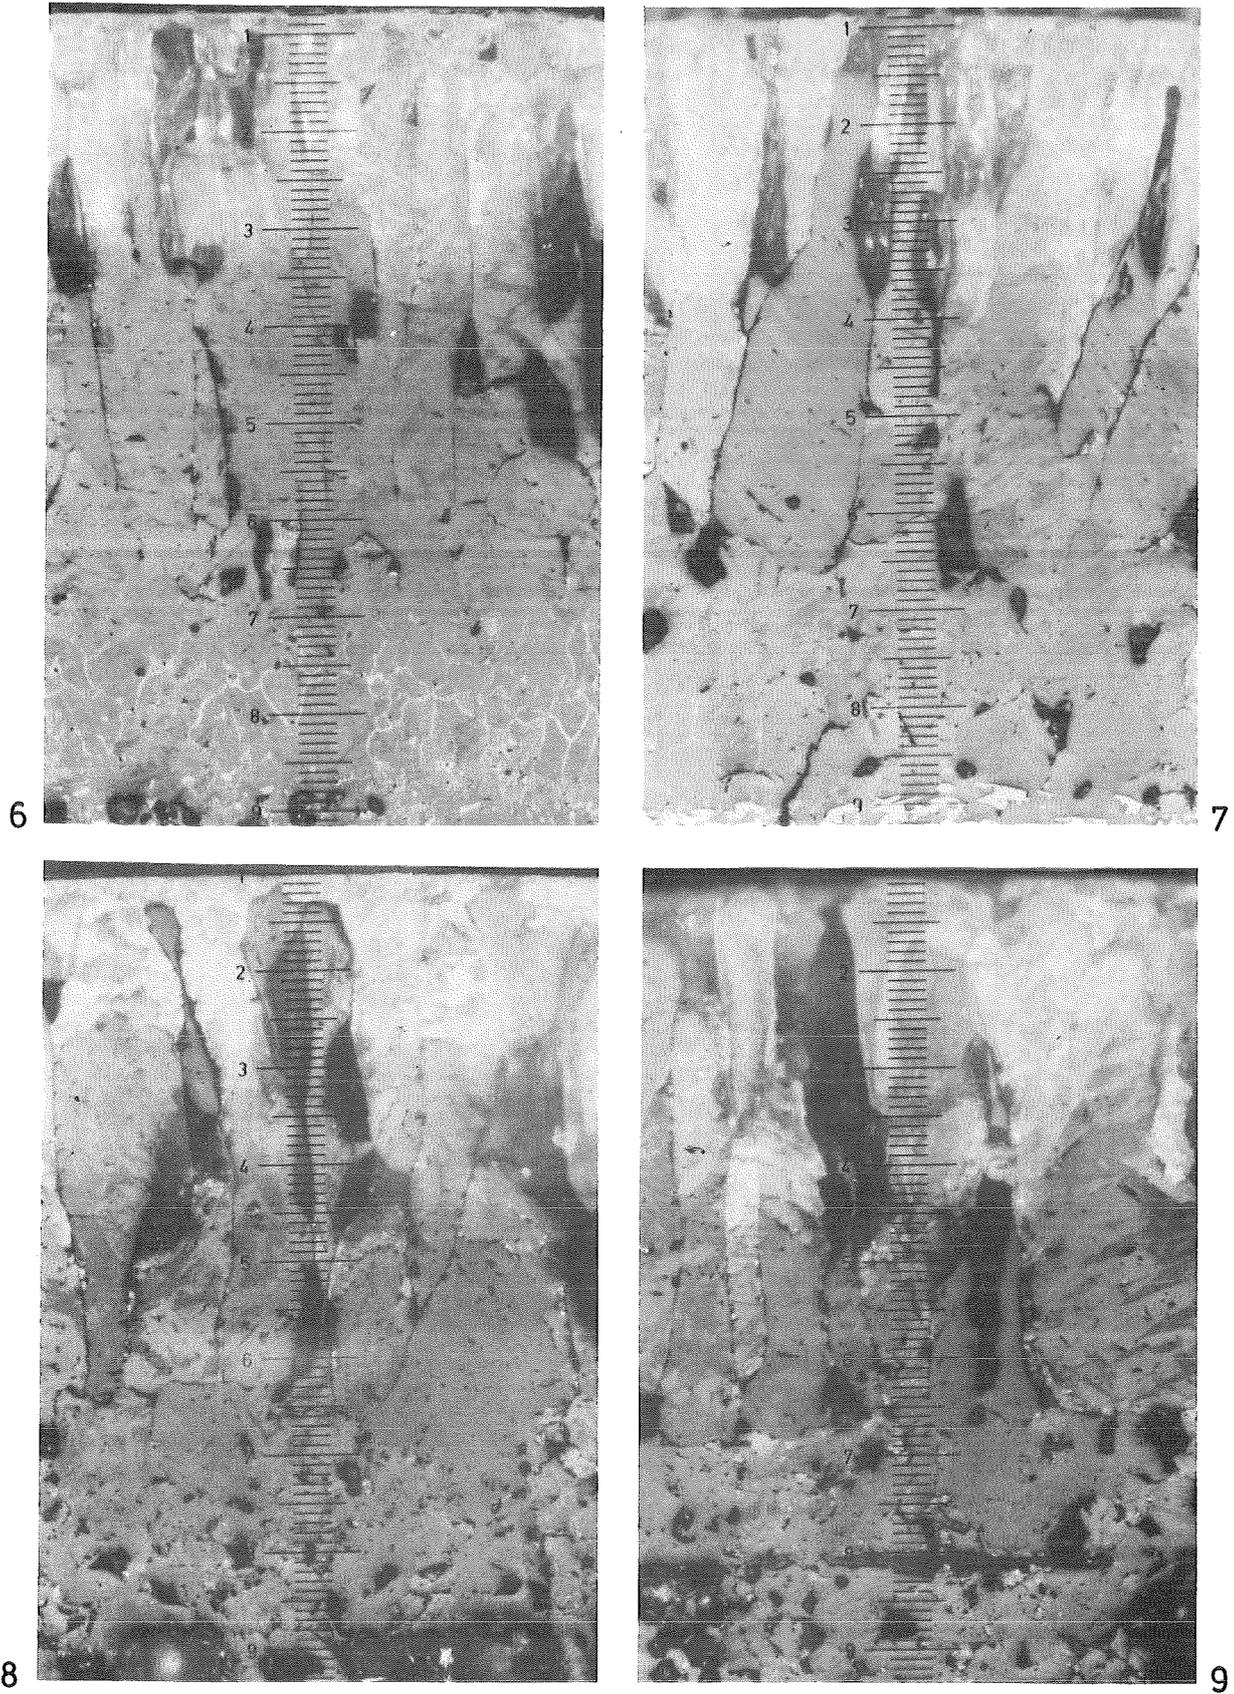
FIG. 40 DETAILS OF THE CROSS SECTION AT 96 MM AT POS SHOWN IN THE OVERVIEW FIG.20 (ESBU-1)

The melt between locations 2 and 3 appears to have run down much earlier than the melt between location 4 and 5 for much less zirconium oxide is found in areas 2 and 3. In Figure 40 locations 6, 7, 8 and 9 show cladding which has had direct access to the steam channel. In comparison to the oxidized cladding in Figure 38 which reacted under the conditions of stagnant steam, a quite different oxide structure is found. In Figure 40 typical large grains of zirconium oxide are found. Location a, c and d in Figures 41, 43 and 44 respectively show regions of oxidized cladding on the same rods which are covered by melt. Here one can clearly see the reaction of the melt with the zirconium oxide as well as the sharp boundary line between the outside surface of the oxidized cladding and the region of the melt. In all the micrographs one can see a high concentration of oxide phases. This appears as a seam around the former boundary of the cladding. Location b in Figure 42, location e in Figure 45 and location f in Figure 46 shows the melt next to the fuel rod and in direct contact with the steam channel. Here the melt adjacent to the UO_2 pellets is in direct contact with the steam and is completely oxidized. In Figure 42 on the right side of the lower picture one can see the UO_2 pellet. On the lower side of the picture, one sees completely oxidized melt which is in direct contact with the steam channel. And in the upper photograph a mixture of zircaloy and oxidized inclusions is seen. In Figure 45, the UO_2 pellet is again seen on the right side, but in this picture the completely oxidized melt is at the top. In Figure 46, the UO_2 pellet once again is on the right side, but the fully oxidized region appears in the lower part of the picture. In Figure 47 position g shows a region of former cladding in direct contact with the steam. The cladding is nearly completely oxidized. Position h on Figure 48 gives the melt in direct contact to the steam. One can see here how the oxidation forms a layer on the surface of the melt. Positions i and k in Figures 49 and 50 show the oxidized shroud.

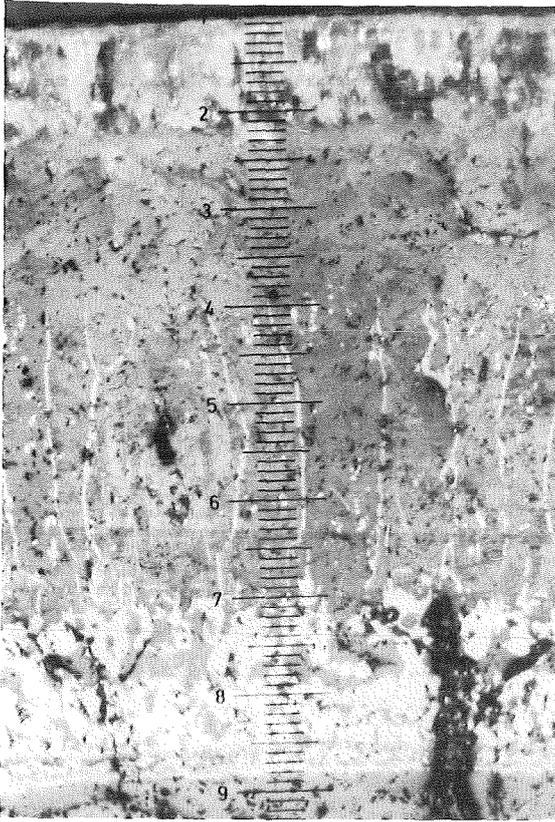
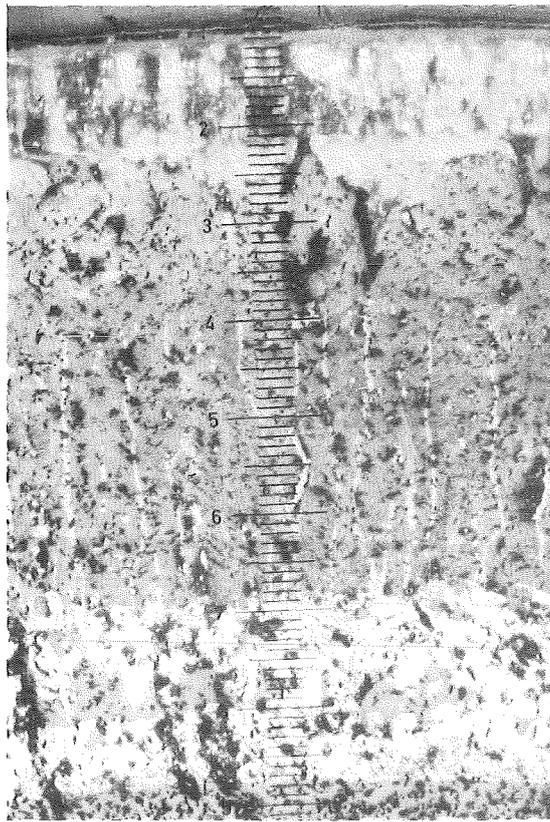
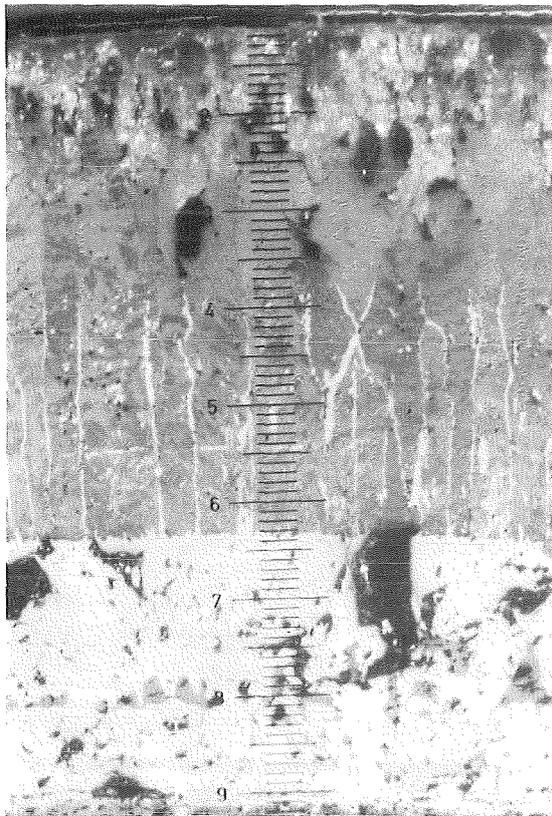
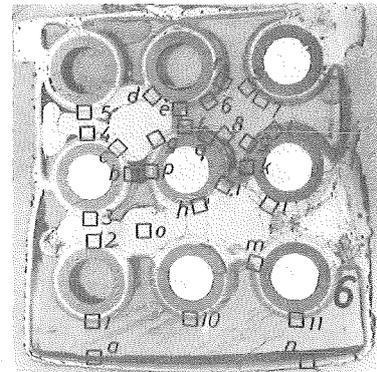
FIG. 51 DETAILS OF THE CROSS SECTION AT 86 MM AT POSITIONS SHOWN IN THE OVERVIEW FIG. 20 (ESBU-1)

The micrographs of the cross section from the 86 mm elevation are given in Figures 51 to 62. In Figure 51 positions 10 and 11 show the oxidation of the cladding which had access to stagnant steam without being covered by the melt. We find more oxidation in positions 10 and 11 than in position 1. This may be due to the fact that the rods at position 10 and 11 were in contact with more melt from the upper region at this elevations and extra heating of these rods may have occurred at this elevation.

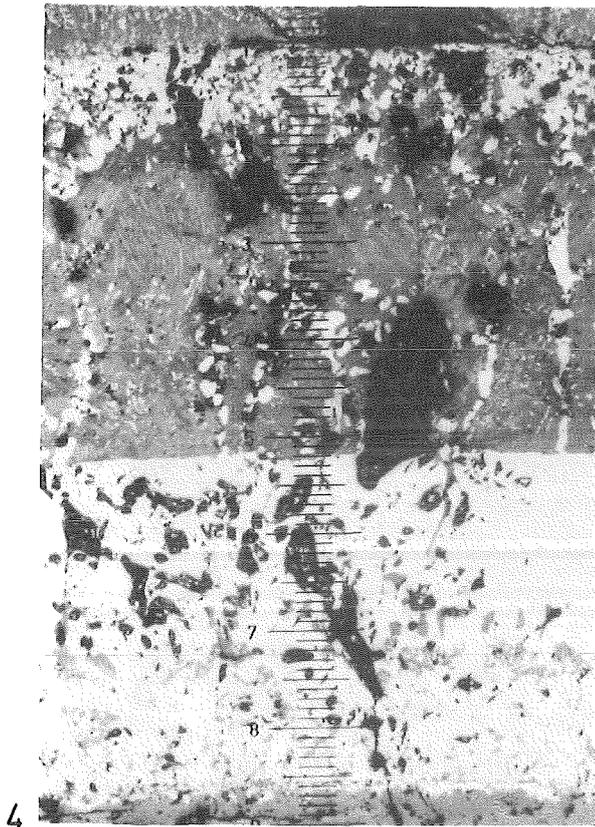
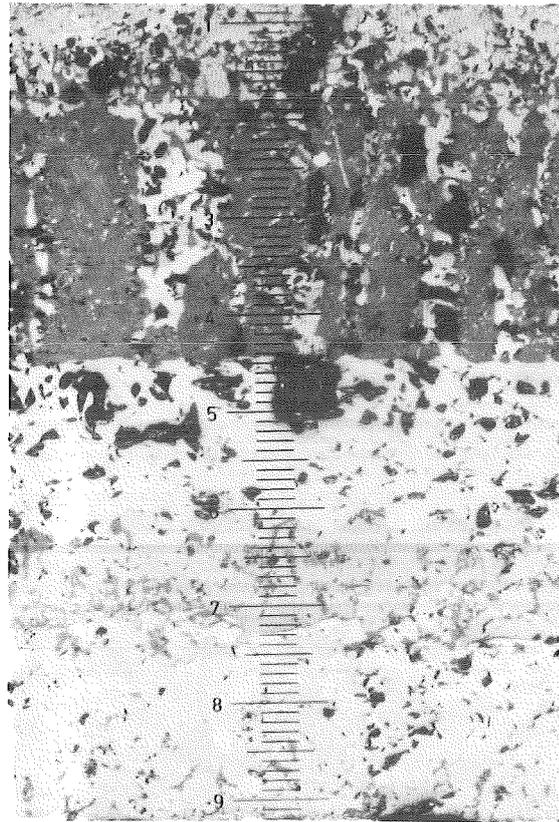
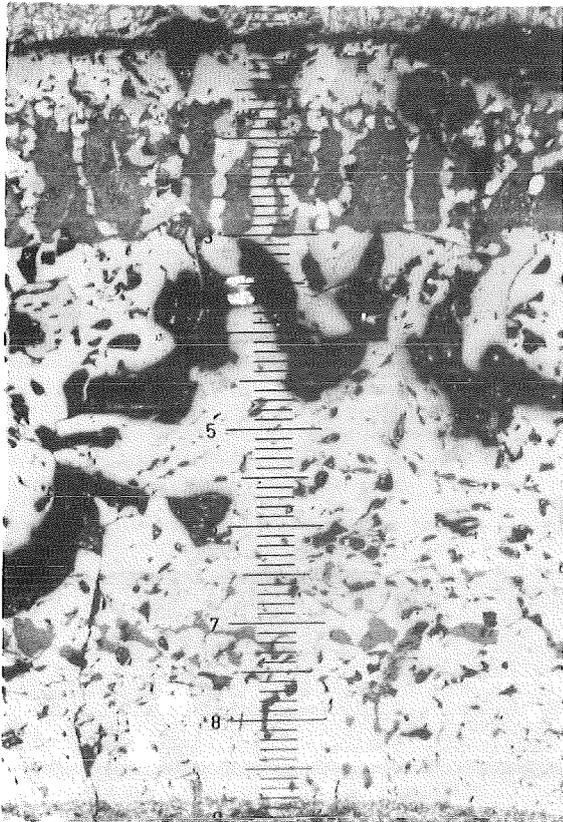
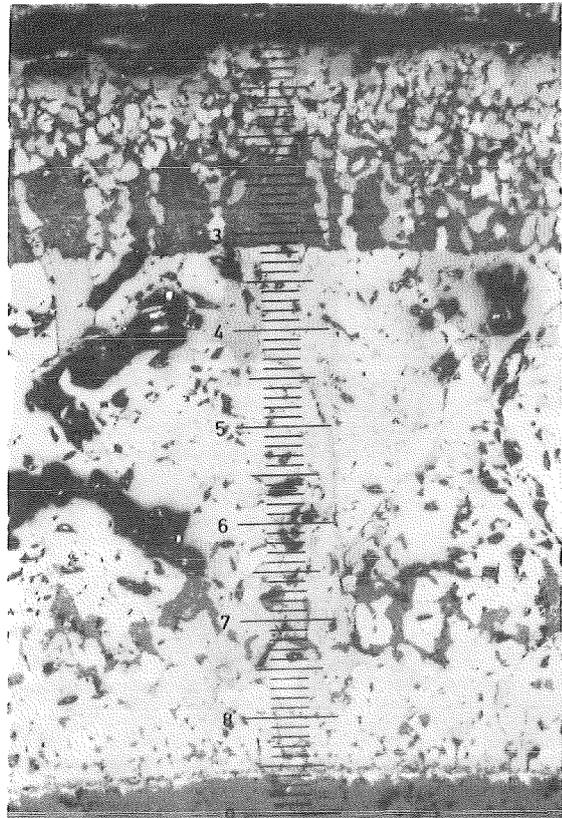
FIG. 52 DETAILS OF THE CROSS SECTION AT 86 MM AT POS. SHOWN IN THE OVERVIEW FIG.20 (ESBU-1)

In Figure 52 positions 2, 3, 4 and 5 are given. At these locations, oxidized cladding was covered by the melt, running down from the upper part of the bundle. One can recognize in all of the pictures that the oxide is attacked by the melt. The thickness of the different oxide layers show that the oxidation behaviour clearly depends on the arrival time of the melt from the upper part of the bundle. If one compares positions 2 and 3 which are adjacent locations on neighbouring rods one finds nearly the same oxide layer thickness although the oxide layer in position 3 is a little bit thicker than in area 2. This is expected as position 3 is located on a side rod sitting between two corner rods and this rod should run a little higher in temperature than a corner rod. If one compares positions 3 and 4 which are on opposite sides of the same rod but otherwise equivalent, a marked difference is seen in the thickness of the oxide layer. This means the melt between the positions 2 and 3 must have come down much earlier than the melt between the positions 4 and 5 and thus in locations 2 and 3 the cladding had a shorter time for oxidation. The thinner oxide layers of area 2 and 3 which were in contact for a longer time with the melt are also more strongly attacked by the melt.

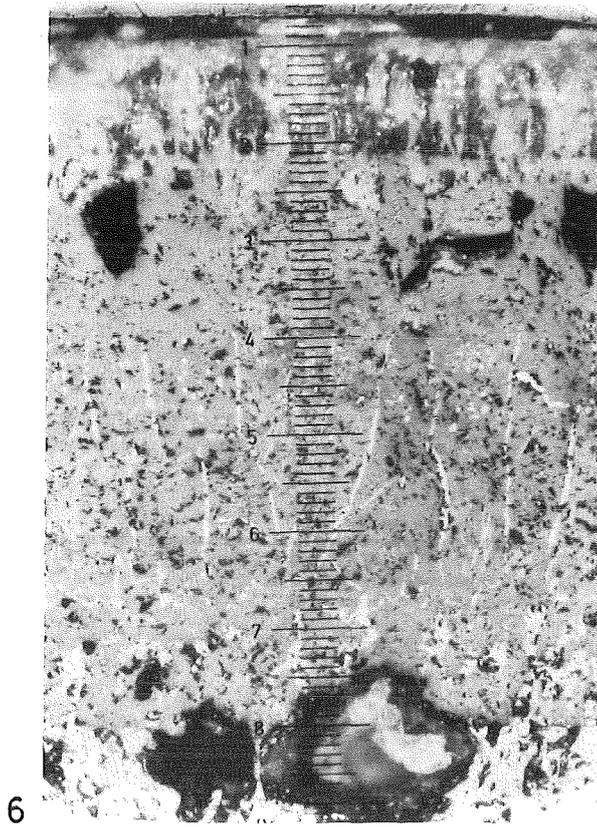
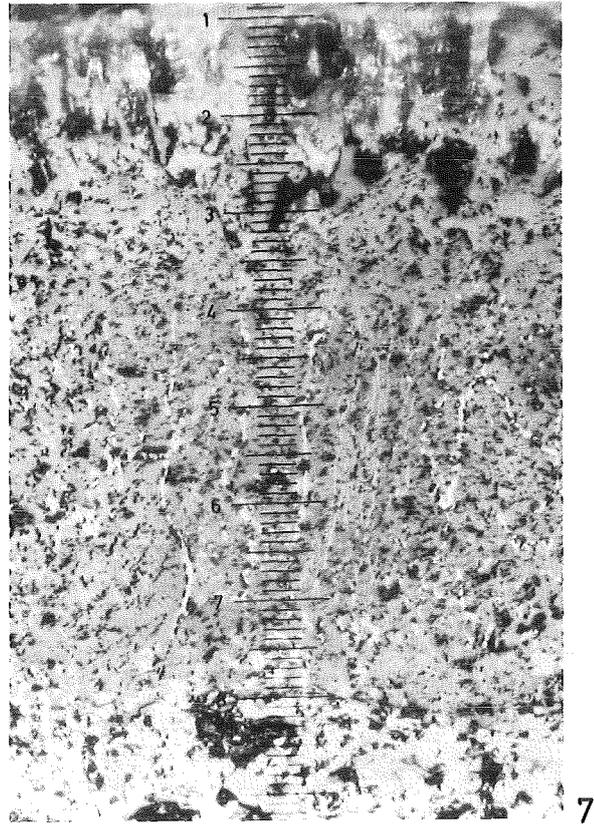
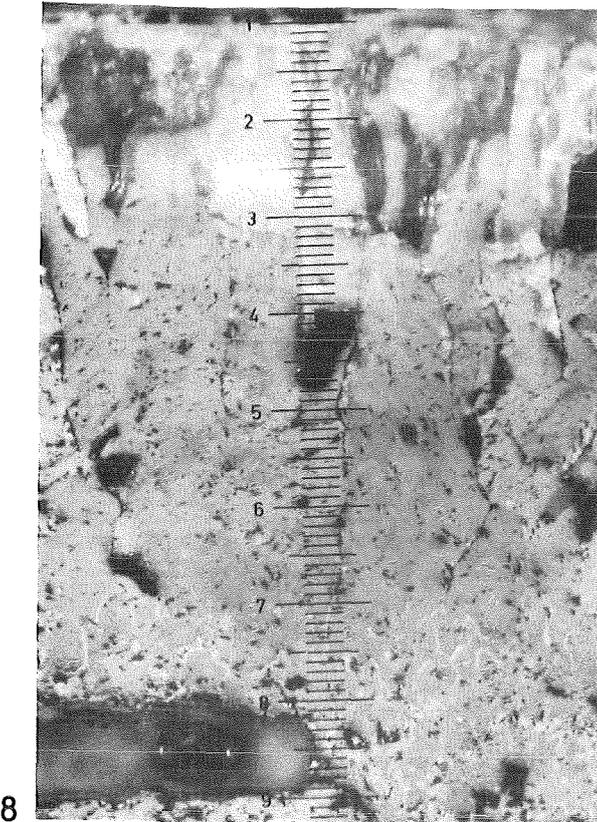
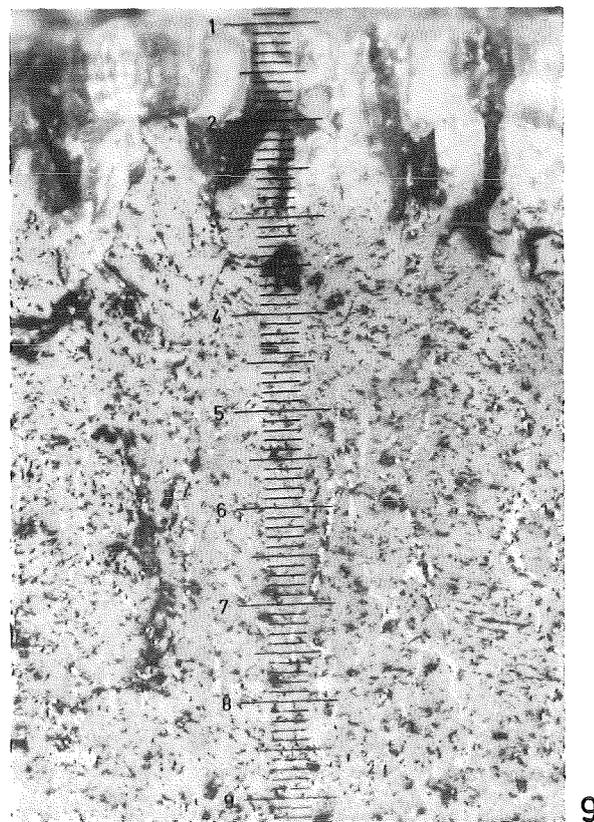
FIG. 53 DETAILS OF THE CROSS SECTION AT 86 MM AT POS. SHOWN IN THE OVERVIEW FIG. 20 (ESBU-1)

In Figure 53, positions 6, 7, 8 and 9 show areas of cladding which were not covered by melt. In these areas the cladding was in direct contact with the steam channel and is fully oxidized. In these pictures, the cladding surface exposed to the flowing steam is at the top and the UO_2 is located in the lower section.

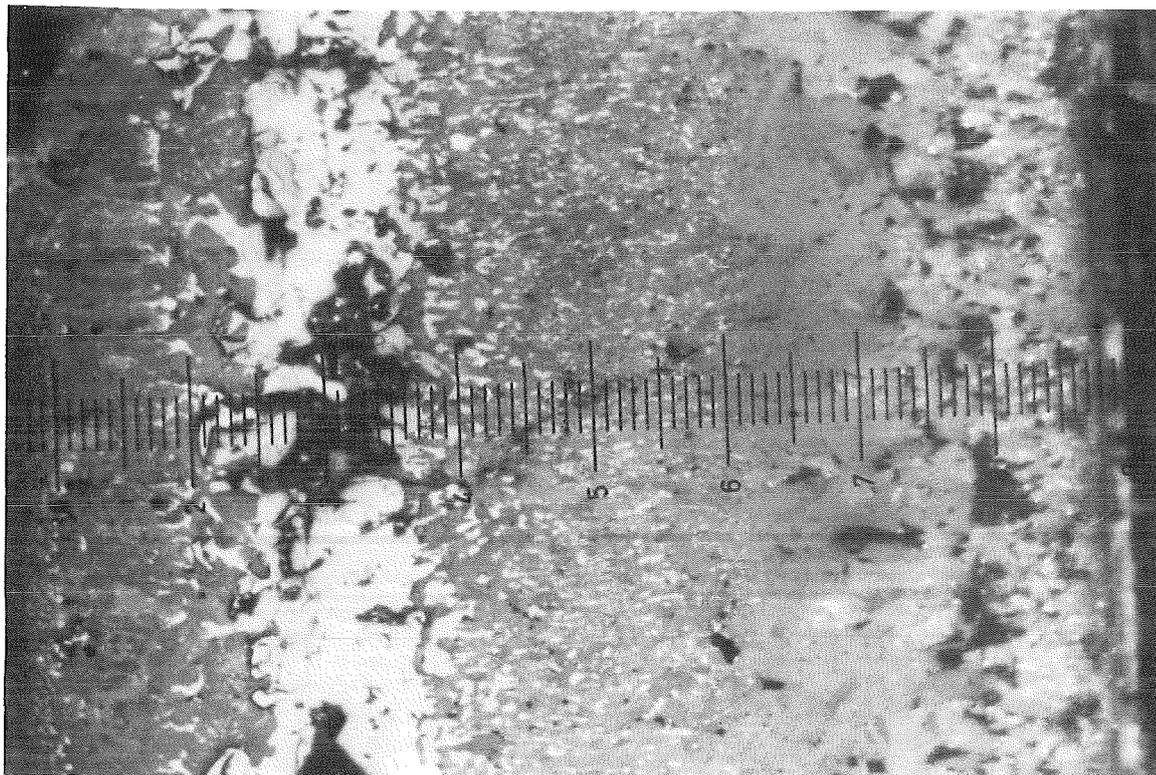
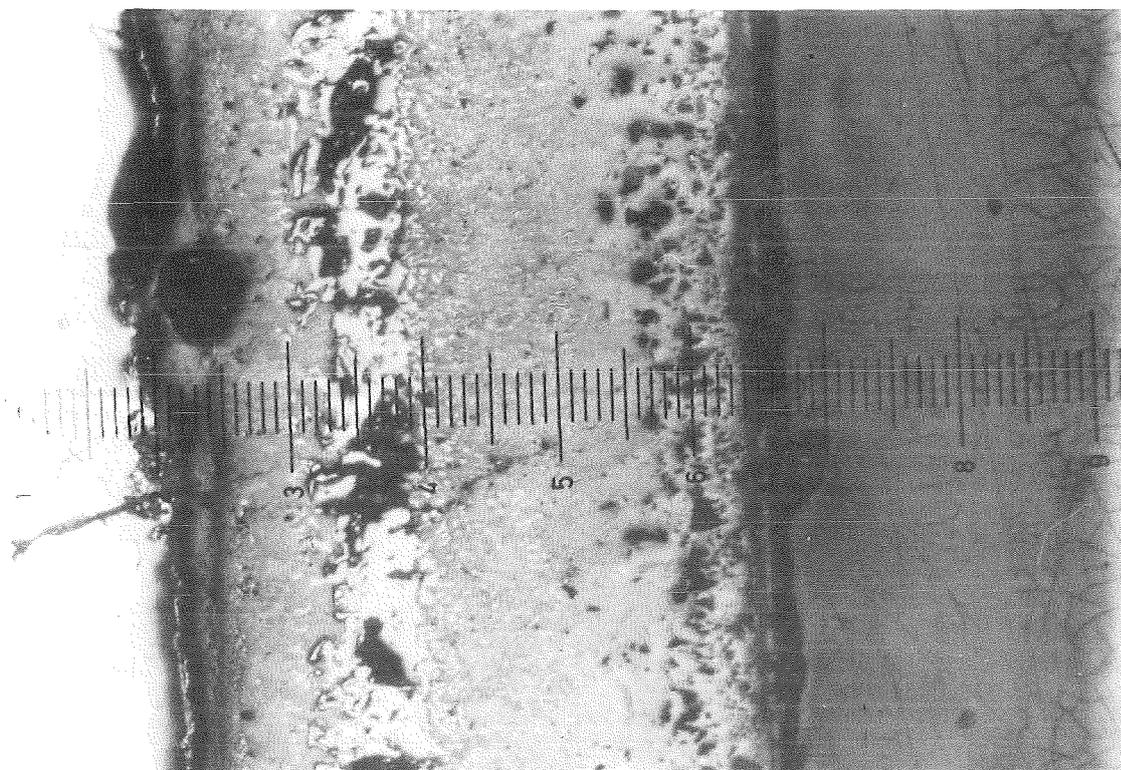
FIG. 54 DETAILS OF THE CROSS SECTION AT 86 MM AT POS. SHOWN IN THE OVERVIEW FIG. 20 (ESBU-1)

A detailed view showing the oxidation of the shroud is given in Figures 54 and 62. Here, the oxide layer on the inside of the shroud is much thicker than the oxide layer on the outside of the shroud. This is because the inside of the shroud had better access to the steam.

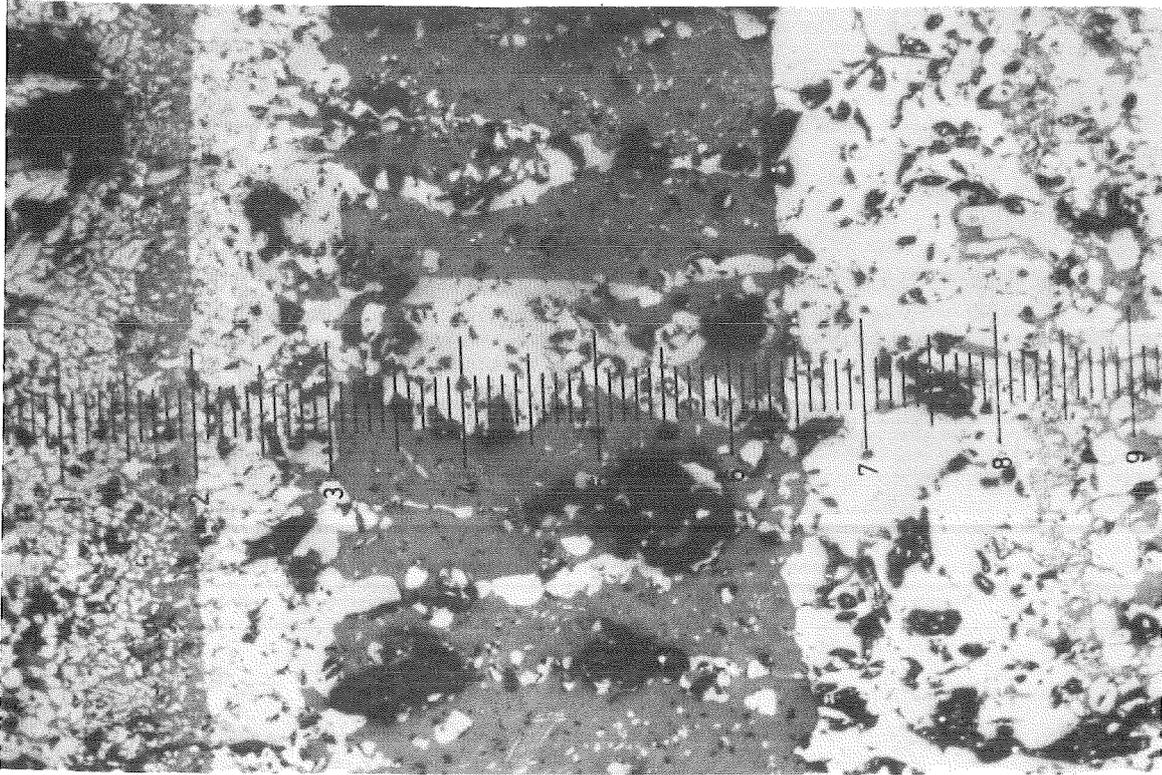
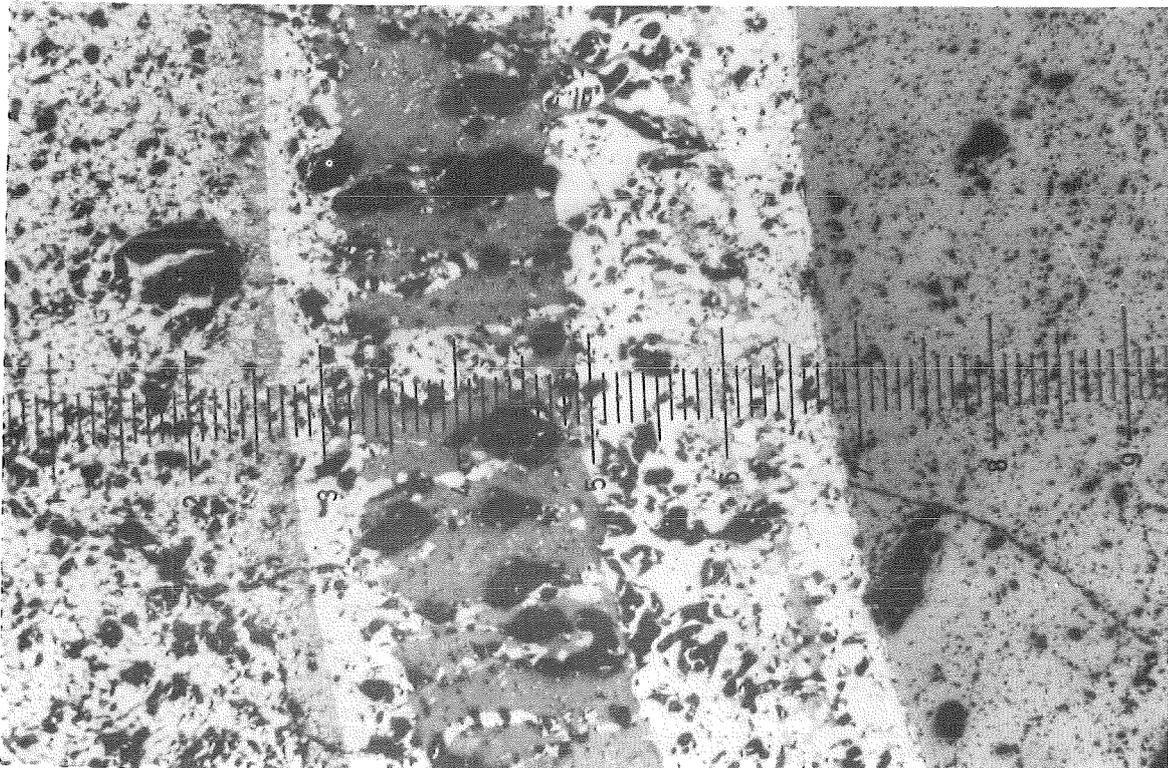
FIG. 55 DETAILS OF THE CROSS SECTION AT 86 MM AT POS. SHOWN IN THE OVERVIEW FIG. 20 (ESBU-1)

Positions b and c on Figures 55 and 56 compare the location on the same fuel rod in which the first location remains uncovered during the test and the second location is covered by the melt from the upper part of the bundle. Figure 56 shows that a strong attack of the oxidized cladding by the melt has occurred. The outer surface of the oxidized cladding is also clearly defined. Position d on Figure 57 shows a region of oxidized cladding which is strongly attacked by the surrounding melt.

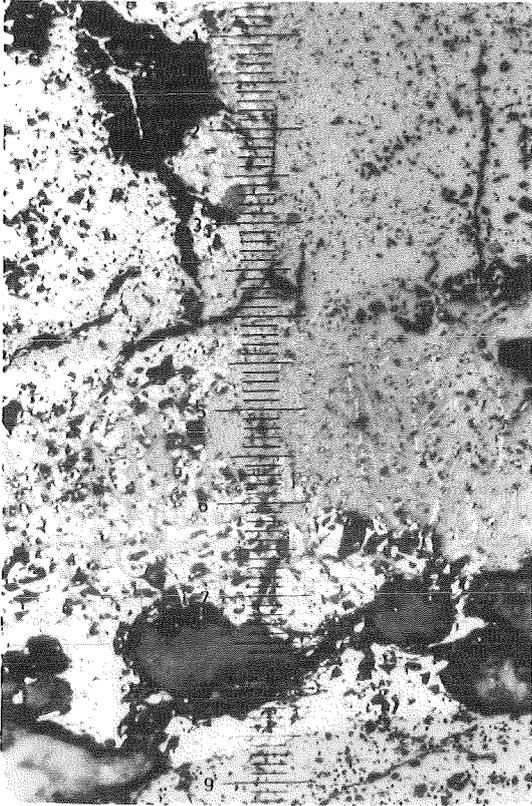
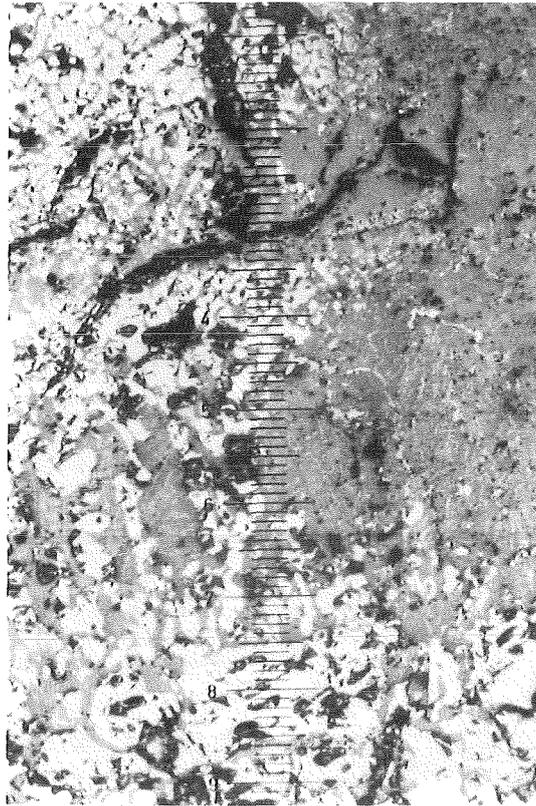
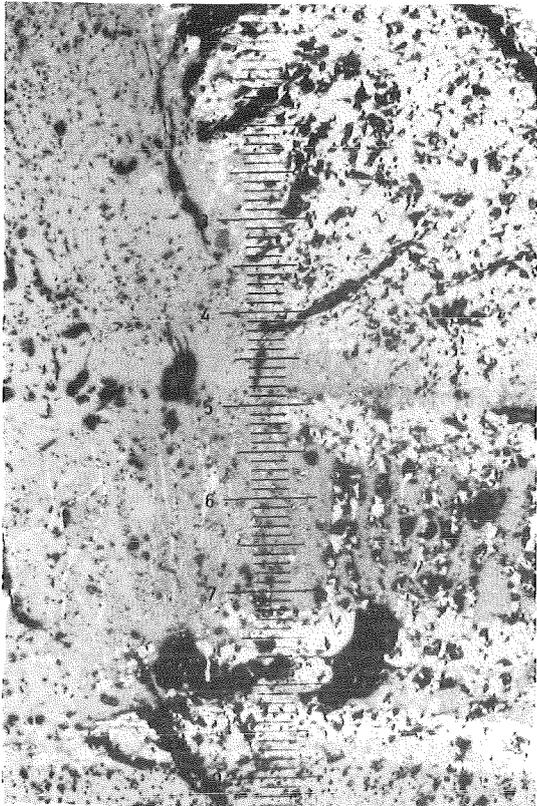
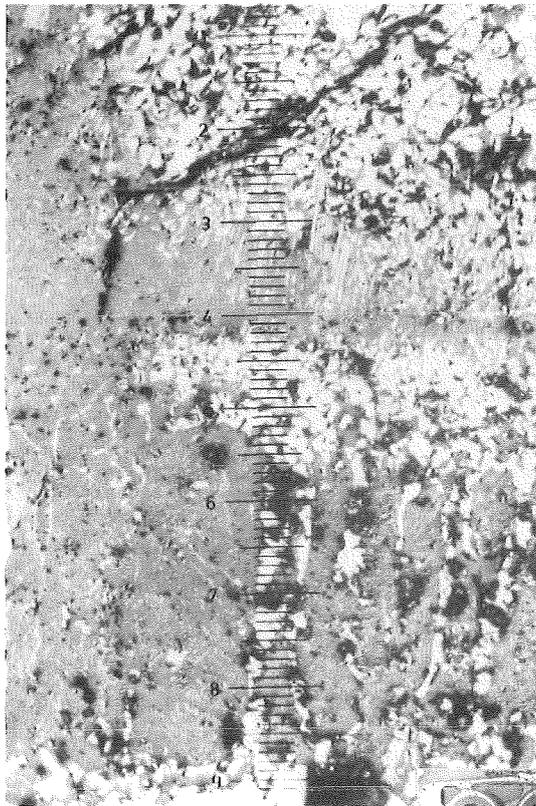
FIG. 58 DETAILS OF THE CROSS SECTION AT 86 MM AT POS. SHOWN IN THE OVERVIEW FIG.20 (ESBU-1)

Positions e and f in Figure 58 show positions in which the melt over the cladding is in direct contact with the steam channel. Here one can see a region in which the previously oxidized zirconium is attacked by the melt and also a region in which the material over the UO_2 is completely oxidized. For position e the completely oxidized melt is located on the right side of the picture. In position f the completely oxidized region is on the left side of the picture. In both cases the UO_2 is seen in the lower end of the picture.

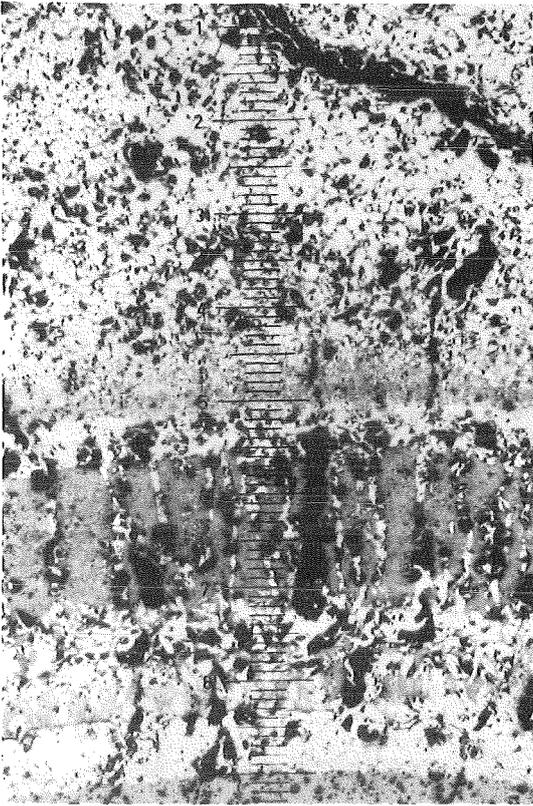
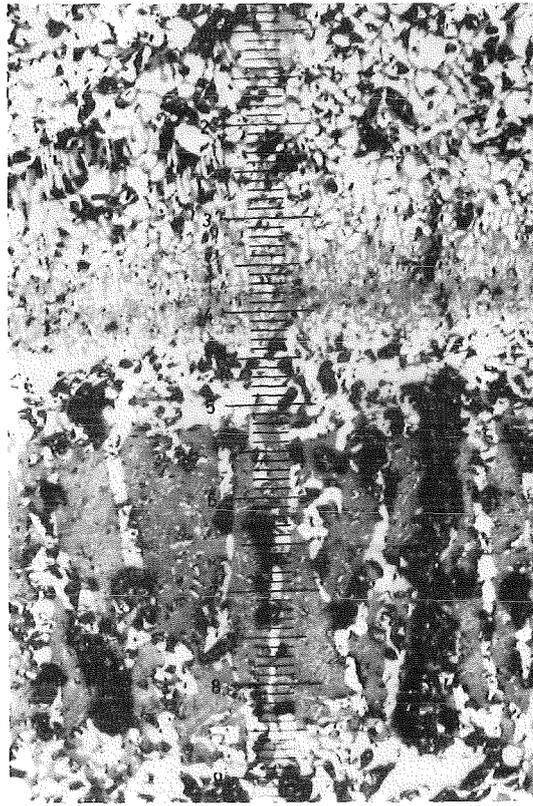
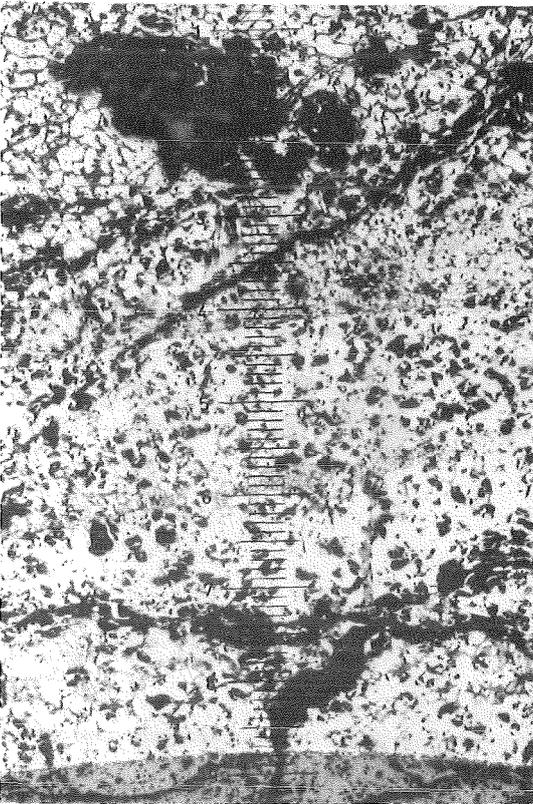
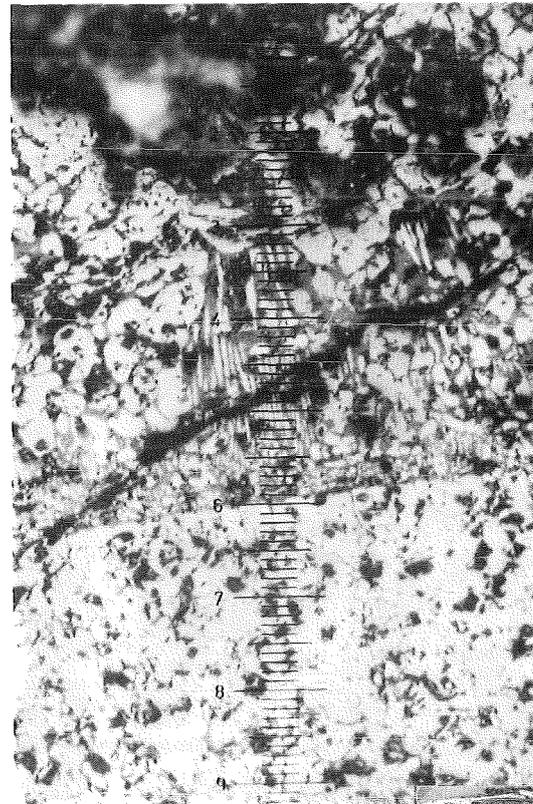
FIG. 59 DETAILS OF THE CROSS SECTION AT 86 MM AT POS. SHOWN IN THE OVERVIEW FIG. 20 (ESBU-1)

Figure 59 shows position g and h on the central rod. Here one can see that at position g much less attack on the zirconium oxide has occurred than at position h. In location h the oxidized cladding has completely disappeared. This means that the melt in this region must have moved down much earlier than in the region corresponding to position g.

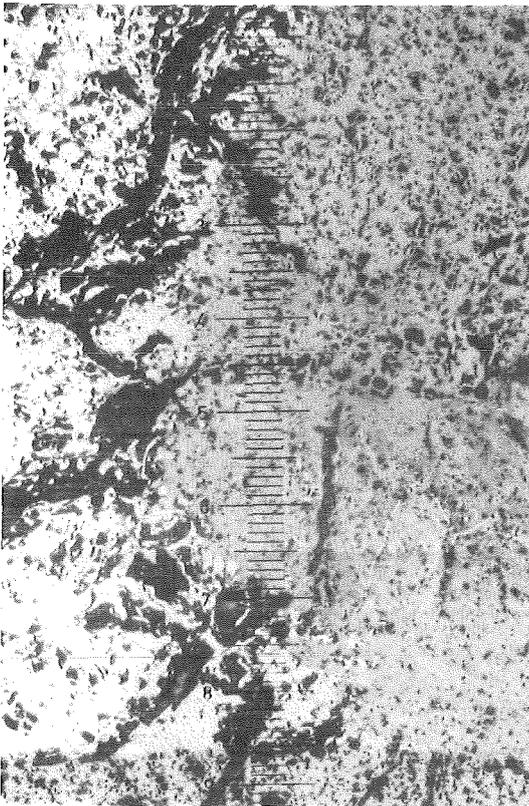
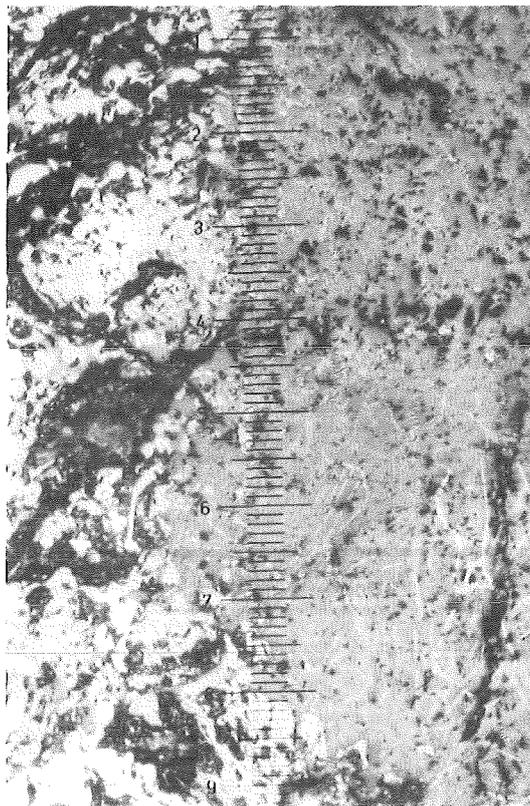
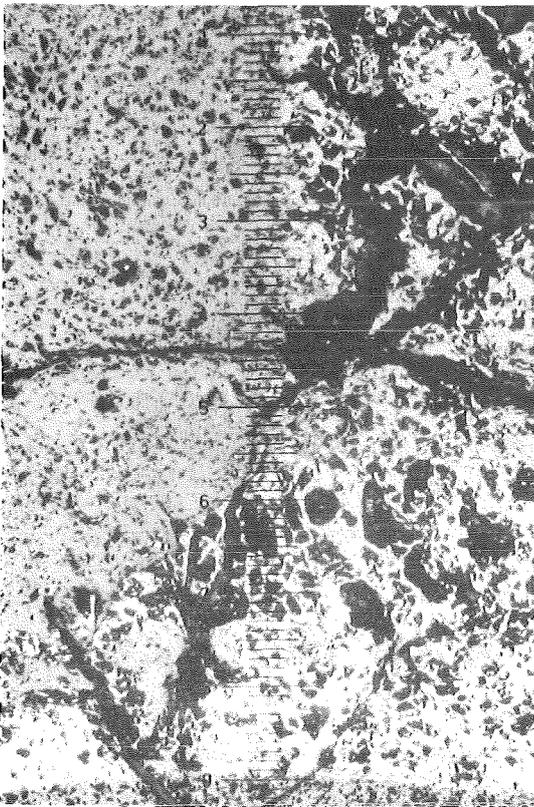
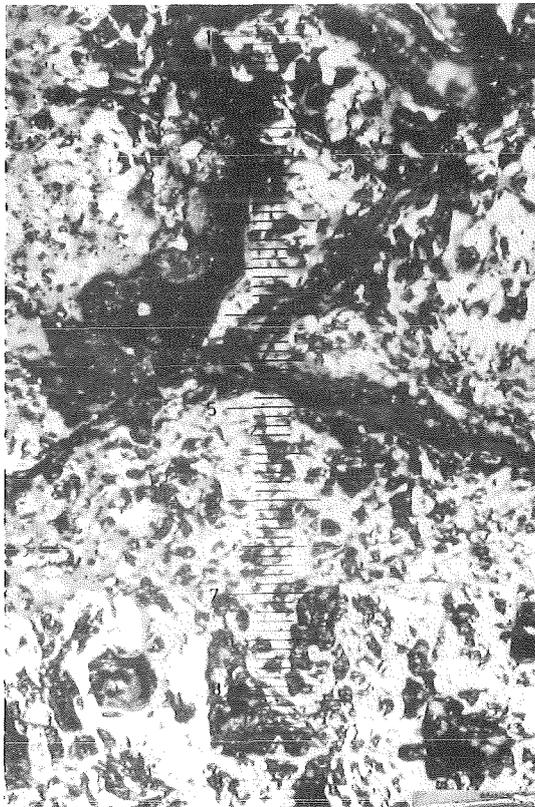
FIG. 60 DETAILS OF THE CROSS SECTION AT 86 MM AT POS. SHOWN IN THE OVERVIEW FIG.20 (ESBU-1)

In location l shown in Figure 61 the oxide layer has completely disappeared. For the regions i, k and m in Figures 60 and 61, the melt is in direct contact to the steam channel and the melt covering the UO_2 in contact with the steam is nearly completely oxidized. In the region where the melt had no direct access to the steam, the ZrO_2 layer has disappeared. The fully oxidized region is shown on the right side of the picture for position i and m and for position k on the left side of the picture.

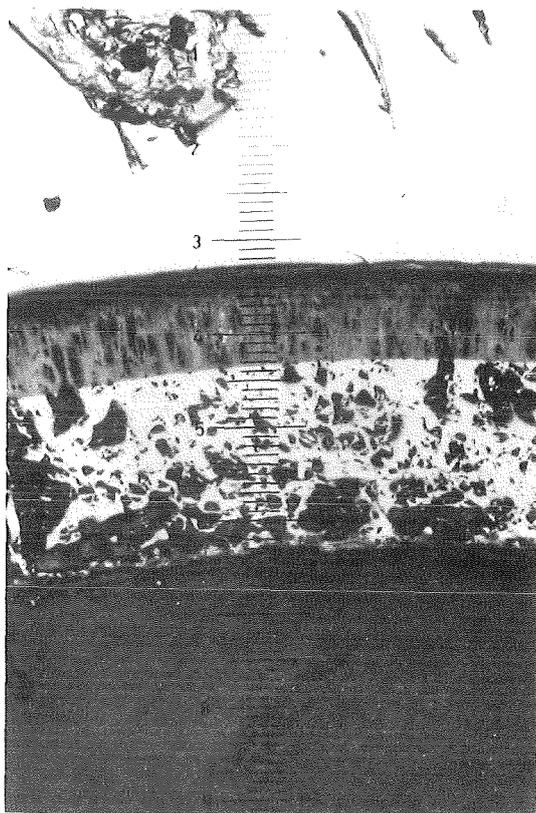
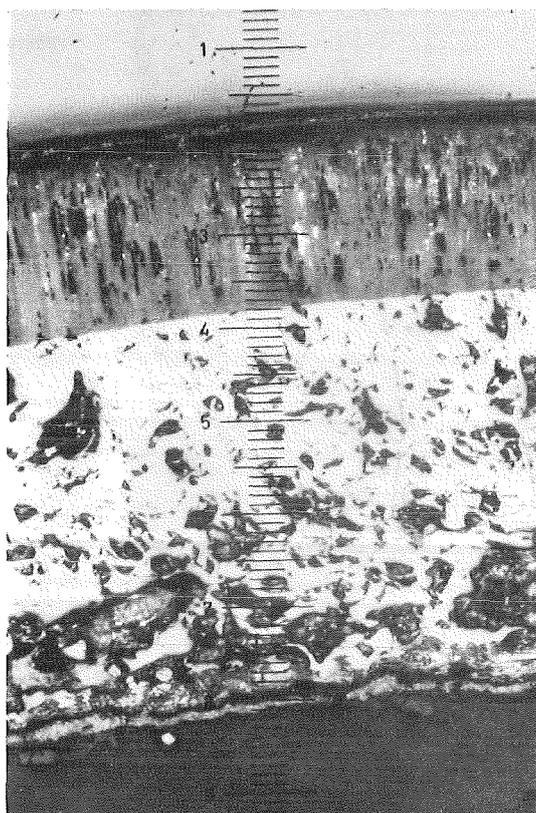
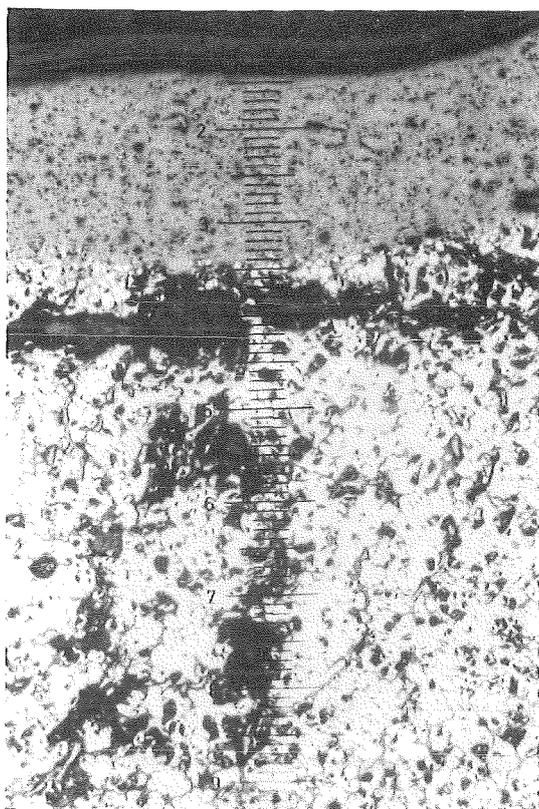
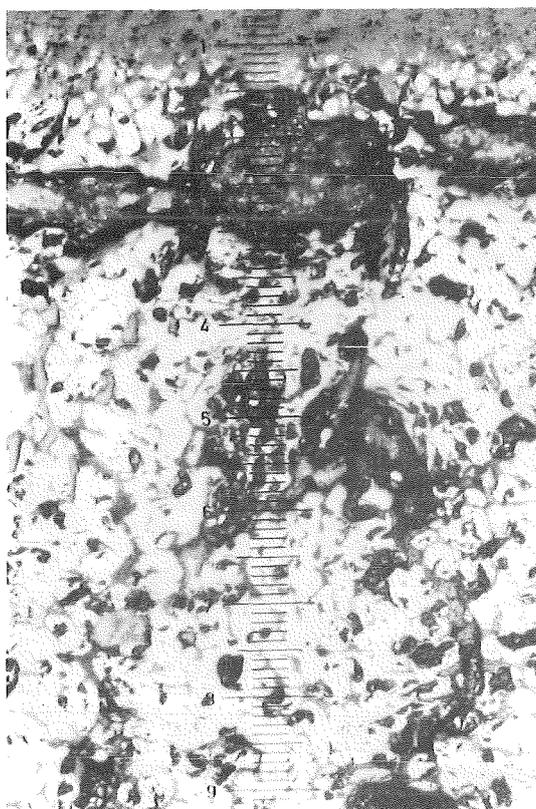
FIG.63 DETAILS OF THE CROSS SECTION AT 76 MM AT POS. SHOWN IN THE OVERVIEW FIG.20 (ESBU-1)

The micrographs of the cross section at 76 mm are shown in Figures 63 to 65. Position 1 shows the oxidation of the cladding with no melt present. Region 5 on Figure 65 shows the thickness of the oxide layer on the central rod. The oxide layer here is nearly three times larger than at position 1 on the outer rod. Area 3 in Figure 64 shows the region of the former cladding on the central rod which was covered by melt. One can recognize here that the oxide layer has disappeared completely. Region 4 in Figure 64 shows the transition from the covered to uncovered region. The uncovered region is on the left and the covered is on the right. Once again no oxidized cladding is left in the covered region. The upper left

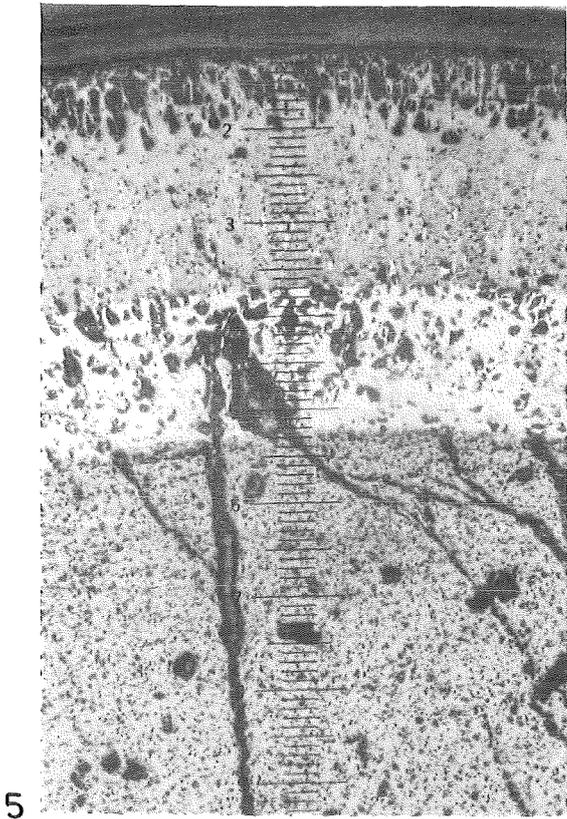
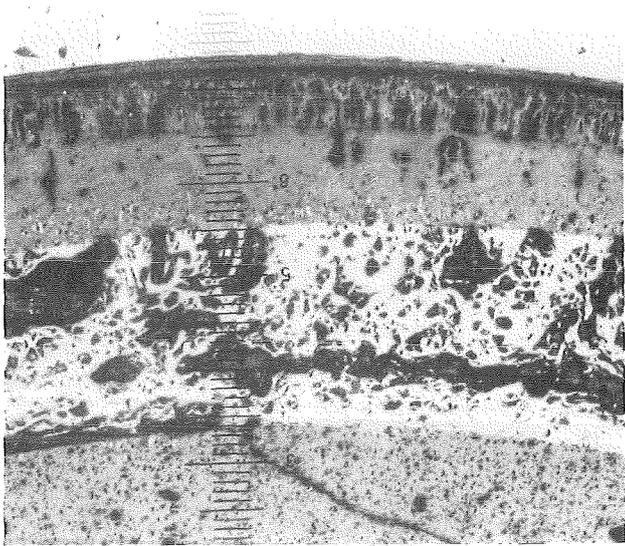
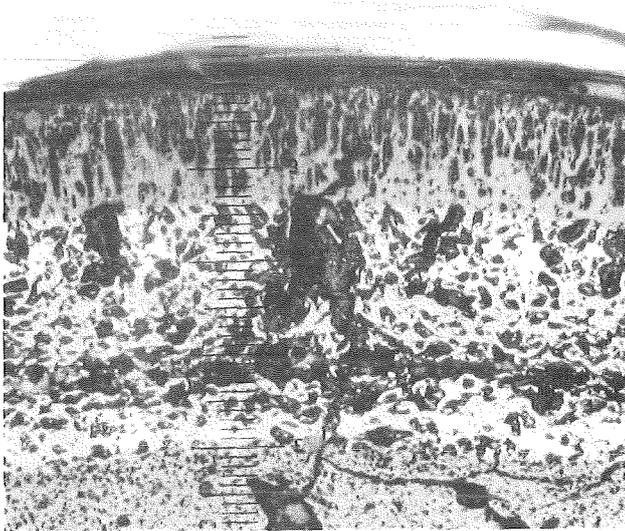
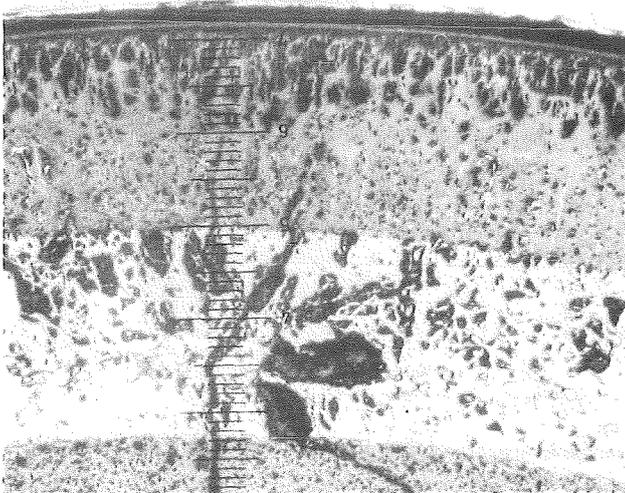
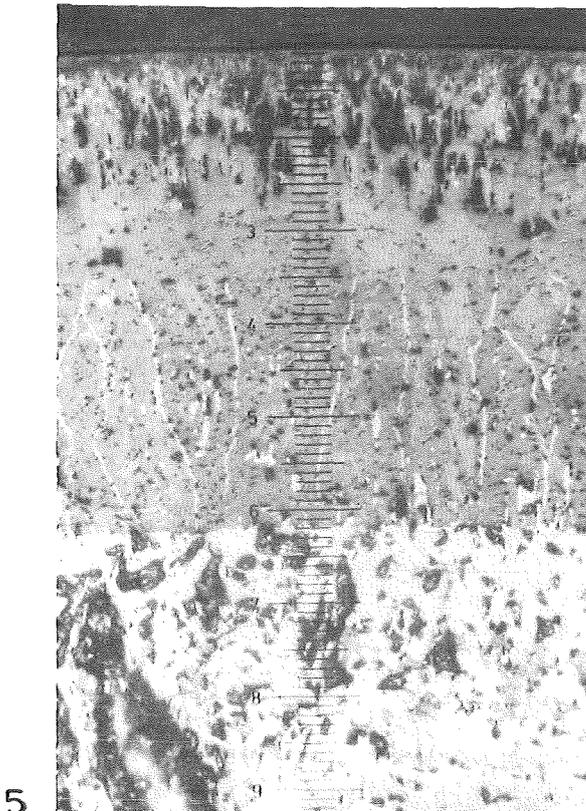
FIG. 65 DETAILS OF THE CROSS SECTION AT 76 MM AT POS. SHOWN IN THE OVERVIEW FIG. 20 (ESBU-1)

hand side of the pictures shows the oxidized melt. Areas 7,8 and 9 in Figure 65 show the thickness of the oxide layer of three outer fuel rods.

The micrographs of cross section 8 at 66 mm are given in Figures 66 and 67. The thicknesses of the oxide layer around the upper right sub-channel are shown in position 2,4, 5 and 6. As expected, the oxide layer of the central fuel rod simulator is the thickest. If one compares the oxide layers at the two equivalent positions 4 and 6, the oxide layer, at location 6 is much thicker. This means this fuel rod must have been somewhat higher in temperature. A thicker oxide layer was found on this fuel rod simulator 10 mm higher at 76 mm in Figure 65.
