KfK 3769
August 1986

Post Test Investigation of the Bundle Test ESBU-1

**On Temperature Escalation in PWR Fuel
Rod Simulator Bundles due to
the Zircaloy/Steam Reaction**

**S. Hagen, H. Kapulla, H. Malauschek,
K. P. Wallenfels, B. J. Buescher**
**Hauptabteilung Ingenieurtechnik
Projekt Nukleare Sicherheit**

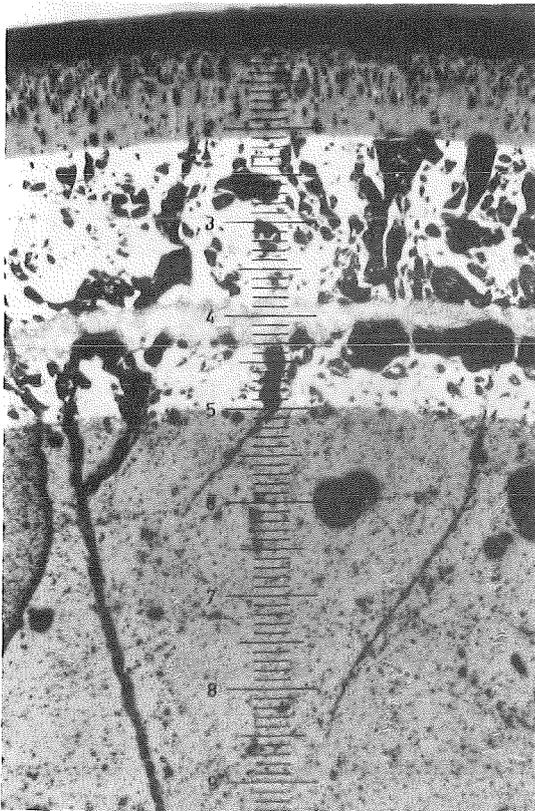
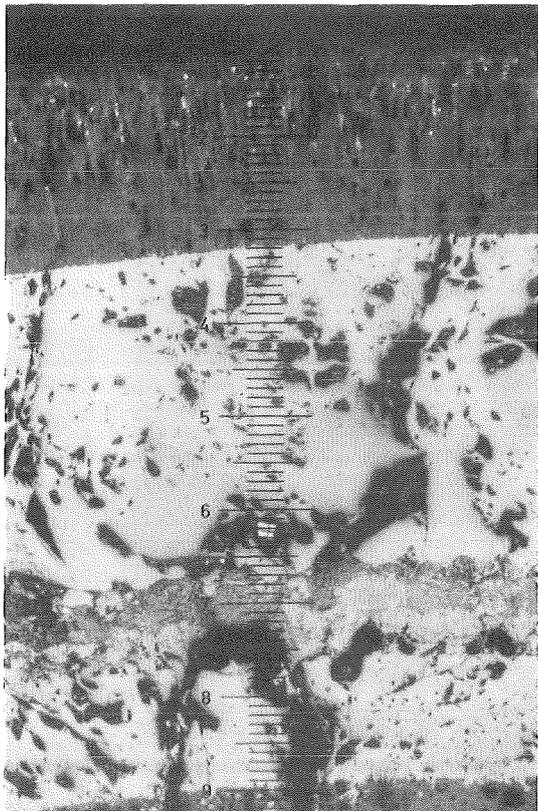
FIG. 66 DETAILS OF THE CROSS SECTION AT 66 MM AT POS. SHOWN IN THE OVERVIEW FIG. 20 (ESBU-1)

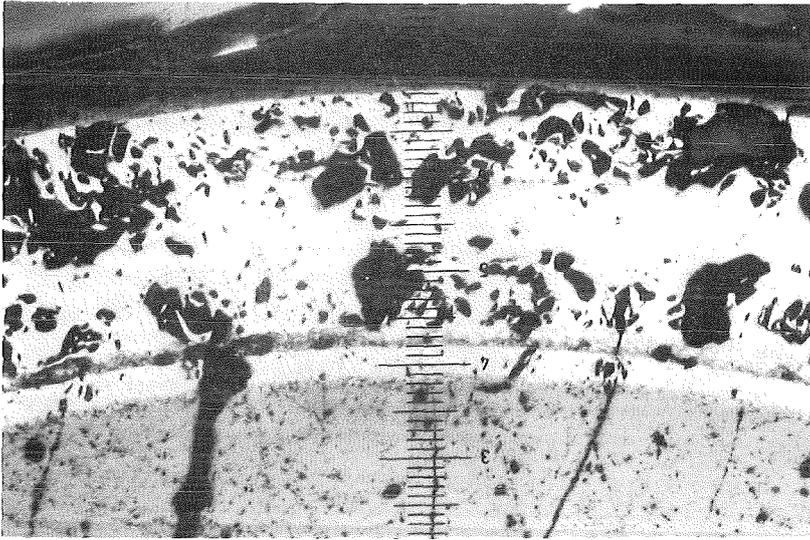
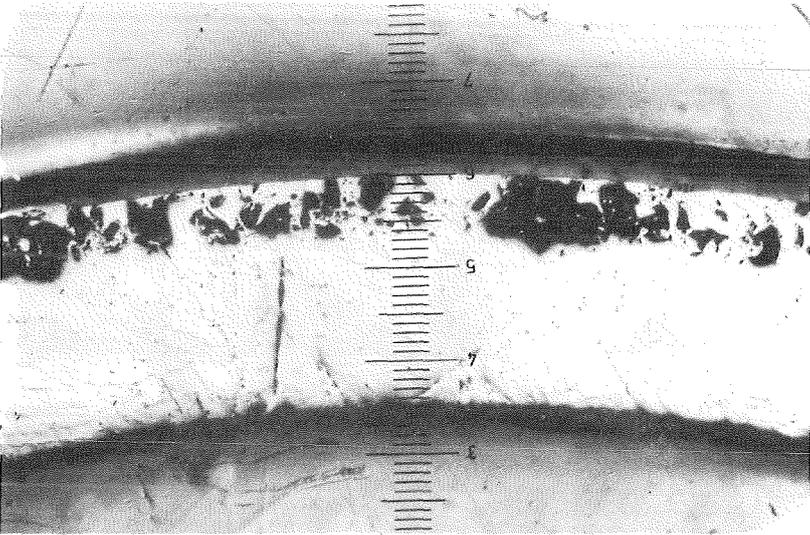
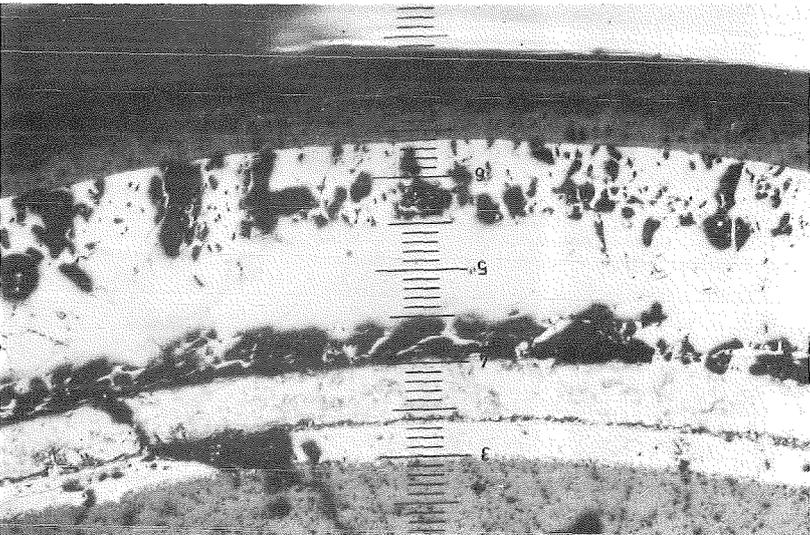
FIG.67 DETAILS OF THE CROSS SECTION AT 66 MM AT POS. SHOWN IN THE OVERVIEW FIG.20 (ESBU-1)

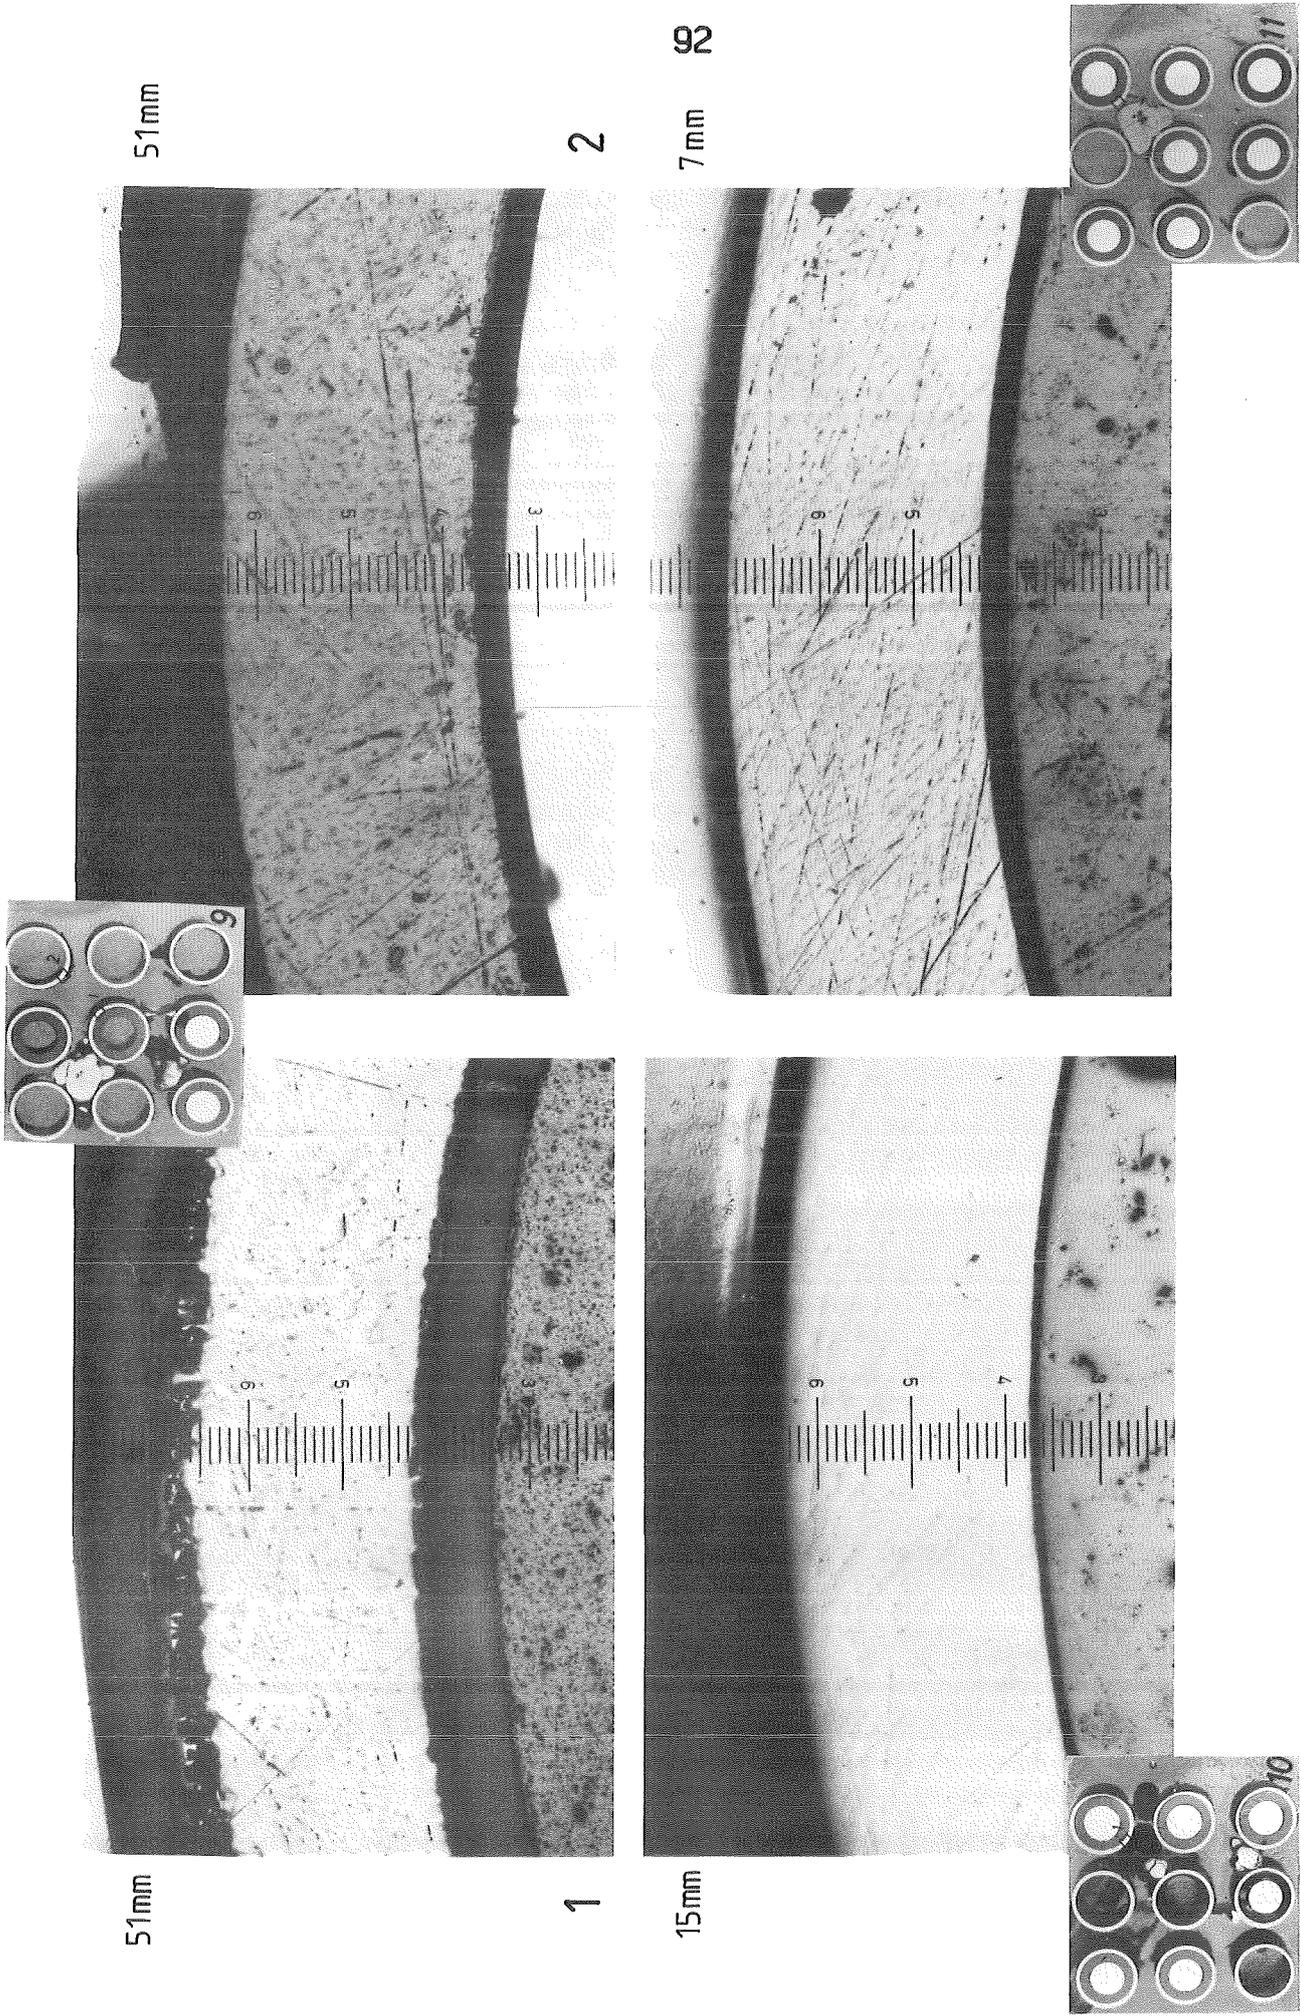
FIG. 68 : DETAILS OF CROSS SECTIONS AT 51, 15 AND 7 MM AT THE POSITIONS SHOWN.

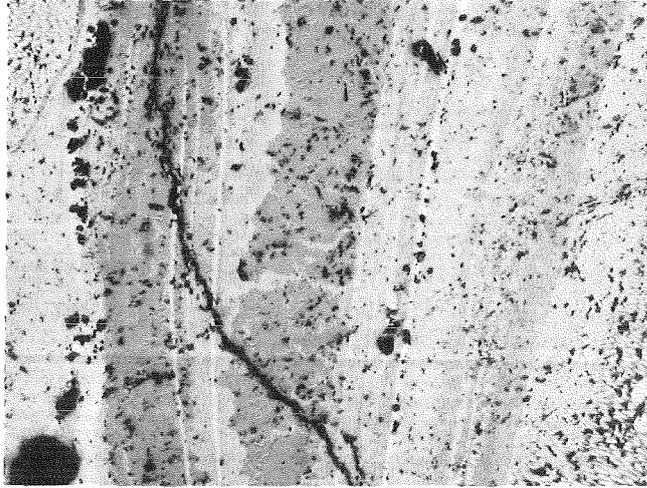
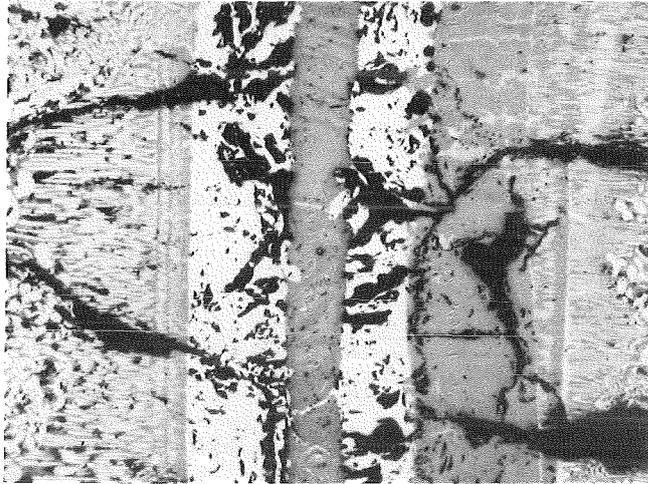
Fig.70a Details of former cladding region A in the cross section at 106mm elevation. (ESBU-1)

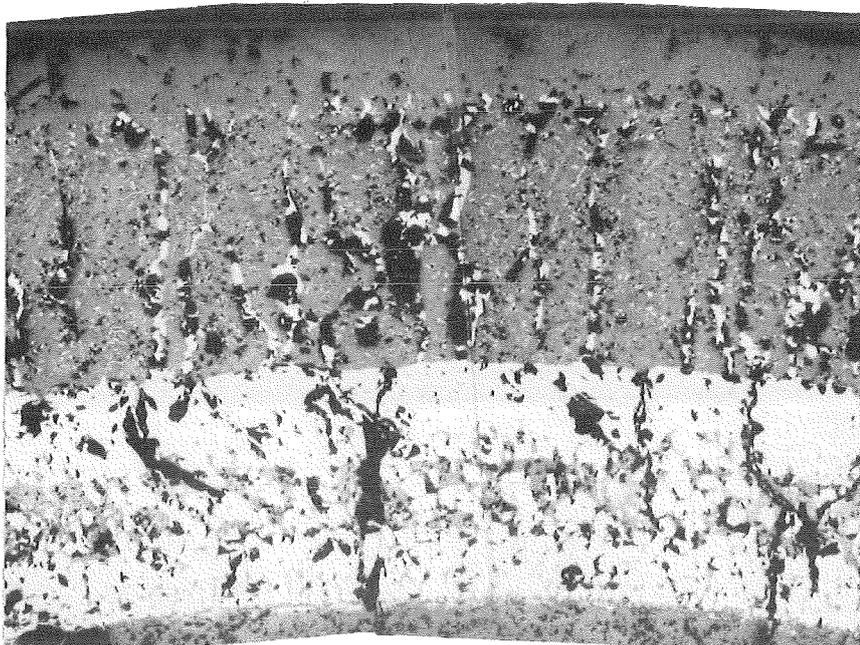
FIG. 73 : COMPARISON OF OXIDIZED PARTS OF CLADDING FROM SAME ROD. MELT COVERED REGIONS (A) AND UNCOVERED REGIONS (G) SHOWN FROM CROSS SECTION AT 86 MM ESBU-1. FIG.

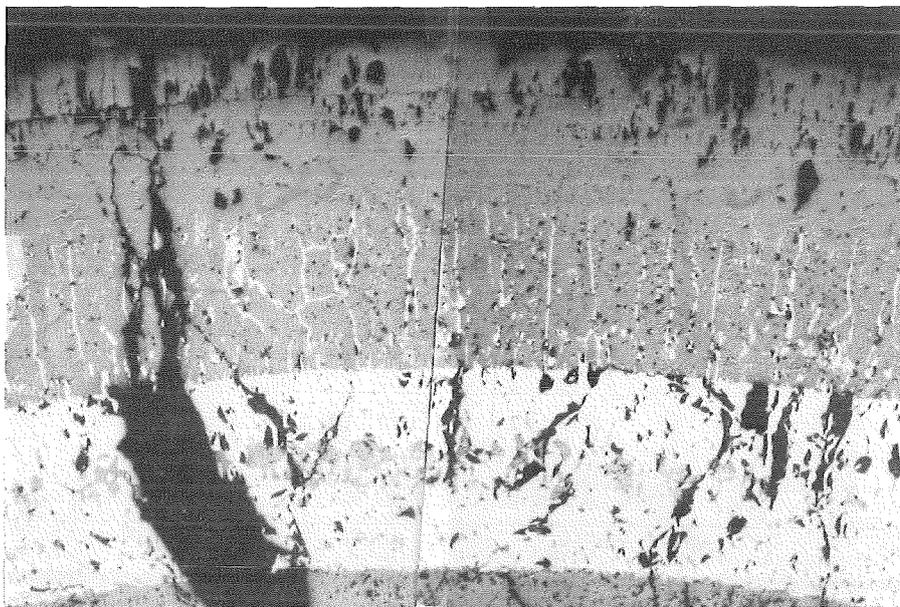
FIG. 74 : COMPARISON OF OXIDIZED PARTS OF CLADDING FROM SAME ROD. MELT COVERED REGIONS (B) AND UNCOVERED REGIONS (E) SHOWN FROM CROSS SECTION AT 86 MM ESBU-1. FIG.

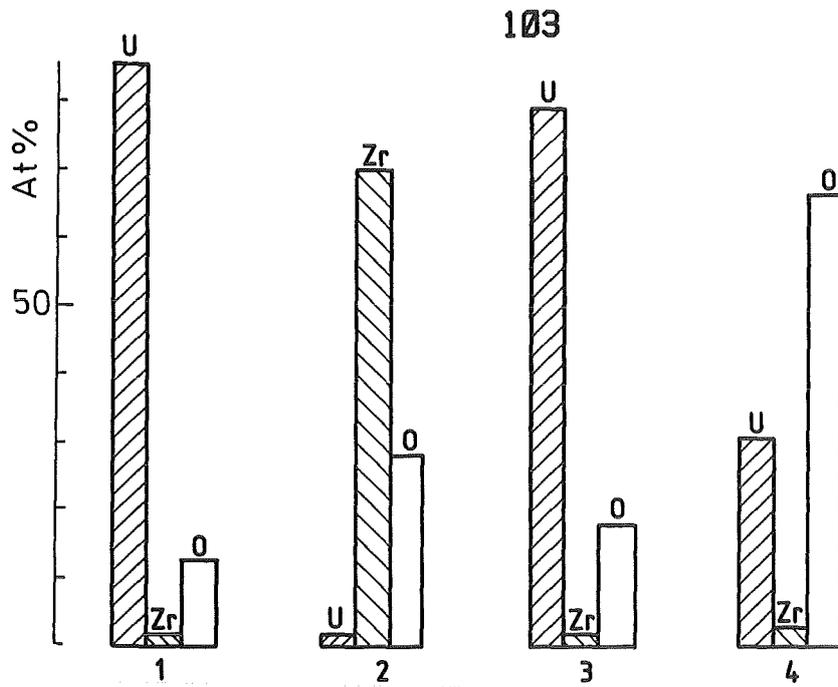
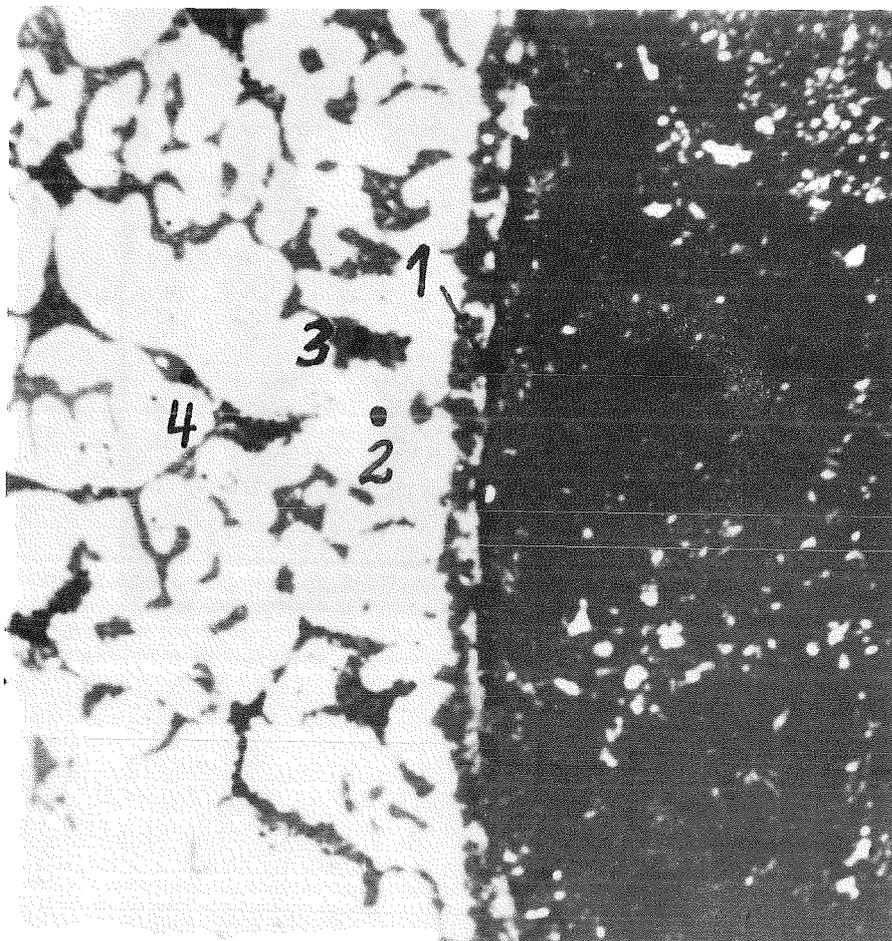
Fig.78 Microprobe results of the phases in the refrozen melt at position 2 in the cross section at 106mm, uncorrected O-values (ESBU-1)

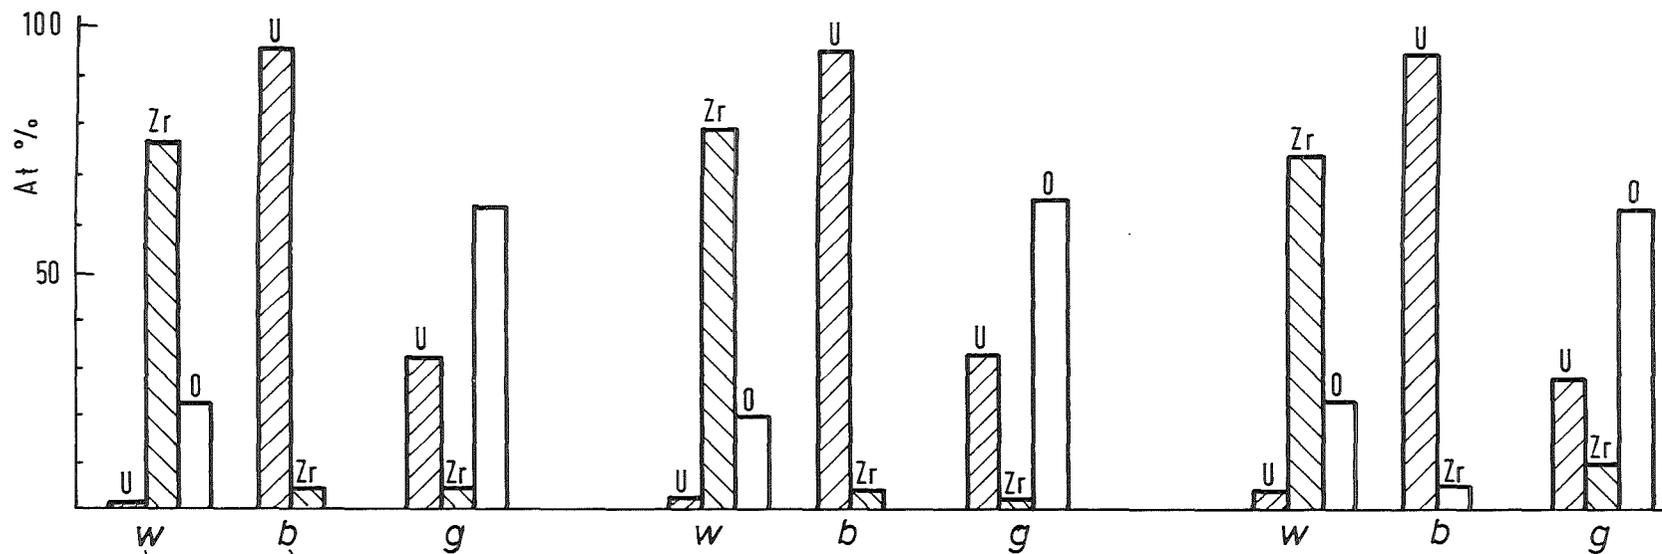
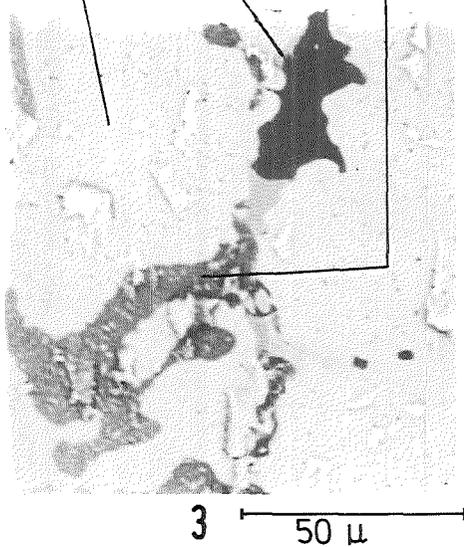
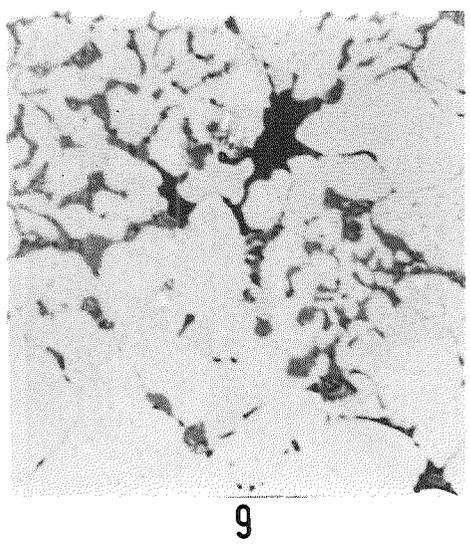
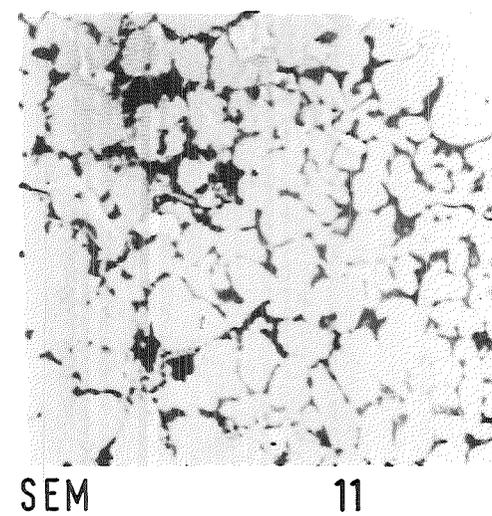
Fig.80 Microprobe analysis of the 3 phases in the refrozen melt for the elevations 3 (116mm), 9 (51mm) and 11 (7mm above bundle bottom) at the position given in fig.79.

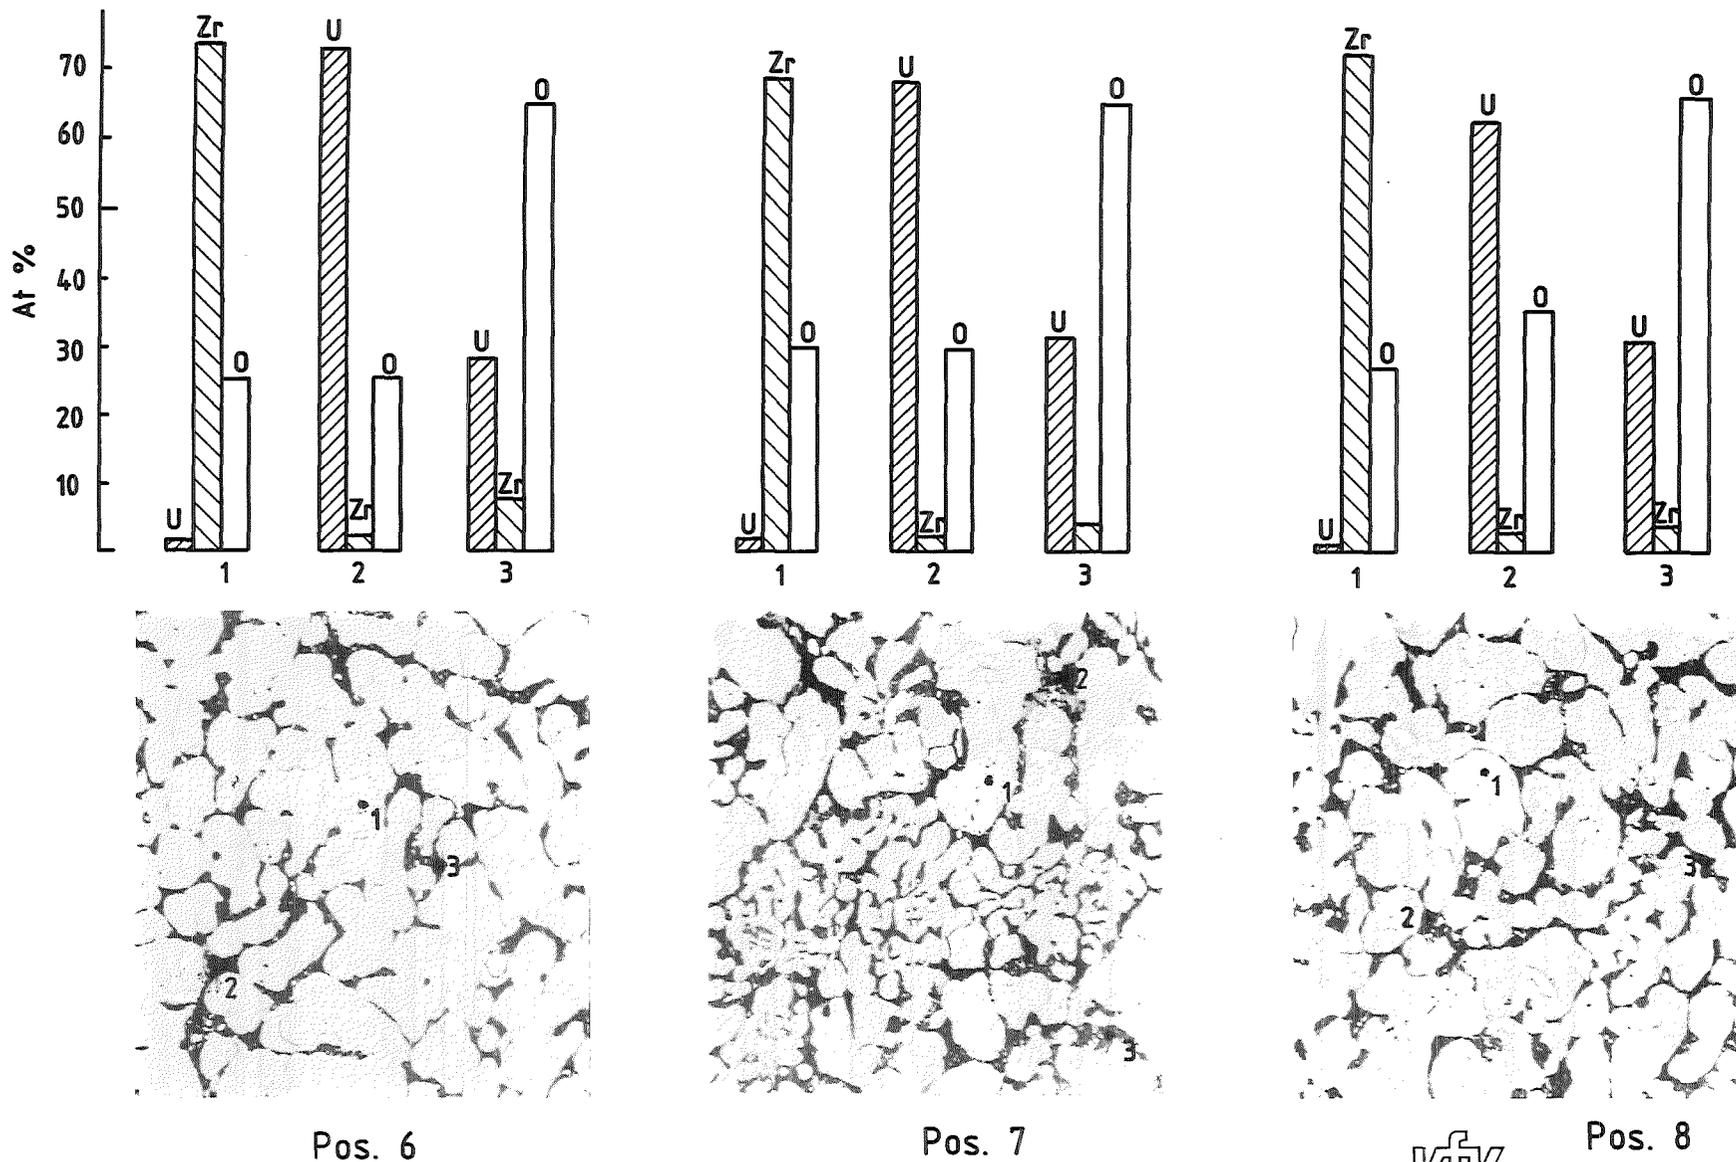
FIG. 82:
 MICROPROBE ANALYSIS OF THE 3 PHASES IN THE REFROZEN MELT
 EBSU-1: CROSS SECTION 4(106MM ABOVE BOTTOM) LOCATIONS SEE PHOTO; SEE FIG. 81

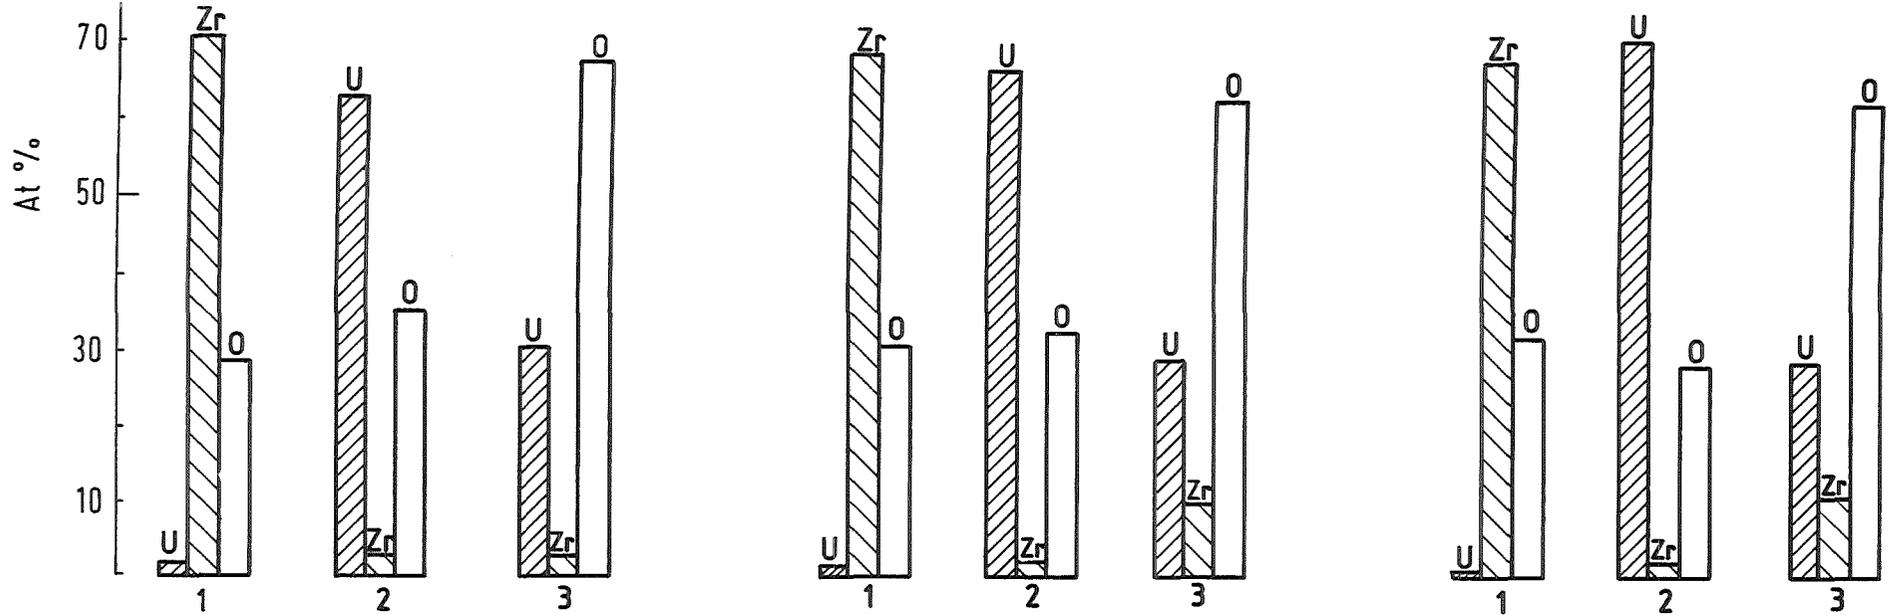
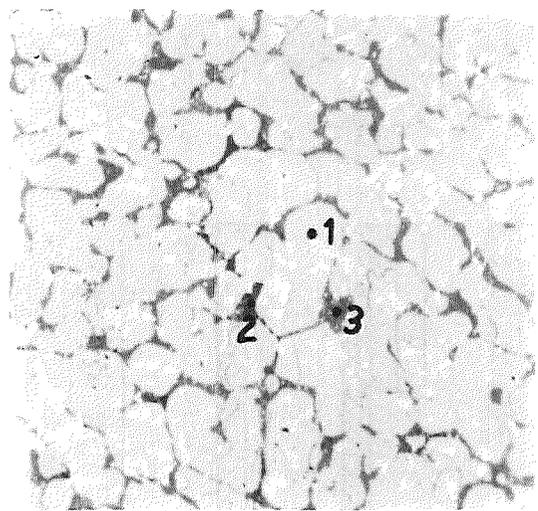
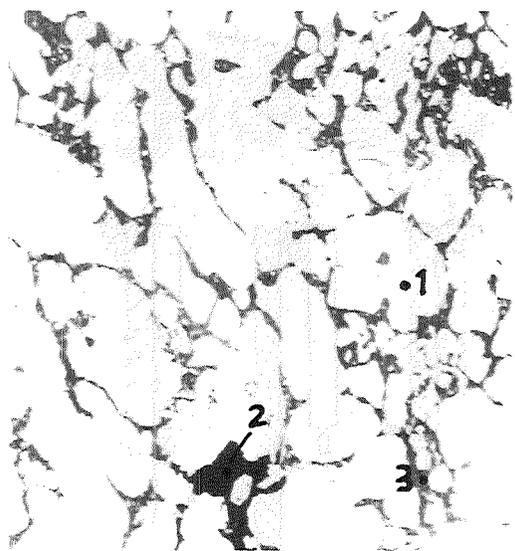
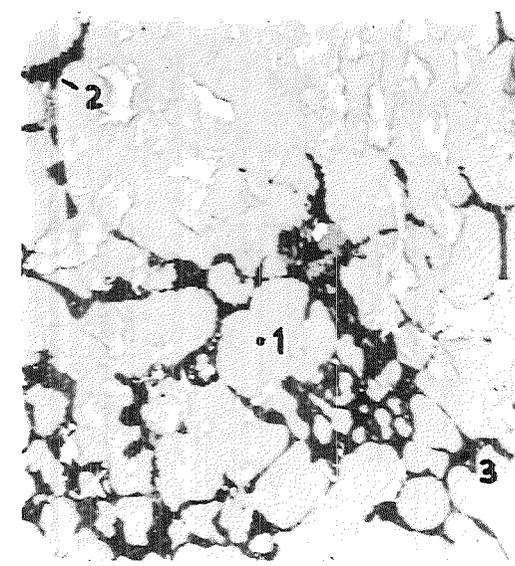
FIG. 83: MICROPROBE ANALYSIS OF THE 3 PHASES IN THE REFROZEN MELT

ESBU-1: CROSS SECTION 4 (106mm ABOVE BOTTOM) LOCATIONS SEE PHOTO; SEE FIG. 81

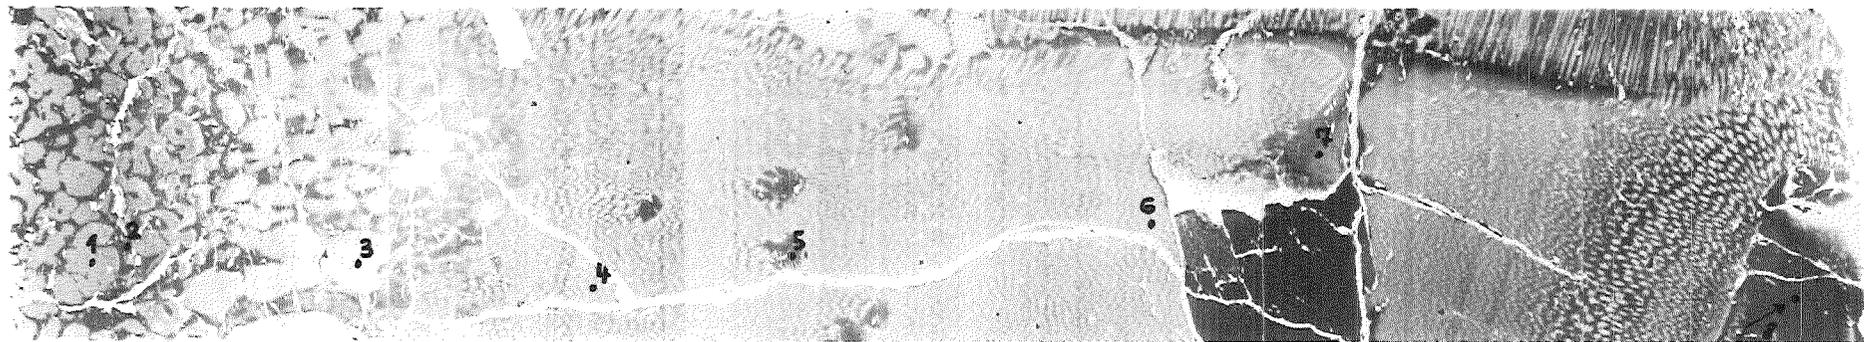
In Figure 86, a SEM picture of a region between two rods is given where the melt was in direct contact with the steam. The mark (St5) in figure 81 should be somewhat higher. The right side of Figure 86 corresponds to the dark seam at the surface of the steam channels. Analysis points St4 to 8 show that this is a fully oxidized region. This layer appears to have formed at high temperatures during the test. One can recognize a fine structure within this oxide layer. Due to the bright and dark appearance of the components one may assume that a separation of the $(Zr,U)O_2$ into ZrO and UO_2 has taken place. From the phase diagram of the U,Zr,O system this is expected to occur at equilibrium conditions.

Fig.86 Oxidation of melt in direct contact with steam
 ESBU-1: Location 5 of cross section 4 (106mm) ; see Fig.81

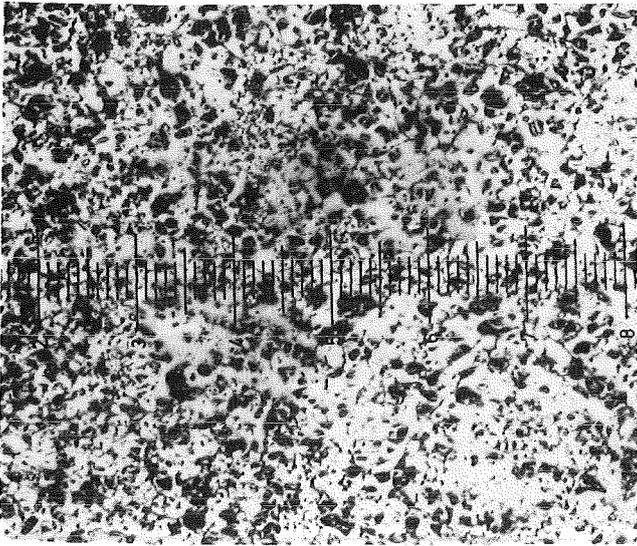
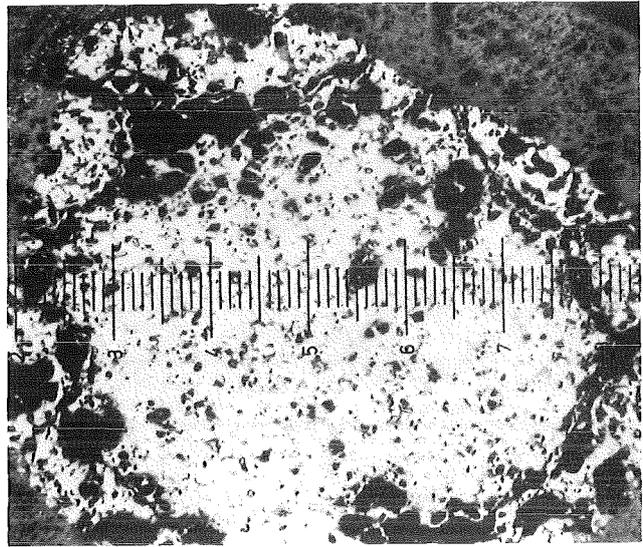
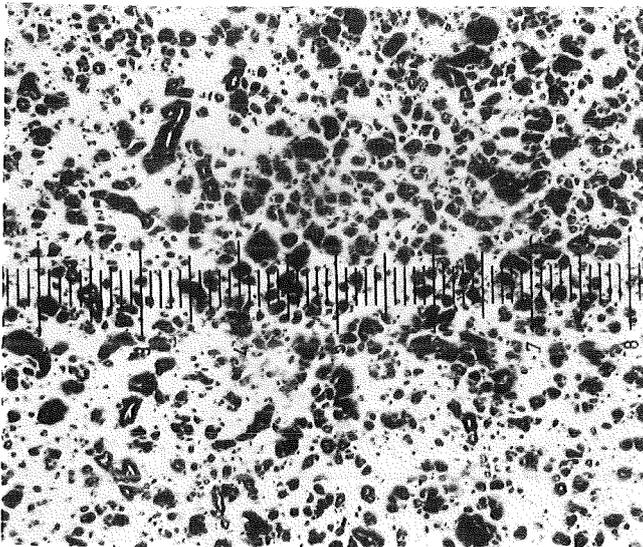
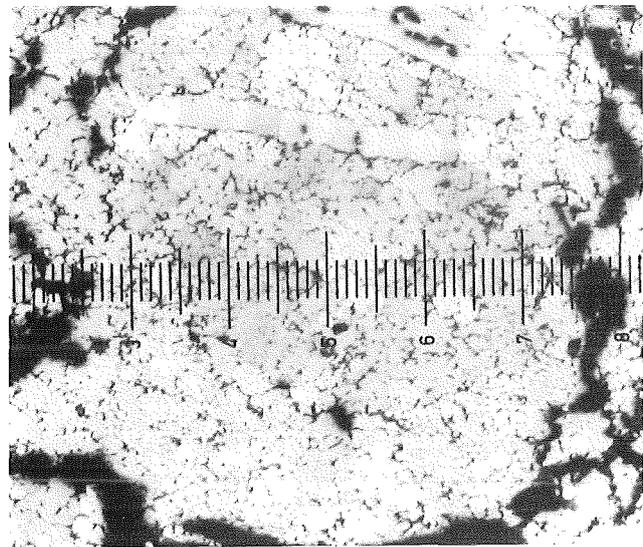
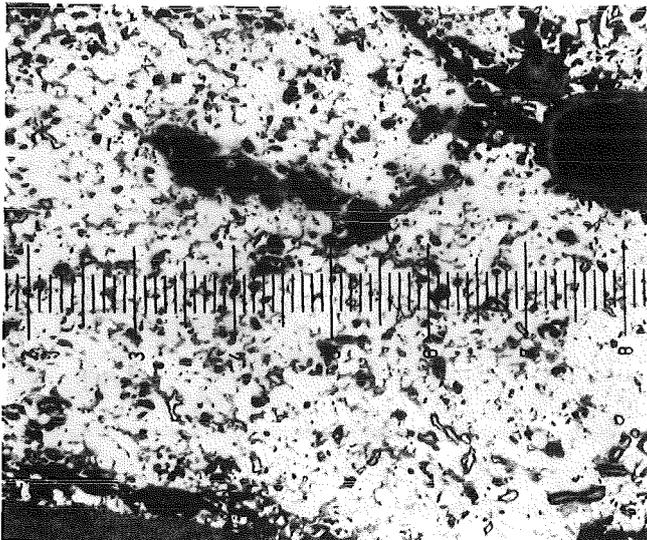
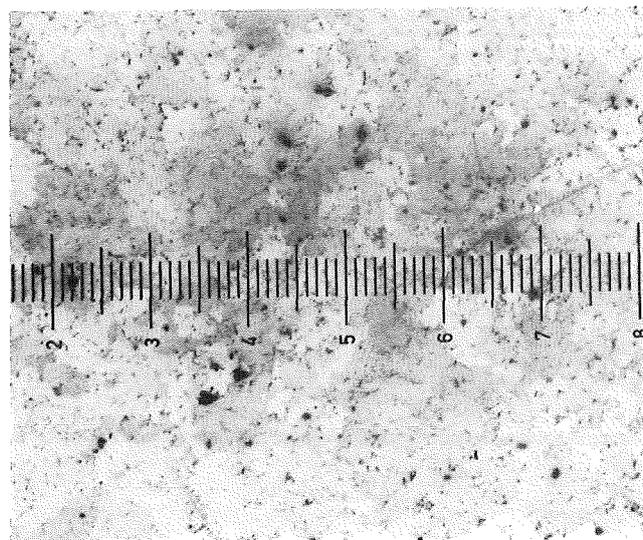
Fig.90: Structure of the refrozen melt for different elevations at the position given in Fig.89 with a magnification 50x (ESBU-1)

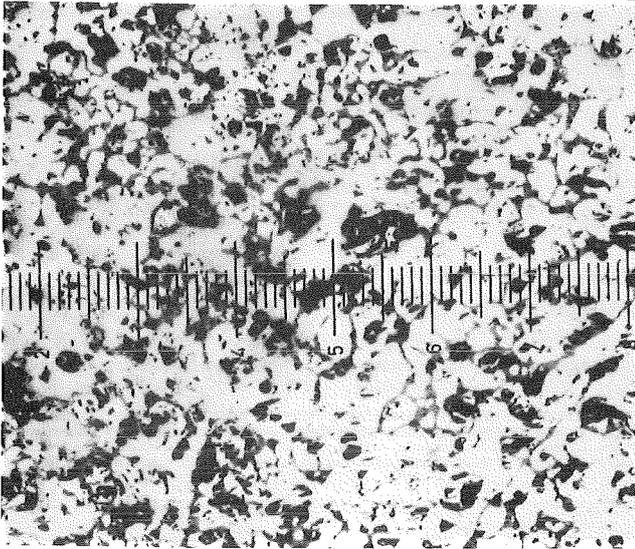
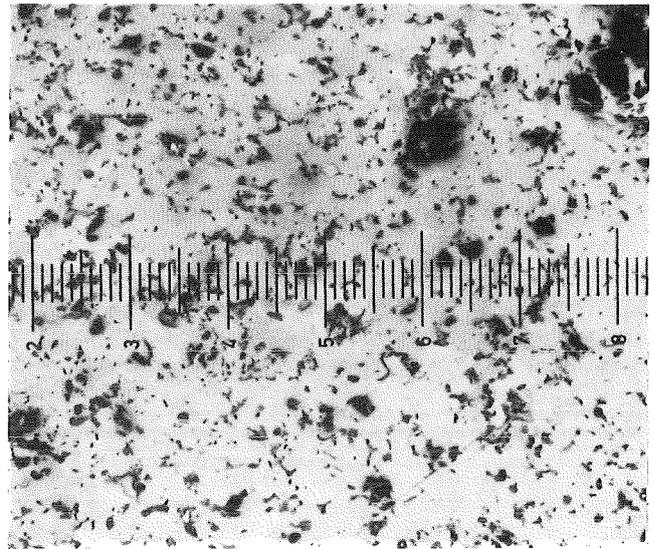
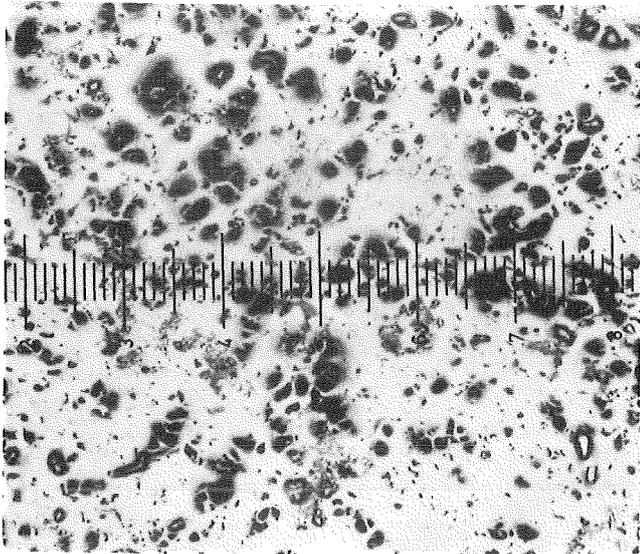
Fig.91: Structure of the refrozen melt for different elevations at the position given in Fig.89 with a magnification 100x (ESBU-1)

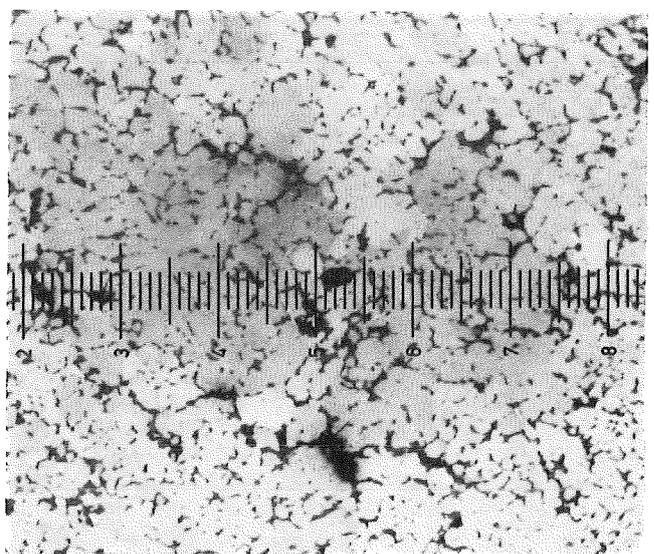
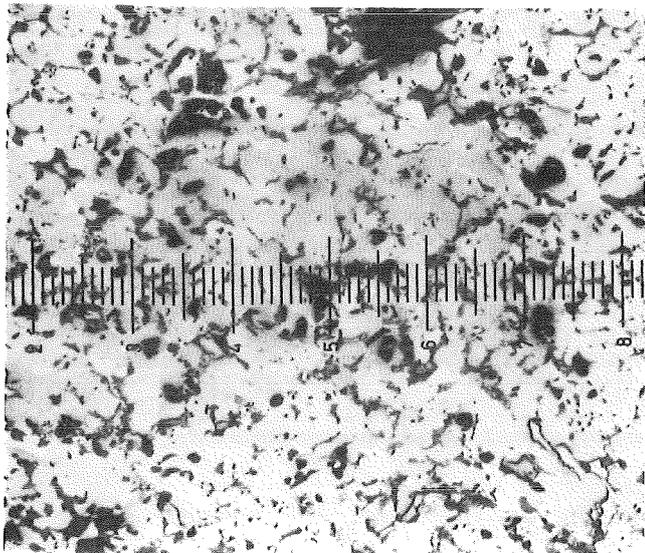
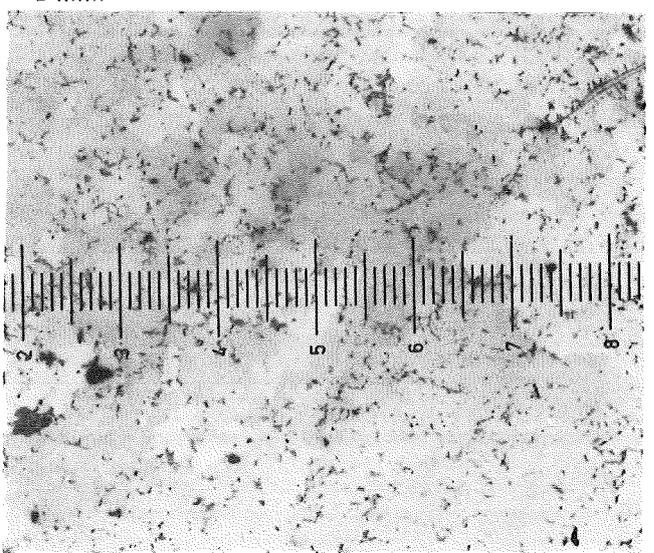
Figure 89 to 93 show the variation in microstructure of the refrozen melt with elevation. In these figures a series of micrographs are shown which were taken at the same cross sectional position of the array at different elevations. The elevations range from 15 mm to 116 mm above the lower end of the cladding and the micrographs were taken at magnifications ranging from 50 x to 500 x.

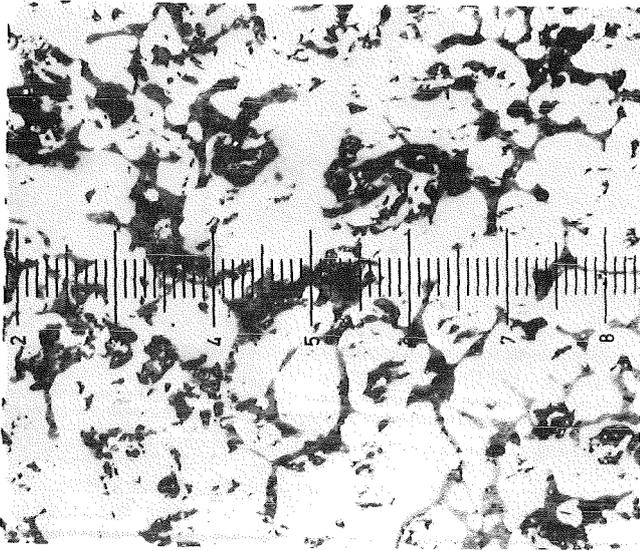
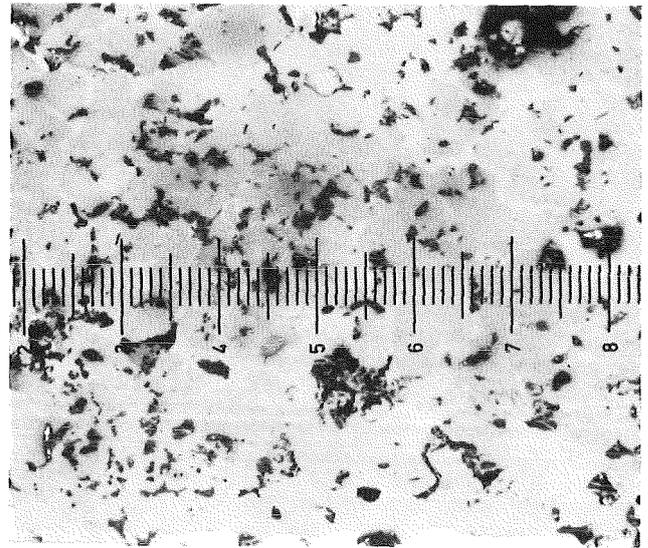
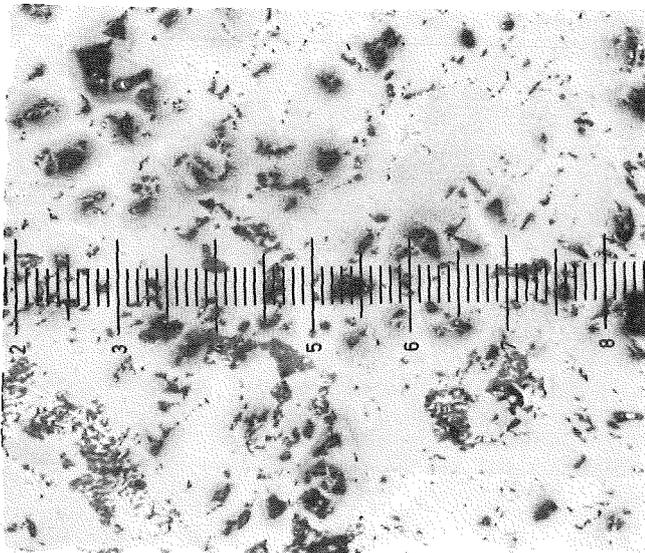
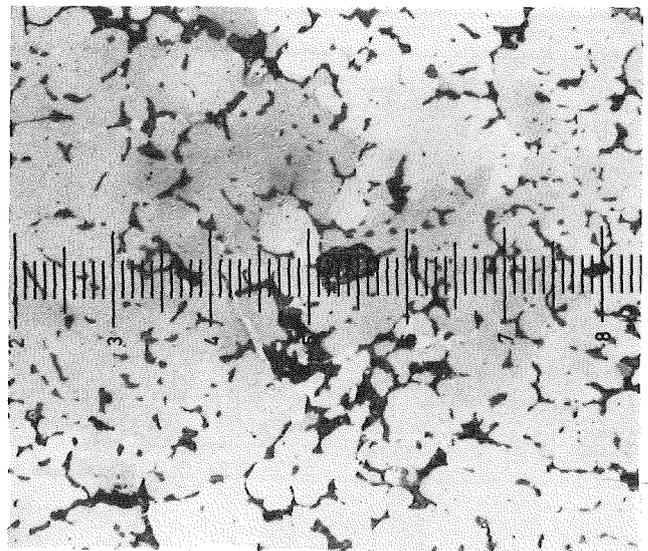
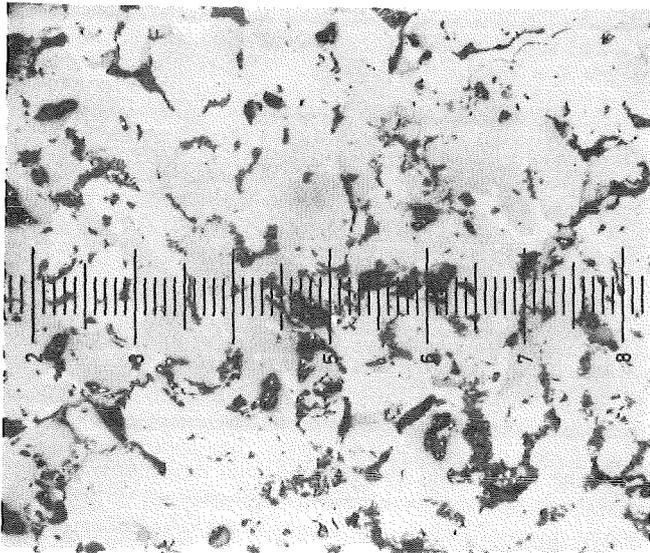
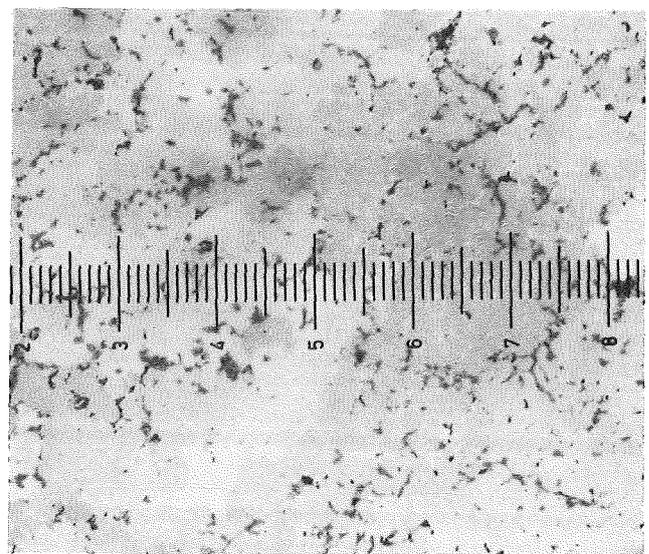
- Fig. 91: Structure of the refrozen melt for different elevations at the position given in Fig. 89 with a magnification 100x (ESBU-1).
- Fig. 92: Structure of the refrozen melt for different elevations at the position given in Fig. 89 with a magnification 200x (ESBU-1).
