KfK 3769
August 1986

Post Test Investigation of the Bundle Test ESBU-1

**On Temperature Escalation in PWR Fuel
Rod Simulator Bundles due to
the Zircaloy/Steam Reaction**

**S. Hagen, H. Kapulla, H. Malauschek,
K. P. Wallenfels, B. J. Buescher**
**Hauptabteilung Ingenieurtechnik
Projekt Nukleare Sicherheit**

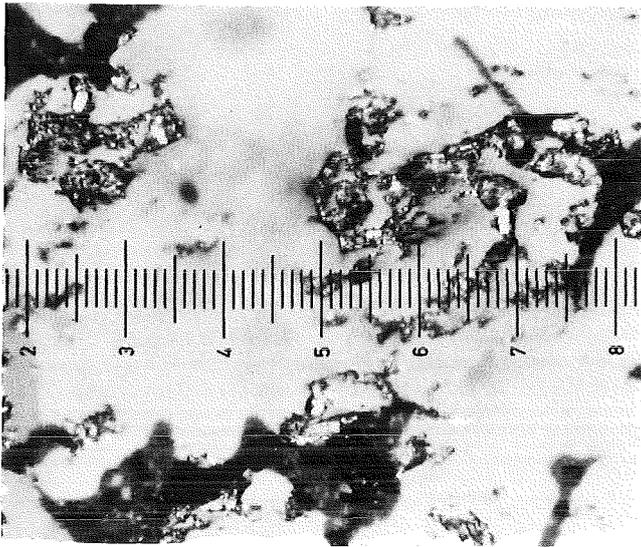
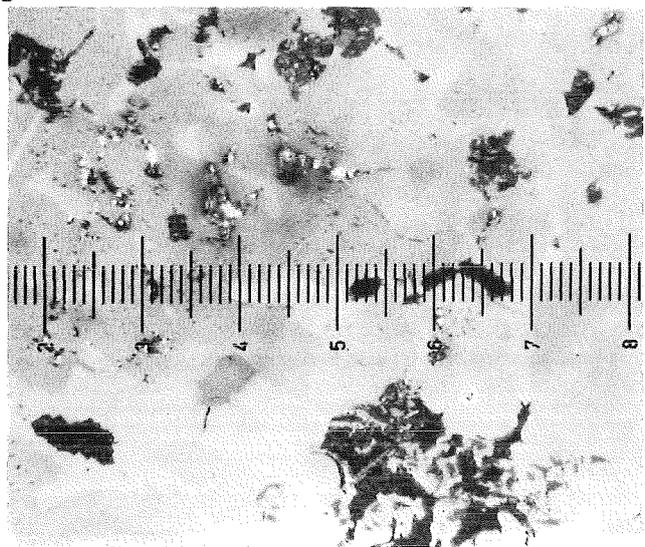
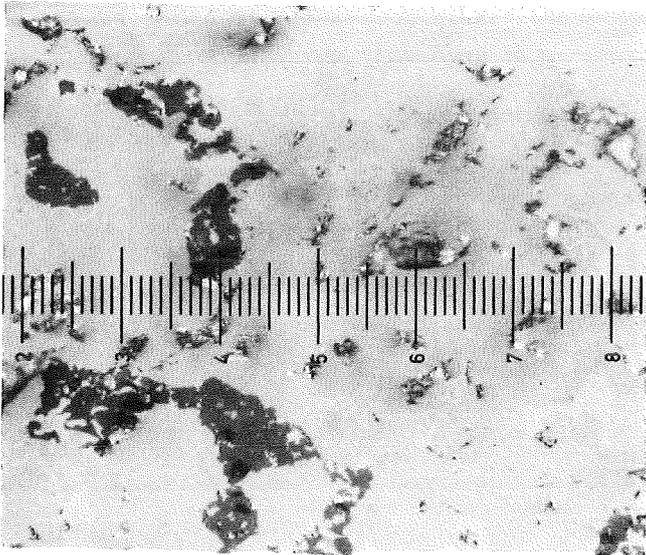
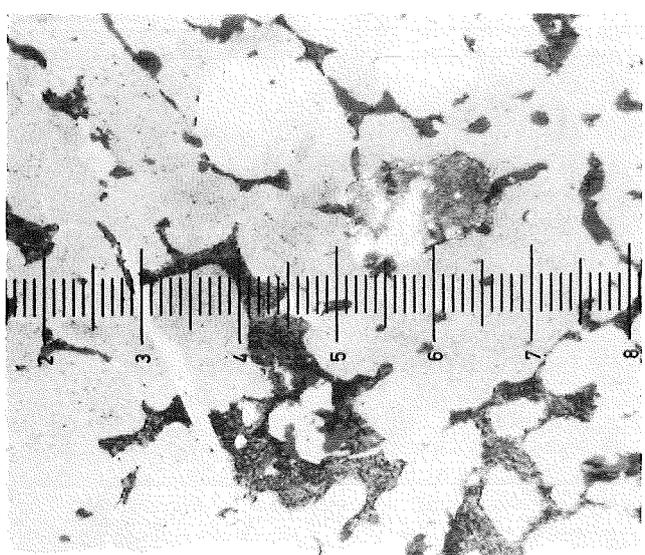
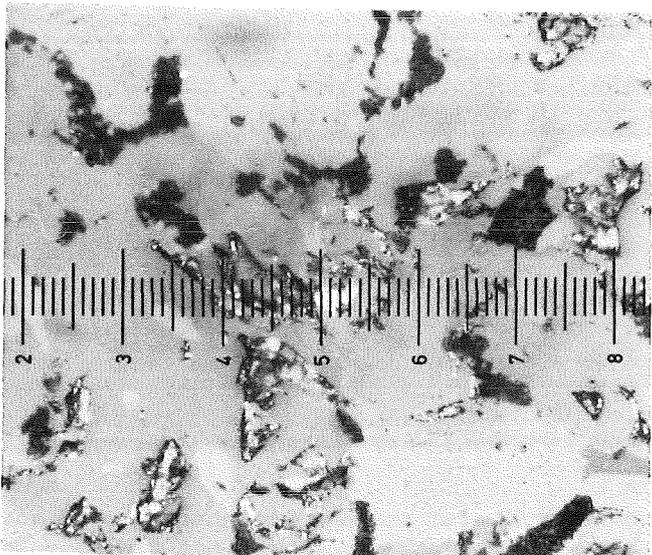
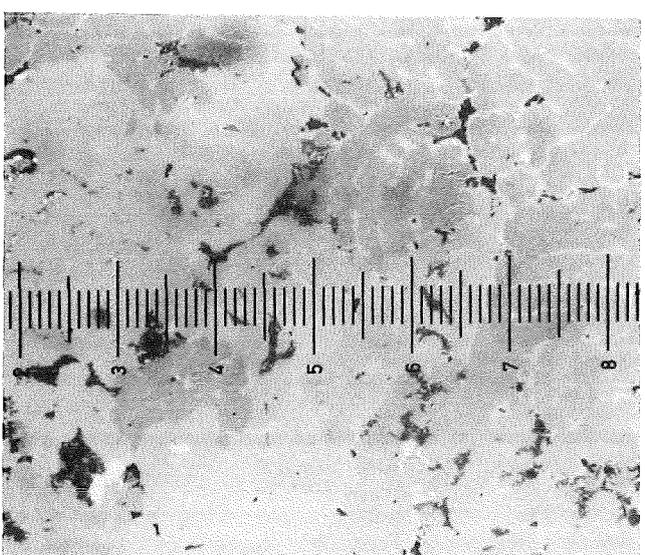
Fig.92: Structure of the refrozen melt for different elevations at the position given in Fig.89 with a magnification 200x (ESBU-1)

Figure 89 to 93 show the variation in microstructure of the refrozen melt with elevation. In these figures a series of micrographs are shown which were taken at the same cross sectional position of the array at different elevations. The elevations range from 15 mm to 116 mm above the lower end of the cladding and the micrographs were taken at magnifications ranging from 50 x to 500 x.

- Fig. 91: Structure of the refrozen melt for different elevations at the position given in Fig. 89 with a magnification 100x (ESBU-1).
- Fig. 92: Structure of the refrozen melt for different elevations at the position given in Fig. 89 with a magnification 200x (ESBU-1).
