## Fluorescent thermal imaging of a quench in insulated and non-insulated REBCO-wound pancake coils following a heater pulse at 77 K

# Fluorescent thermal imaging of a quench in insulated and non-insulated REBCO-wound pancake coils following a heater pulse at 77 K

Keywords: thermal imaging, HTS, non-insulated coil, insulated coil, fluorescent thermal imaging

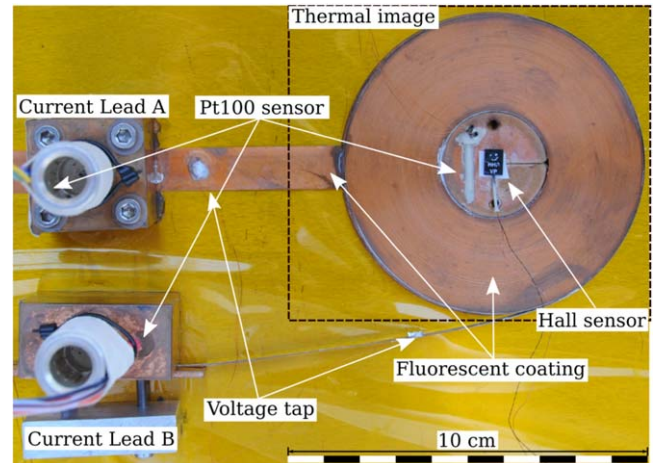
**Figure 1.** Picture of the non-insulated coil in the measurement assembly. The black rectangle indicates the thermal image as recorded by the camera. Reproduced from [10]. © IOP Publishing Ltd. All rights reserved.

The coils were cooled to 77 K in a custom-made cryostat assembly, using conduction cooling on an aluminium surface in a 77 K nitrogen gas atmosphere [10]. The camera was positioned above the coil and provided a top-down look as indicated in figure 1. Due to the absence of a liquid coolant, it is reasonable to assume that the majority of the heat dissipated in the resistor was absorbed by either the heat capacity of the resistor itself or transferred to the coil. Heat transfer to the nitrogen gas environment over the small surface of the resistor was neglected for practical purposes. Although only a small amount of glue was used for mounting the heaters, the number of turns in contact with the heater was not exactly the same in the two coils.

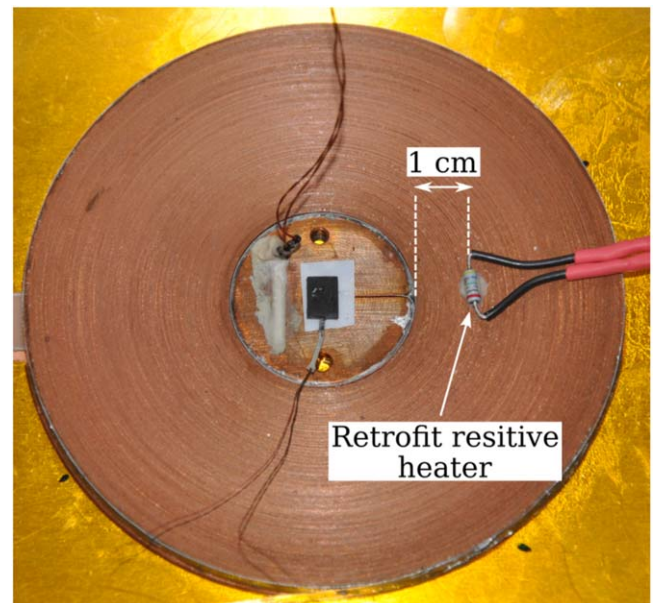
**Figure 2.** Picture of the insulated coil with a  $5 \Omega$  resistor mounted on its surface, used as a heater for creating a local disturbance.

The effect of local disturbances on coil stability and quench propagation are often studied using an embedded heater inside the coil [13, 14]. Due to requirements of previous measurement, the coils presented here were instead retrofitted with a resistive heater to study similar phenomena. The heater consisted of a resistor, with a nominal resistance of  $5 \Omega$  at 77 K, mounted on the surface of the windings. The position of the heater was approximately 1 cm from the coil bobbin, on the side opposite to the 12 mm wide HTS current lead. The resistor was mounted on the surface of the coil—already coated with the fluorescent coating—using X60 two-component glue. It was in contact with only a few turns, as shown in figure 2.

Thermal images recorded during the normal transition of the coil are shown in figure 8. In this measurement, even though the heater was positioned 1 cm away from the coil's centre (figure 2), no considerable heating was visible during the heater pulse (figure 8). Then in figure 8, it is visible that the thermal runaway has in fact started from around the coil's centre (the bobbin) and propagated outwards, starting from the moment of rapid coil voltage appearance. Thereafter, in figure 8, the temperature around the centre increased and started propagating further into the body of the coil. Finally, at 241 s in figure 8, just before ramping down the coil, most of the coil was above 100 K, with the centre being close to 130 K. In this figure it is also visible that the 12 mm wide HTS current lead was also heating, and reaching above 150 K. The cooling of this current lead was sub-optimal and hence such an effect was expected.

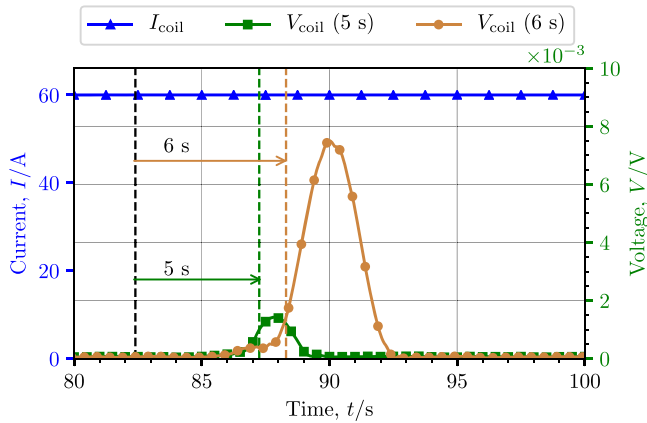
**Figure 3.** Effects of a 5 and 6 s long heat pulses at a power of 3.2 W on the insulated coil. The dashed lines indicate the heater pulse duration. The pulses were synchronized in the plot to start at 82.35 s.

For heater pulse durations of up to 2 s, the coil voltage remained stable and the thermal imaging showed barely detectable fluctuations caused by the heater itself, not related to the coil operation. This indicates that the superconductor itself did not incur losses due to a transfer into the dissipative state (in any significant manner). For increased heater pulse durations, the coil voltage rose and also recovered on its own after the disturbance was stopped. The results of electrical measurements of 5–6 s long heater pulses are shown in figure 3. The two heater pulses caused an approximately

2 and 8 mV signal across the coil terminals, after which the coil promptly recovered. During these two measurements, still no localized heating was detected in the coil.

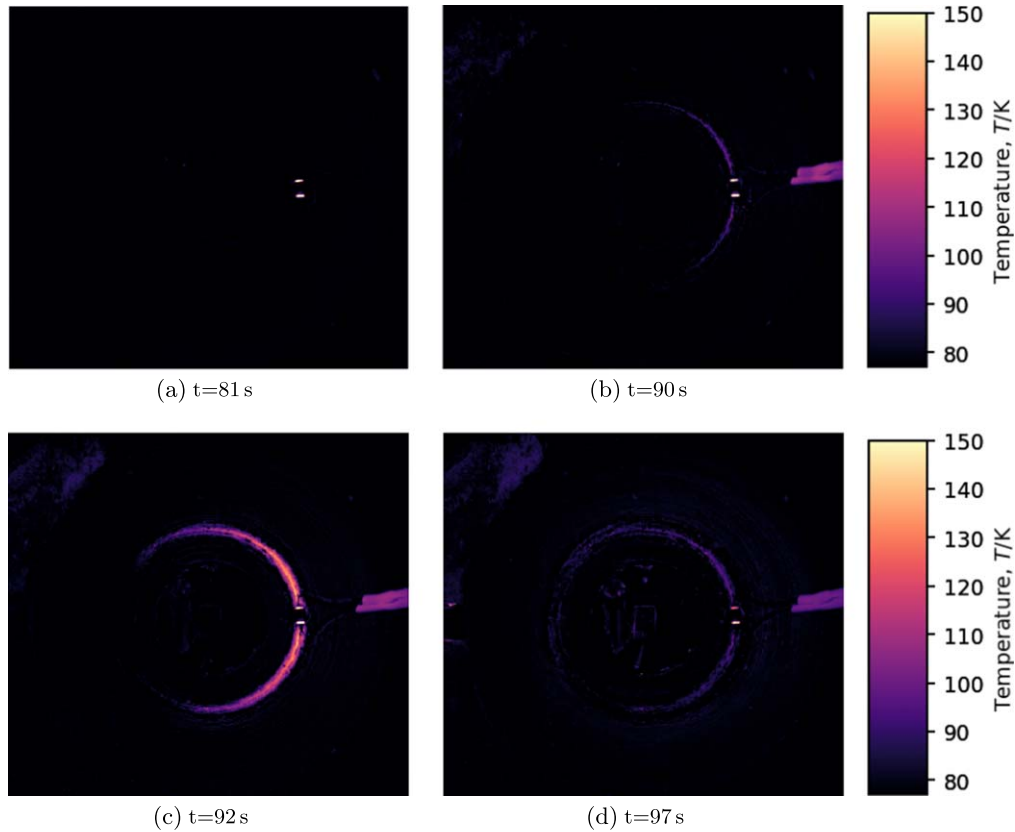
**Figure 5.** Thermal images of the normal transition in the insulated coil caused by a 7 s long heater pulse. Note that discolouring of the heater and cables is noise and not related to the thermal imaging.

At a pulse length of 7 s, the coil was no longer able to recover from the heat input and a normal transition was recorded. This is shown in figure 4. A detectable voltage rise was measured during the heater pulse. However, the voltage continued to rise even after the heater pulse ended. Simultaneously, in the thermal images, it is visible that the windings touched by the heater started to transit into the normal conducting regime and incurred Joule losses, followed by heating, as shown in figure 5. The heater pulse started approximately at 81 s, as shown in figure 5, where the heater is causing optical artefacts, which are actually not relevant to the thermal imaging. In figure 5, 2 s after the heater pulse ended, distinct heating is visible in the coil around the heater at a coil voltage of  $\sim 0.2 \text{ V}$ . The temperature in the windings then peaked at 92 s (figure 5), where only the turns directly in contact with the heater were affected. At 97 s figure 5 shows the cooling down of the involved turns. As expected, the electrical and thermal insulation provided by the Kapton layer between the turns greatly reduces the heat propagation in the radial direction of the insulated coil. As a consequence, merely the windings in direct contact with the surface-mounted heater were heating. It is also visible that heating was present mostly around the heater, diminishing progressively along the length of the turn with an overall hot zone of approximately 70% of the circumference of the involved windings. These results show—from a thermal perspective—the existing problem of protecting insulated HTS coils as developed hot spots do not propagate considerably inside the body of the coil, but are restricted to a small fraction of the windings.

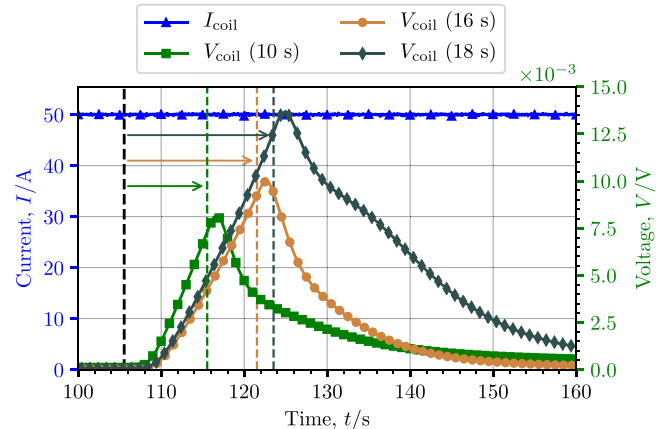
**Figure 6.** Voltage response of the NI coil to heater pulses of 3.2 W for durations of 10, 16 and 18 s. The pulses were synchronized in the plot to start at 105.5 s.

to experimental considerations, in the measurements shown here, the coil was ramped to a slightly lower current, i.e. ~75% of  $I_c$  (50 A). The ramping rate was kept at  $5 \text{ A s}^{-1}$  and upon reaching the target current level, the coil was then given 90 s to stabilize. The heater was then pulsed with the same current of 800 mA for various durations. Figure 6 shows a summary of the effects of heater pulses applied to the NI coil for durations of 10, 16 and 18 s. Coil terminal voltages were measured in the range of 8 mV, where longer pulses caused a progressively larger electrical voltage across the coil’s terminals. After each

heater pulse, the coil recovered to steady state operation. The rate of voltage rise was higher for the experiment with the 10 s heater pulse than in the other two measurements.

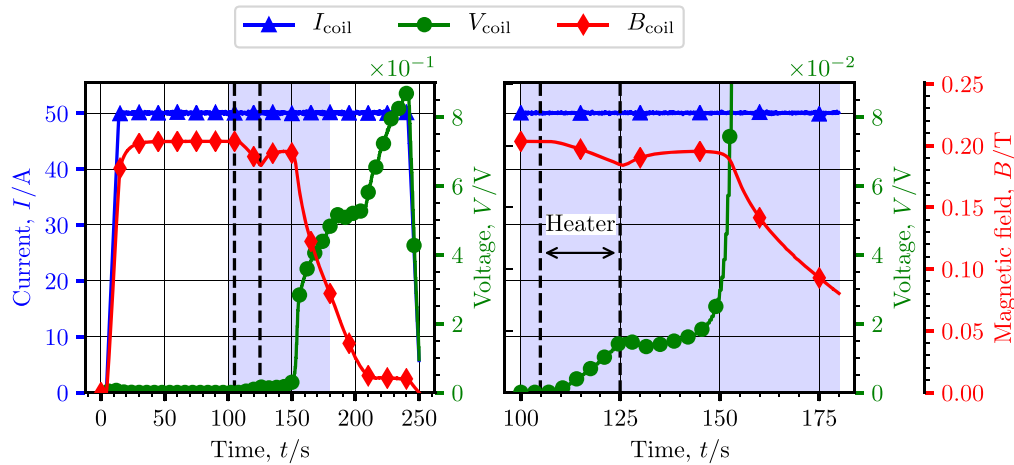
**Figure 7.** Electrical measurement of the quench in the non-insulated coil caused by a 20 s long heater pulse at a power of 3.2 W. The highlighted area is shown in greater resolution. Note the changed scale of the measured voltage.

When increasing the heater pulse duration to 20 s, a runaway was observed as shown in figure 7.

During the heater pulse, a distinct voltage rise was visible across the coil terminals. However, after stopping the heater disturbance the coil showed signs of self-recovery initially. This effect is visible on the recovering coil voltage in figure 7 after 125 s as well as on the increasing magnetic field. The combination of these two signals indicate currents transferring back into the spiral path of the coil. However, a few seconds later ( $\sim 130$  s) the coil voltage started to rise again and the magnetic field did not increase any further towards the previous plateau. Yet another  $\sim 5$  s later a sharp voltage rise was recorded, indicating that part of the coil was transitioning from superconducting to normal conducting state. After this rapid voltage rise and drastic reduction in the magnetic field, further rise in voltage became more linear and the magnetic field fell and stabilized at  $\sim 10\%$  of its original value. Following the initial sharp voltage rise, indicating a normal transition inside the windings, the coil was operated for another 100 s before de-energizing. The peak heating power reached before ramping down was around 40 W, as estimated from  $P = I \cdot V$ . After the experiment, the critical current was re-measured and found to be unchanged, indicating that no permanent damage was done to the coil.

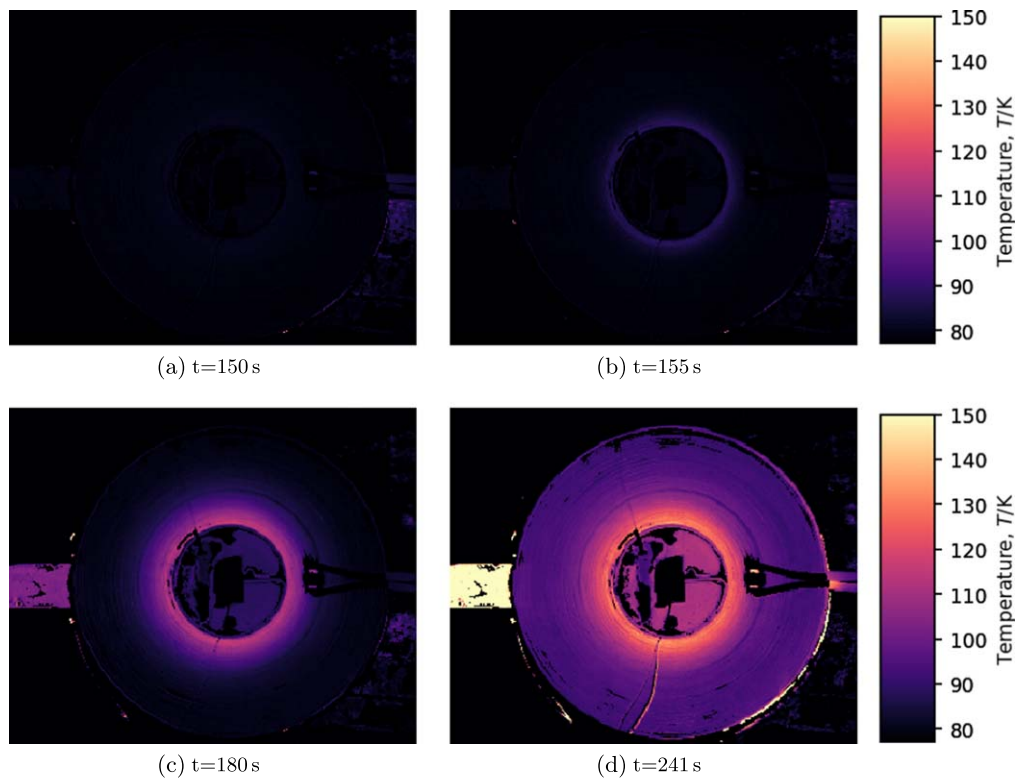
**Figure 8.** Thermal images of the normal transition in the the non-insulated coil during 20 s heater pulse measurement. Note that discolouring of the heater and cables is noise and not related to the thermal imaging.

The results indicate that while the normal transition in the non-insulated coil was initially triggered by a long heat load at a localized disturbance, the transition itself did not originate from this position. Instead, the current redistribution inside the coil caused the weakest part of the coil to begin a transition, which then spread across the coil. In this coil design, the weakest point was the centre of the coil around the copper bobbin, where the magnetic field is the strongest and hence degrades the critical current of the conductor to the highest extent [15]. Simultaneously, Joule losses were present due to a soldered joint between the copper bobbin and the HTS coil itself, thereby further reducing the critical current density. After the initial normal transition of superconducting windings around the centre of the coil, the coil voltage rise became more linear, with more current flowing through the turn-to-turn contact resistances. This effect is also clear in the thermal recording, where the centre of the coil heats up rapidly, followed by a more gradual heating in the body of the coil.
