Correlation of microstructural and mechanical properties of neutron irradiated EUROFER97 steel

M. Klimenkov*, U. Jäntsch, M. Rieth, A. Möslang

Karlsruhe Institute of Technology (KIT), Institute for Applied Materials - Applied Materials Physics (IAM-AWP), Hermann-von-Helmholtz-Platz 1, 76344 Eggenstein-Leopoldshafen, Germany

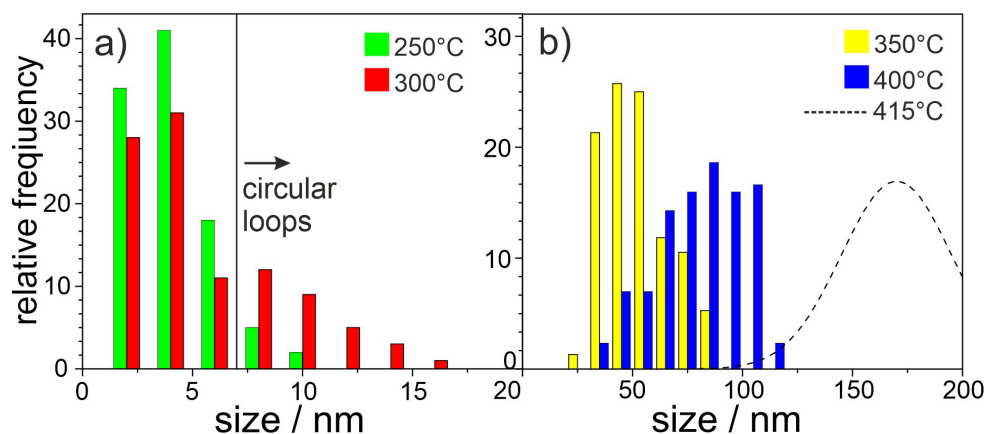
Fig. 7 Size distribution histograms of dislocation loops for 250°C and 300°C as well as for 350°C and 400°C irradiation temperatures (a,b). The estimated size distribution for 450°C was plotted as a dashed line in the part (b) due to the lack of reliable statistics.

The size distribution histograms of the dislocation loops are displayed in different colours in Fig 7. Most loops formed at 250°C and 300°C are highly disperse "black dots" of a few nanometers (Fig. 7a). At temperatures $\leq 300^\circ\text{C}$ the majority of defects are "black dots" with sizes typically less than 5nm (Figs. 1, 2). Their quantity reaches 90% at 250°C and 70% at 300°C. By "black dots" we mean small dislocation loops (≤ 6 nm size), which are spot (dot) like images with no recognizable structure in the TEM analyses. On the other hand, the larger loops typically show a circular structure. In general, the size at which the loops will appear as rings depends strongly on the sample thickness, alignment of the g -vector, application of weak beam orientation and other imaging conditions. The dividing line at 7 nm in the diagram (Fig. 7a) shows the boundary between black points and circular loops. At higher radiation temperatures the loop size increases strongly and reaches ~ 180 nm at 415°C (Fig. 7b). The size distribution for 415°C was drawn with the dashed line due to the poor statistics and significant

uncertainties in the size estimation. Loops larger than 100 nm are in most cases not fully preserved in the TEM foil and their actual size has been estimated. The large loops can be identified as such, if at least 1/3 of the original circle remains in the thin foil, so that a considerable proportion of the smaller sections of the loops has been excluded from the statistics. This also influences the results of the size evaluation of the sample irradiated at 400°C. The drawing of a histogram for 415°C has been omitted because of poor statistics and considerable uncertainties in size estimation. Moreover, the cut section of the loop can be recognized as such if it has at least 1/3 of the original circle, so a notable fraction of the smaller loops sections was not recognized as a “radiation-induced defect”.

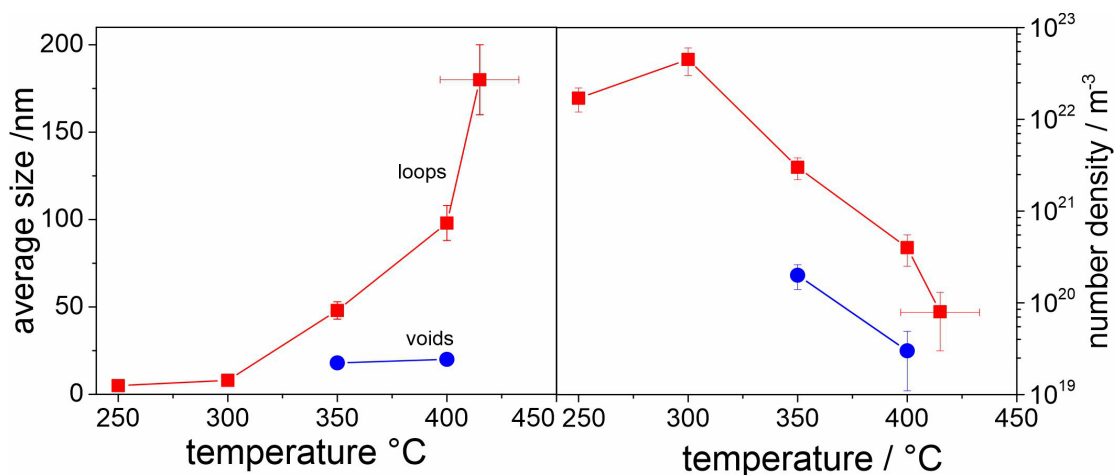
Fig. 8 Dependence of average size of dislocation loops and voids (blue circles) on irradiation temperature (a) and number density (b).

The average loop size and the number density as a function of the irradiation temperature are shown in Fig. 8a,b (red squares). The size increases from less than 10 nm in the material irradiated at $\leq 300^\circ\text{C}$ to 180 nm at 415°C (Fig. 8a). The number densities of visible dislocation loops are drawn in Fig. 8b as a logarithmic function for all irradiation temperatures (red squares). The highest number density of dislocation loops $4.6 \cdot 10^{22} \text{ m}^{-3}$ was measured at 300°C,

whereas at 250°C it amounted to $1.6 \cdot 10^{22} \text{ m}^{-3}$. The value decreases continuously toward 415°C irradiation temperature, resulting in a value more than two orders of magnitude lower compared to that at 250°C. The voids were detected only in the material irradiated at 350°C and 400°C (blue circles in Fig. 8a,b). Their average size is about 18 nm at 350°C and 20 nm at 400°C. At 400°C, the voids show a very low number density. The swelling and density numbers were estimated with an error of 70%.

Fig. 8 Dependence of average size of dislocation loops (red squares) and voids (blue circles) on irradiation temperature (a) and number density (b).

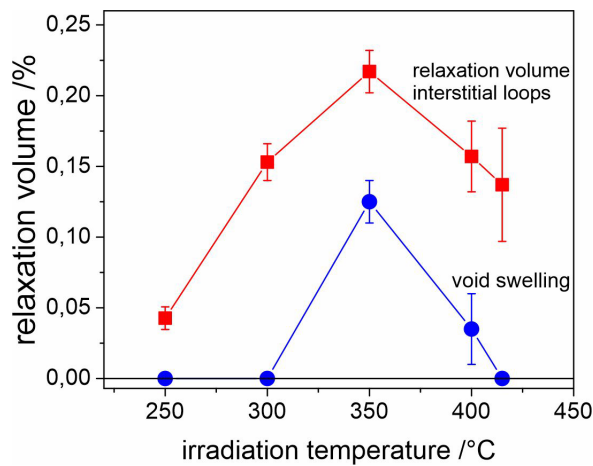
Fig. 9 Relaxation volume caused by dislocation loops (red squares) and void swelling (blue squares) as a function of radiation temperature.

$\approx 0.3-0.6T_m$. In EUROFER97, the formation of voids was observed only at 350°C and 400°C with 0.2% and 0.04% cavity swelling, respectively (Fig. 9). The swelling caused by the presence of voids is usually calculated as a simple sum of the volumes of all voids observed, divided by the volume of the material in which the cavities were counted [20].

The maximum of the relaxation volume of 0.21% was reached at the irradiation temperature of 350°C. At this temperature the void swelling also shows the highest value of 0.13%. The previous investigations show that the radiation-induced void swelling reaches the maximum value at 420°C [23]. It was also assumed that no void and loops were formed at the higher temperatures. Our results confirm these conclusions only in relation to voids which were detected at higher temperature in materials with higher helium concentration [24]. On the other hand, we clearly show that the formation of loops also occurred at higher temperatures, but they are not always visible in the TEM (Fig. 6). It should also be mentioned that the maximum of void swelling appears in EUROFER97 at $\sim 50^\circ\text{C}$ lower temperature than in F82H steel [23]. The formation of loops with the size $>150\text{nm}$ in pure single crystal iron after ion irradiation at 500°C was reported in [25]. The absence of a grain boundary or other inhomogeneities can lead to the formation of loops with a size of several hundred nanometers. In the present study, the
