Experimental investigation of carbon long fiber reinforced polyamide 6 exposed to environmental conditions

To enhance the possibilities in lightweight constructions in terms of processability and recyclability, fiber reinforced thermoplastics are a promising class of materials. In this context, the fiber-matrix interface has a major influence on the mechanical properties of the composite. With polyamide 6 (PA6) being a hygroscopic thermoplastic, the effects of elevated humidity and temperature on the mechanical behavior must be considered [1]. This study aims to characterize the micro-mechanical material properties of carbon long fiber reinforced PA6 in quasi-static tensile tests after exposure to elevated temperature and humidity levels. Therefore, the specimens are conditioned in different climates and tested afterwards. In order to determine the initiation and propagation of matrix cracks, interface failure, and fiber fracture, the experiments are conducted on a micro-scale with an average cross-section of 0.03 mm^2 . The damage patterns are captured using optical microscopy and SEM images. The effects of conditioning at various temperature and humidity levels are discussed. Th

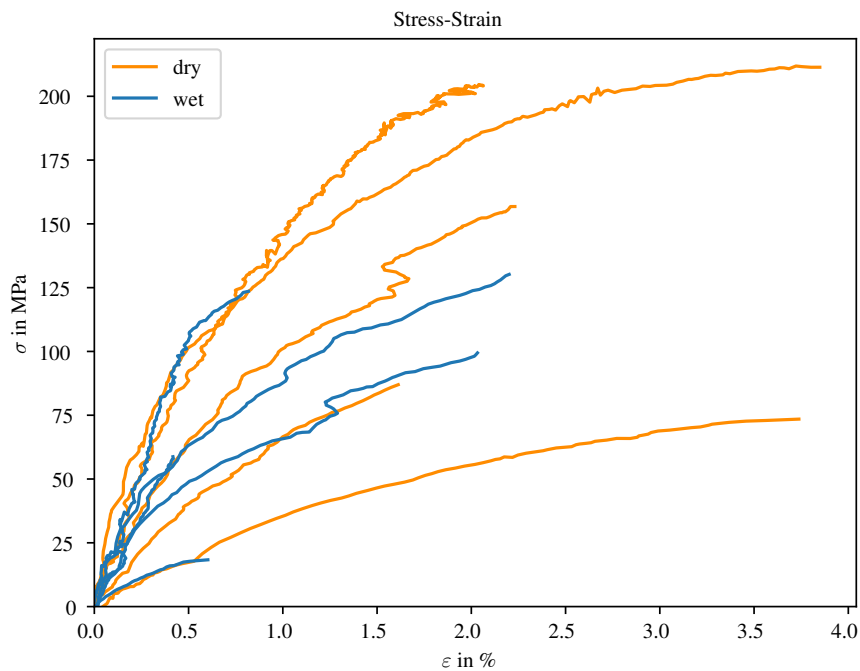
Fig. 5: Stress-Strain curve for dry and wet specimens.

The results for the quasi-static testing are displayed in Fig. 5. Generally, a large scatter in the results was observed, which can be explained by the geometric properties of the specimens. Due to the small cross-sectional area of 0.03 mm², the heterogeneous micro-structure does not average over the specimen's volume, i.e. one sample may contain fiber-rich regions whereas another does not. Additionally, fiber distribution and content were found to vary significantly between samples.
