Construction and Building Materials

Bond performance of fly ash-based geopolymer mortar in simulated concrete sewer substrate

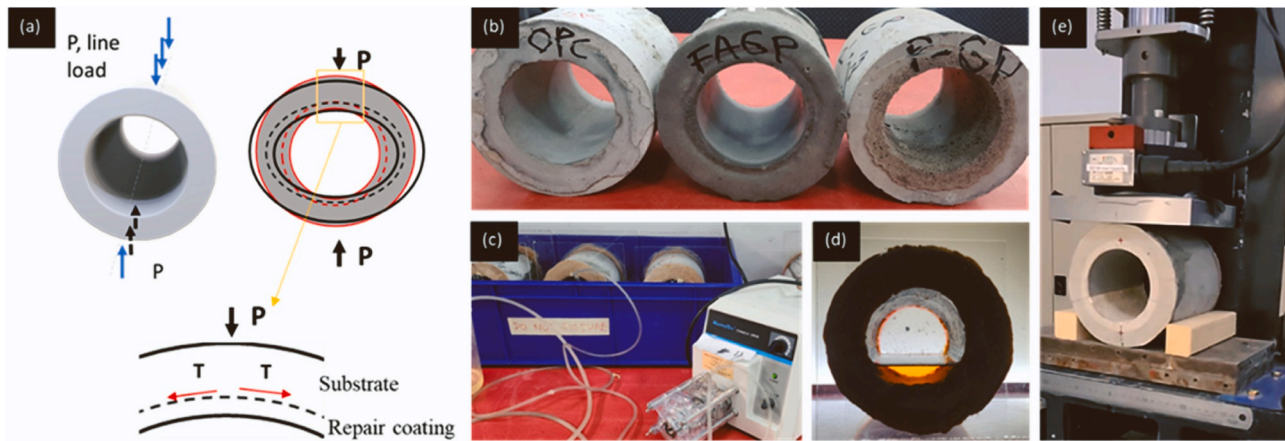
Fig. 2. – (a) Ring deflection set-up for a pipe under a line load, (b) concrete pipe segments lined with repair binders, (c) experimental set up for aggressive H₂SO₄ acid exposure, (d) P-GP mortar-lined pipe after 1000 hrs of acid exposure, and (e) a pipe segment under loading.

critical for evaluating the composite properties. Fig. 2(a) depicts the ring deflection diagram for a pipe under a line load, a typical test setup for a subterranean sewer pipe. However, assessing the fractures at a given load or at the failure load does not suffice; monitoring fracture genesis and propagation by measuring field stain is critical to understanding the repair impact, which is still poorly understood in assessing in situ pipe repair liners.

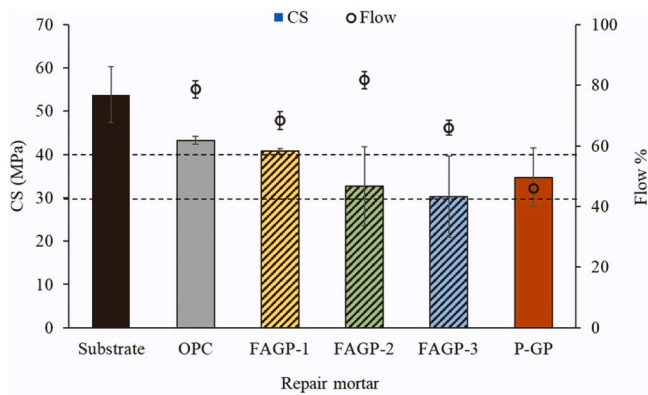
Fig. 3. – Results for flow value of fresh repair mortars and 28-day compressive strength.

2.5.1.2. Compressive strength. Material testing on the substrate and repair materials supplemented the bond tests. Compressive testing was performed on 50 mm × 100 mm cylinders using 100 kN capacity MTS Universal Testing equipment at a loading rate of 0.5 kN/s. The ASTM C109 [48] the standard was used to assess compressive strength; all tests were performed in triplicate, and the average results and standard deviations are reported in Fig. 3.

Fig. 3 illustrates the flow characteristics and 28-day compressive strength of repair mortars and the substrate concrete used in this study. According to the flow measurement, the fresh FAGP-2 flow was

equivalent to OPC mortar (around 80 % flow), whilst the flow values for other FAGP were within the 60–80 % range and were observed as satisfactory workability (neither very dry nor self-compacting). A flow consistency of 80 %–90 % was optimal for the vertical pouring of the mortar liner without fine aggregate segregation. Compared to the P-GP, it showed the lowest flow of all, which was 46 %. As can be seen from the compressive strength results, conventional concrete sewers have a compressive strength of 45–50 MPa. However, this study sought a higher strength (>50 MPa) for substrate concrete to distinguish failure modes/patterns. The mechanical strength properties of the mortars differed as expected, which is reflected in Fig. 3. The compressive strength of FAGP-1 was the highest compared to the other geopolymer repair mortars, and it was 40 MPa, equivalent to OPC repair mortar. The compressive strength of the remaining three geopolymer mortar mixes, including the commercial geopolymer, was lower and in the 30–35 MPa range. The strength increases in FAGP-1 compared to other types of FAGP geopolymer is attributed to the higher activator content in the mix. This aided in accelerating the geopolymerisation reaction, resulting in higher strength than the other two types.

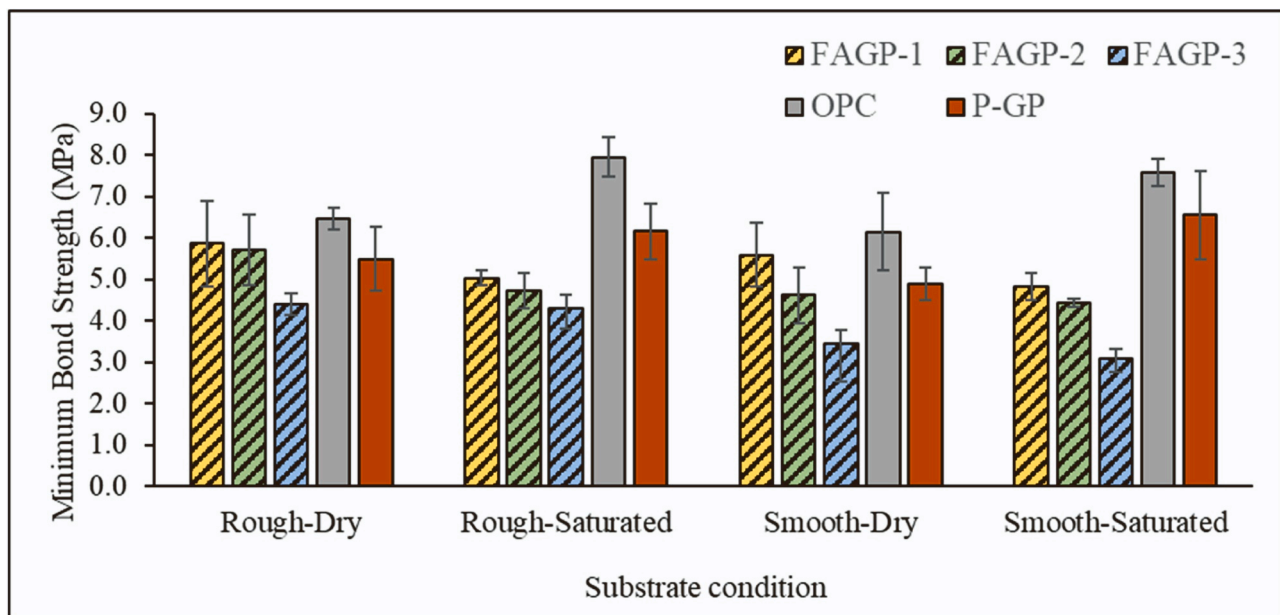
Fig. 4. – Comparison of minimum shear bond strength between repair mortars at substrates with different surface roughness and moisture levels.

respectively, as shown in Table 3. The minimum bond strength for repair, as stipulated by ASTM C882, is the slant shear stress at the point of failure [19]. The minimal bond strength has been adopted as the actual bond strength for cases where the failure occurred exclusively at the bond interface (a shear failure). Although interface roughness and specimen geometry influence slant shear strength, distinguishing bond characteristics between repair materials prepared and evaluated under the same conditions is advantageous [53]. Fig. 4 depicts the minimum

bond strength of each mortar at various substrate conditions. Mortar bond strength results and the corresponding failures are discussed in detail below.

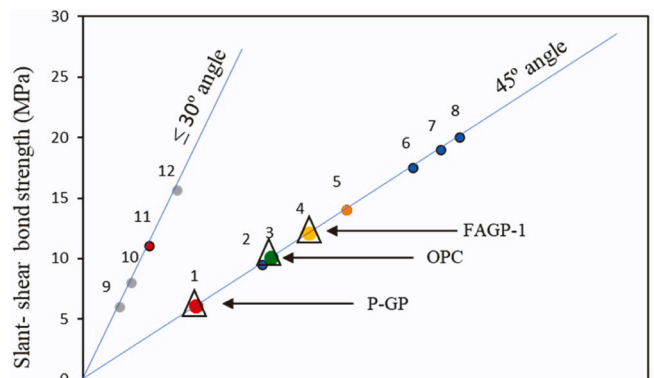
Fig. 6. – Comparison of slant shear bond strength results between published data and the current study.

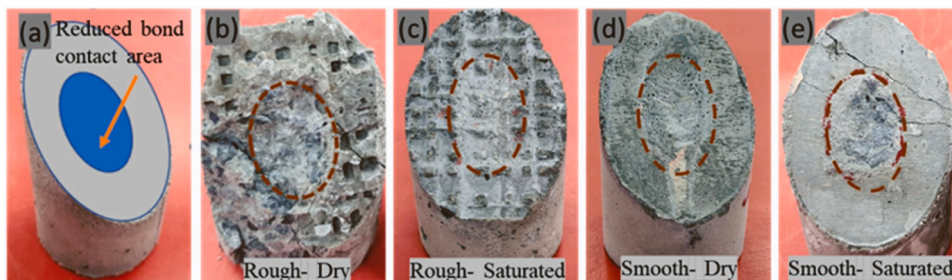
Fig. 5. – Shear failure seen in representative FAGP-1 specimens with (a) reduced bond contact area; substrates at (b) Rough- Dry, (c) Rough-Saturated, (d) Smooth-Dry, and (e) Smooth-Saturated.

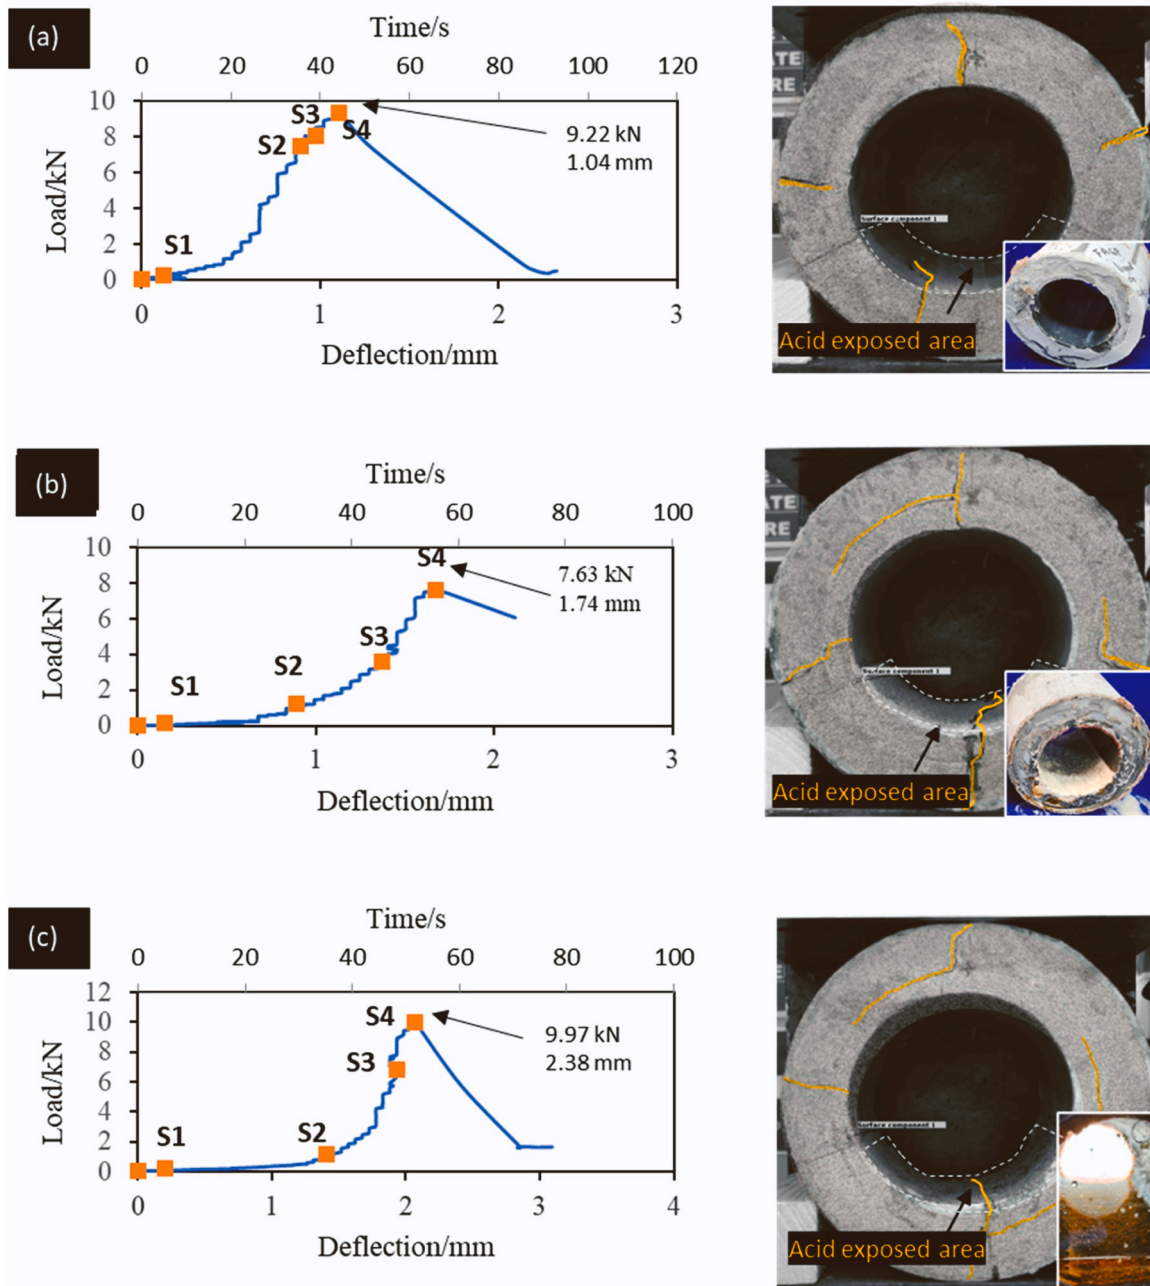
Fig. 7. – Load- deflection-time curves alongside with failure patterns of the repair mortar-coated composite specimens; (a) FAGP-1, (b) OPC, and (c) P-GP.

Fig. 7 shows the load- deflection-time curves alongside failure patterns of the repair mortar-coated composite specimens. The failure loads for FAGP-1, OPC and P-GP specimens were 9.22 kN, 7.63 kN and 9.97 kN at the deflection of 1.04 mm, 1.74 mm, and 2.38 mm, respectively. All specimens developed obvious fractures in the tension areas of the vertical plane (below the neutral axis) and transverse plane (above the neutral axis), typical of an unreinforced concrete pipe under a two-edge bearing load. However, as seen in Fig. 7(b) and (c), the cracks in both OPC and P-GP have propagated along the bond interface, indicating a sign of debonding of the repair layer from the concrete substrate. This can be due to either poor bonding or shrinkage-induced stresses, which caused the bond failure at the ITZ. However, no evaluations were made to assess the inherent shrinkage properties of the materials in this study. It is advantageous to analyse the stresses at the bond interface to correlate the failure load with deflection and fracture behaviour. In response, full-field strain distribution maps were employed to establish the highly stressed areas at the bonding zone; maps were acquired at various stages, from crack initiation to failure, using the DIC technique. Visual representations of individual segments of mortar-coated concrete pipes following the acid treatment are depicted in Fig. 7. The strain maps were also anticipated to demonstrate the impact of acid degradation on the bonded region.

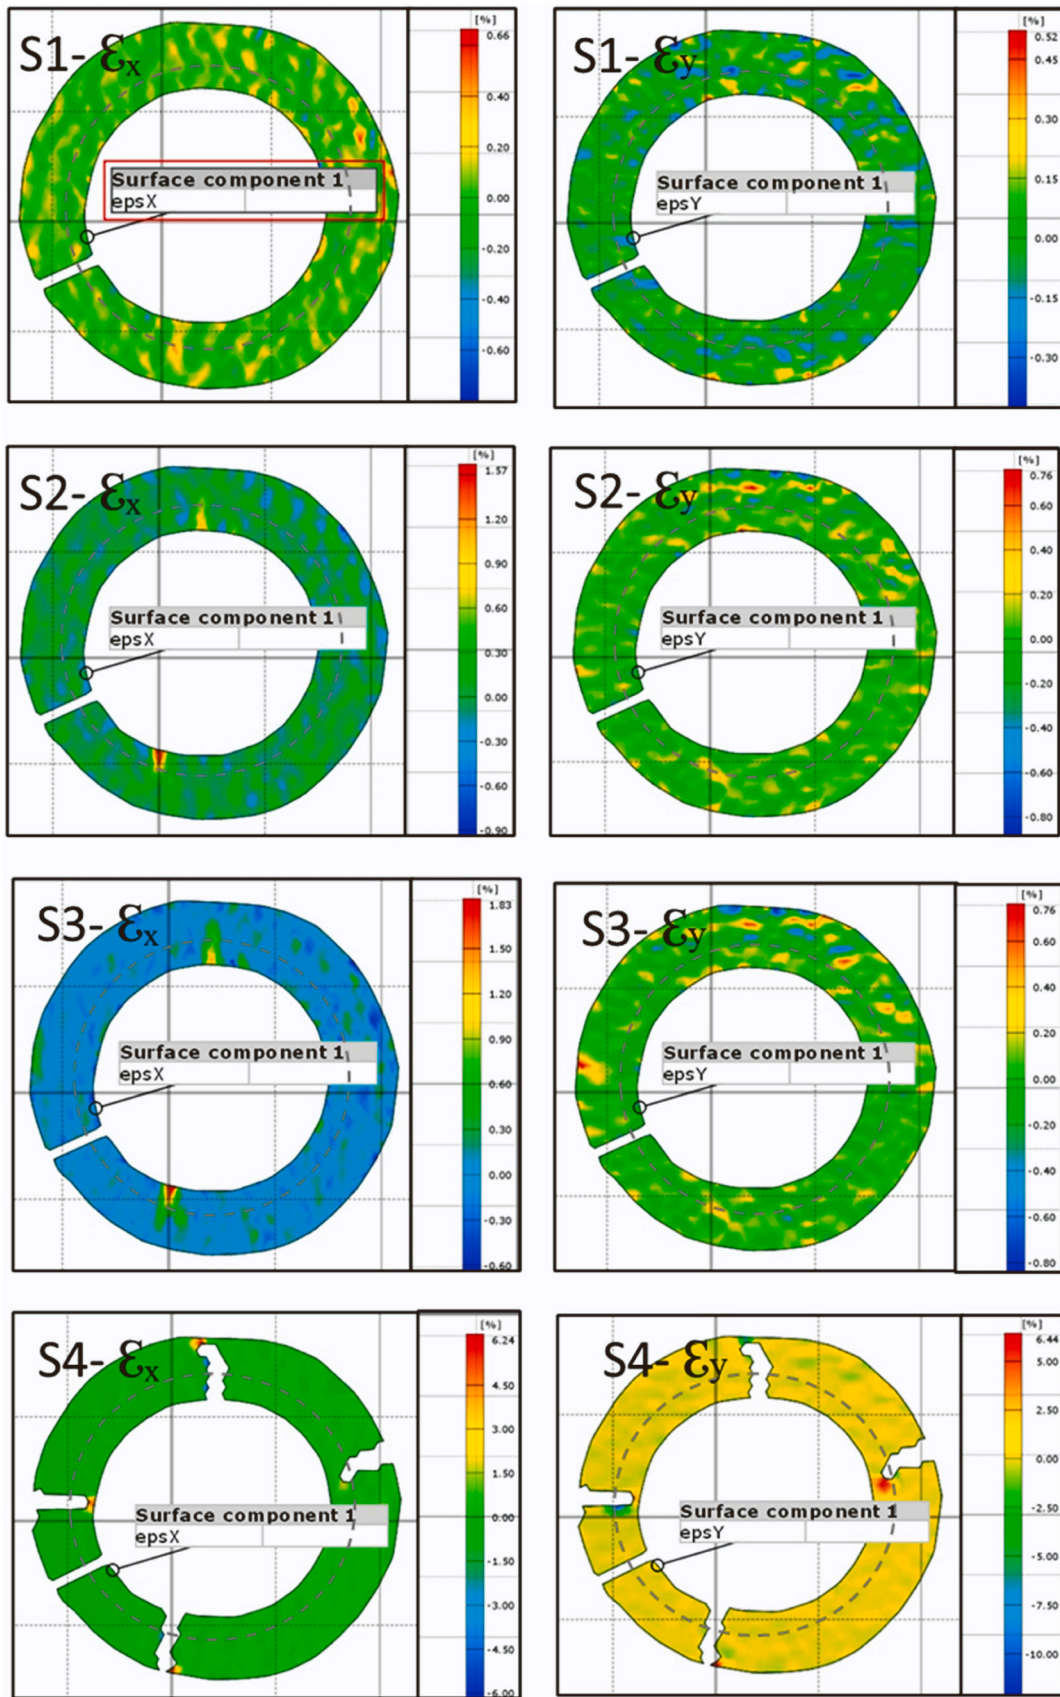
Fig. 8. – Full-field strain distribution maps of FAGP-1, at different stages during the test.

Fig. 8 to 10 show the full-field strain distribution maps of FAGP-1, OPC, and P-GP at different stages during the test. In the x and y directions, strain is designated by ϵ_x and ϵ_y , respectively. These strains represent the axial and circumferential strains, respectively. Subscripts S1, S2, S3 and S4 are appended to differentiate the corresponding stages from start to failure (shown in Fig. 7). The S1 stage, which is common to all types of mortar, consists of strain maps collected five seconds after the test begins and used as a reference point for comparing the strain developed during subsequent stages. The initial occurrence of crack formation is denoted as S2, while S3 represents the point at which failure occurs in the coating material or the onset of debonding between the repair and the substrate. S4, on the other hand, corresponds to the time of specimen failure. Fig. 8(S1) depicts the full-field strain maps of FAGP-1 in the x and y directions, captured five seconds after the test commenced (S1). It is evident that at S1, the ϵ_x within the full-field is

considerably low ($< 0.2\%$ in both tension and compression) and was mostly evenly distributed, with the exception of a few patches of strains, S1- ϵ_x ranging from 0.4% to 0.66%. The corresponding ϵ in the y-direction showed scattered strain patches at the top and bottom sides of the ring surface along the axial loading plane at a value of S1- $\epsilon_y = 0.3\%$. In Fig. 8(S2), an initiation of cracks can be seen on the repair coating at both crown and base areas at the load of 7.43 kN and 0.91 mm deflection. At S2, the maximum strain reported in the x and y directions was 1.57% and 0.76%, respectively. As seen in Fig. 8(S3), increasing the load leads to increased ϵ_x (up to 1.83%), causing vertical crack propagation. A transverse crack in the concrete substrate was observed in S3, five seconds before failure. Despite the presence of dispersed patches of compressive strain around the bond zone, no evidence of debonding was observed at the ITZ. In Fig. 8(S4), the strain maps at the point of failure are depicted.

It is observed that there are no discernible strain variations or micro-cracks along the bond line, except for the prominent splits in the tension regions of the repair composite surface. This observation corroborates with the slant shear test results that the bond strength between geopolymer, and concrete is substantial despite a Smooth-Saturated substrate condition. The influence of acid exposure on the coating material or the bond zone is also not apparent in the FAGP strain maps, confirming FAGP's acid resistivity and lower permeability in transporting chemical compounds into the repair layer and beyond.

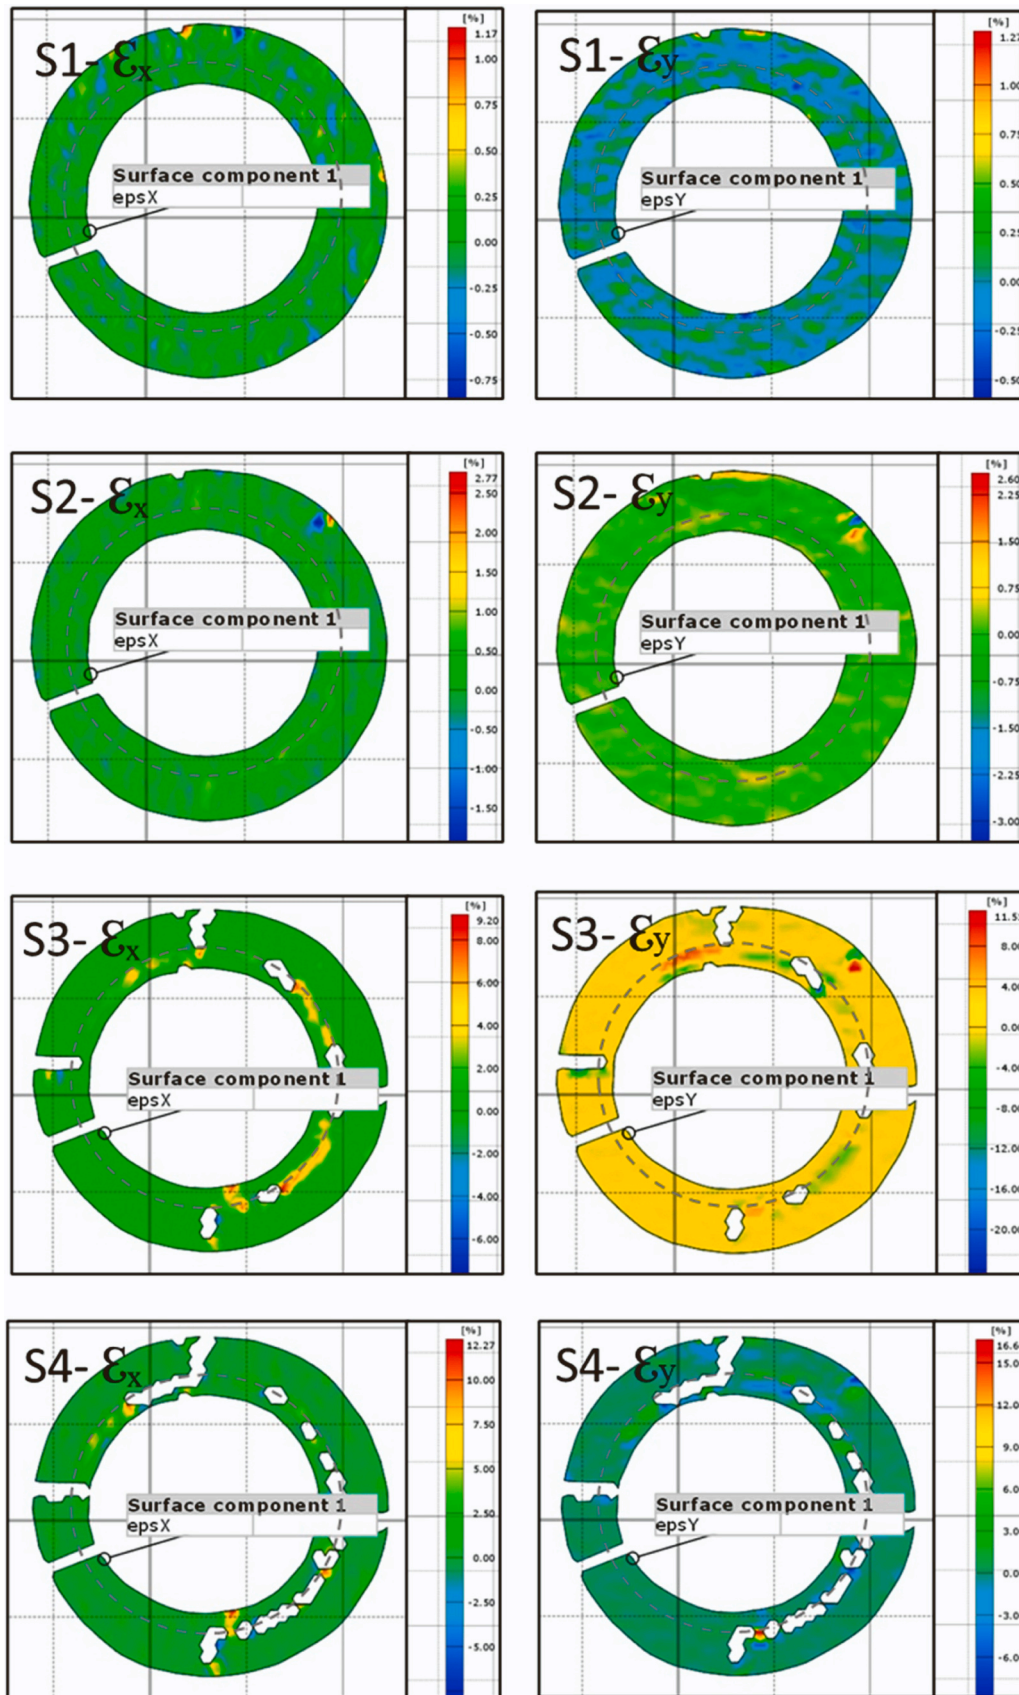
Fig. 10. – Full-field strain distribution maps of P-GP, at different stages during the test.

P-GP-coated concrete pipe full-field strain distribution maps are shown in Fig. 10. Like FAGP and OPC, this study considers phases S1 to S4. S1 records the x and y strain maps as the reference 5 seconds after the test began. Both x and y were strain-neutral at S1. S2, the crack initialisation stage, began 30 seconds after the test began, later than OPC but earlier than FAGP’s first crack. Compared to OPC, the strain levels of the P-GP repaired surface at the crack initiation stage were lower and -1.5 – 2.77 % and -3 – 2.6 % in the x and y directions, respectively. However, strain along the bond plane was apparent and ranged from $\epsilon_x = 0.25$ %– 0.5 %. At stage S3, the debonding of the overlay was detected, and it was after 8 seconds from S2. The delamination initiated at the bond plane at the pipe’s bottom and propagated towards the

crown area. This can be attributed to acid permeation into the bond plane producing bond failure before repair material failure. Notably, this failure pattern differed from the similar stage S3 failure pattern observed for OPC. The recorded load value for P-GP at S3 was 6.78 kN, twice as high as the stated load value for OPC. Fig. 10 (S4) shows the full-field strain maps of a P-GP lined pipe at failure (at 9.97 kN), where ϵ_x and ϵ_y were comparable to OPC at the time of failure.
