Does copper material induce VBNC state in drinking water biofilm bacteria?

Jungfer, C., Varela Villarreal, J., Brändle, K., Friedrich, F., Obst, U., Schwartz, T.

BACKGROUND AND EXPERIMENTAL APPROACH

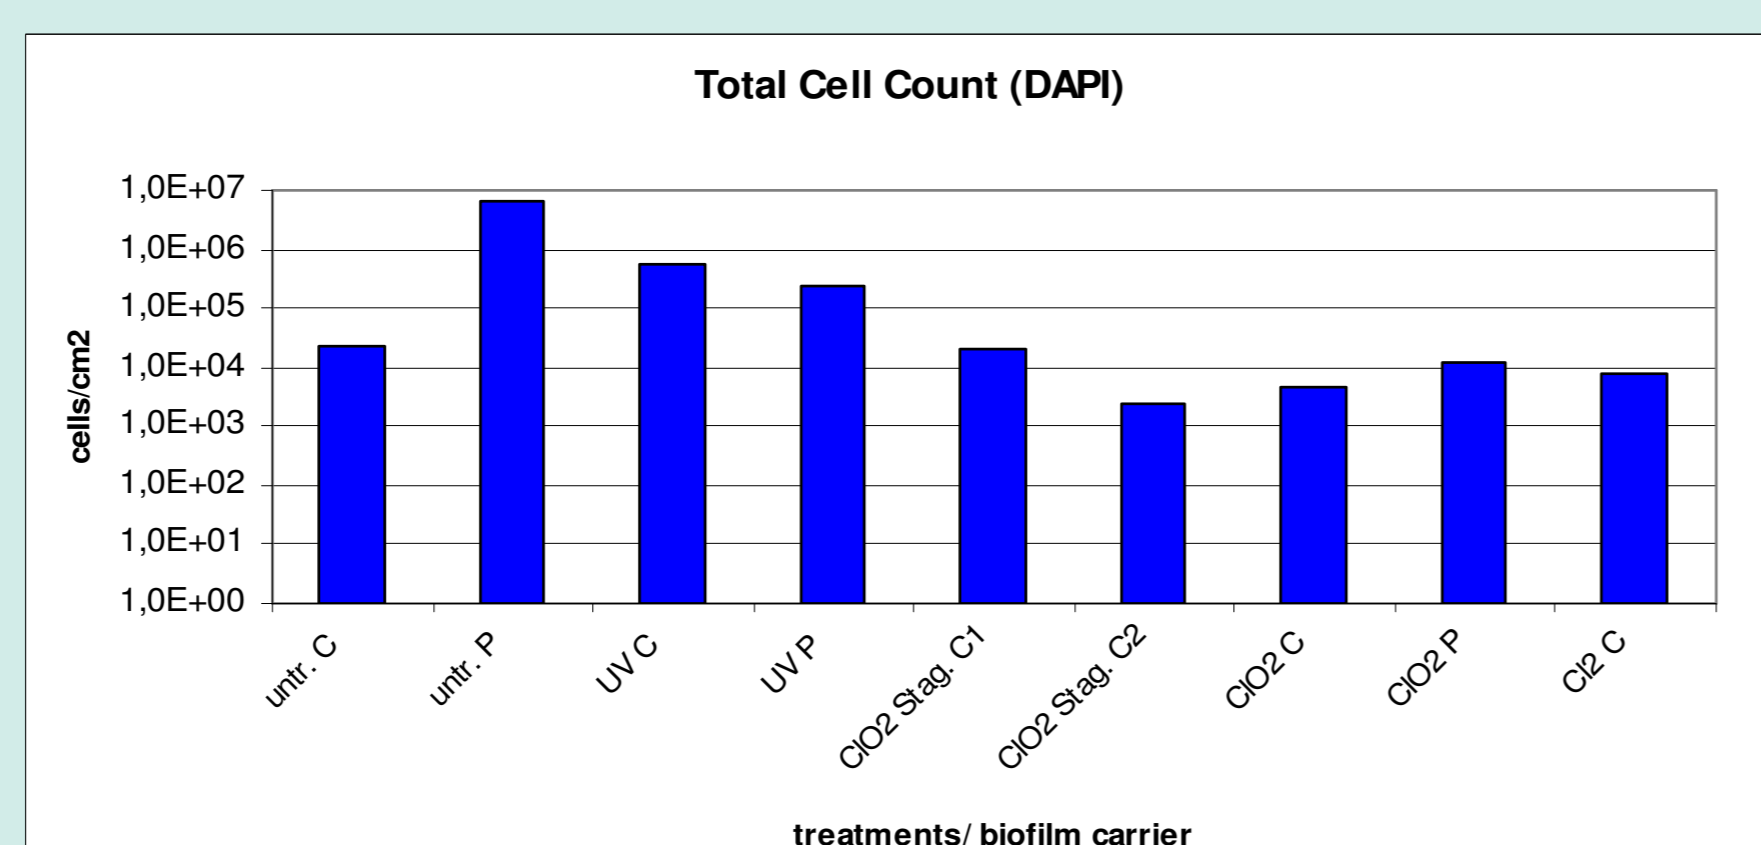
High **TOTAL CELL COUNTS** (10^4 up to 10^6 cells/cm²) were detected without disinfection and after UV disinfection. After chemical disinfection treatment 10^3 up to 10^4 cells/cm² were observed.

Treatments: untr.: untreated; UV: UV disinfection; ClO₂: chlorine dioxide disinfection; Cl₂: chlorine disinfection; Stag.: stagnation. **Biofilm carrier:** c: coupons; p: pipes
