First results of the bundle test QUENCH-L3 with optimized ZIRLO[™] claddings

J. Stuckert, M. Große, J. Moch, C. Rössger, M. Steinbrück, M. Walter

QWS-21, Karlsruhe 2015

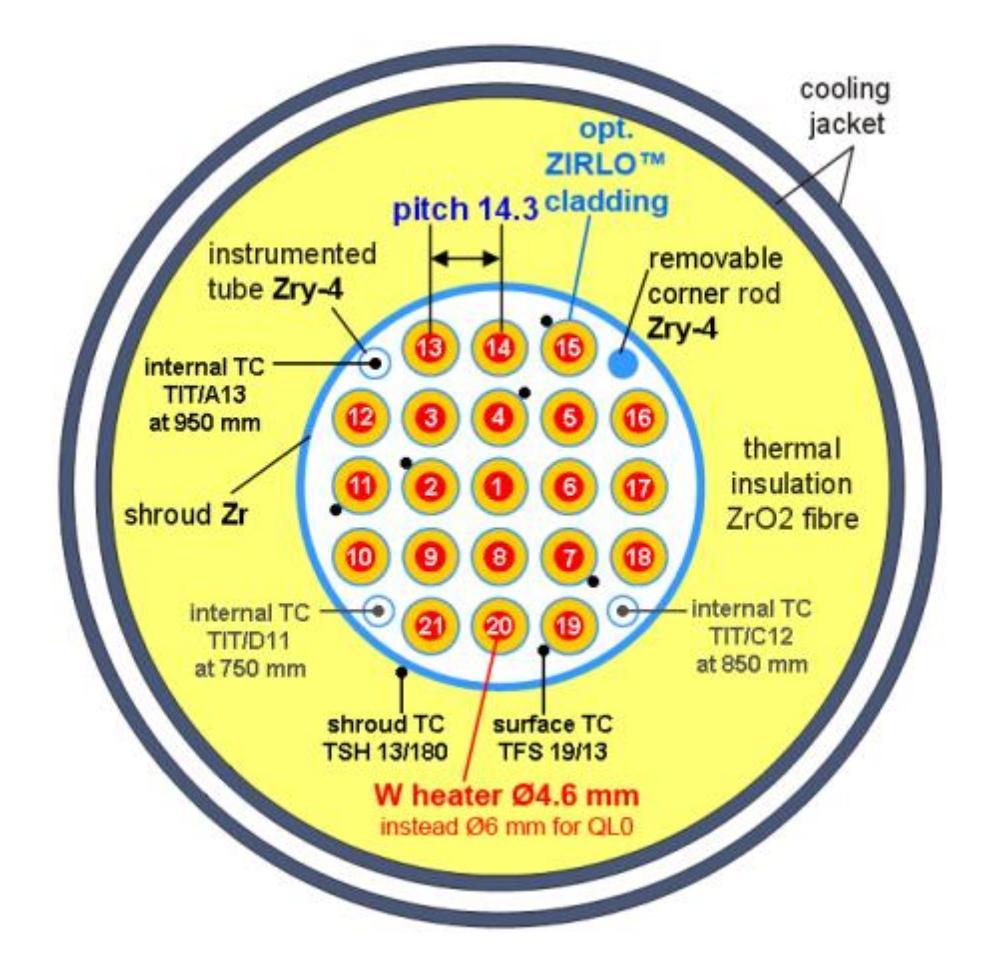
Cross-section of the QUENCH-L3 bundle

- The use of *tungsten* heaters with smaller diameter (*4.6 mm*) instead tungsten heaters (QUENCH-L0) or tantalum heaters (QUENCH-L1) with diameter of 6 mm has allowed to reach a higher heat rate.
- 2) All rods are filled with Kr with p=55 bar at T_{pct} =800 K (similar to QUENCH-L1).

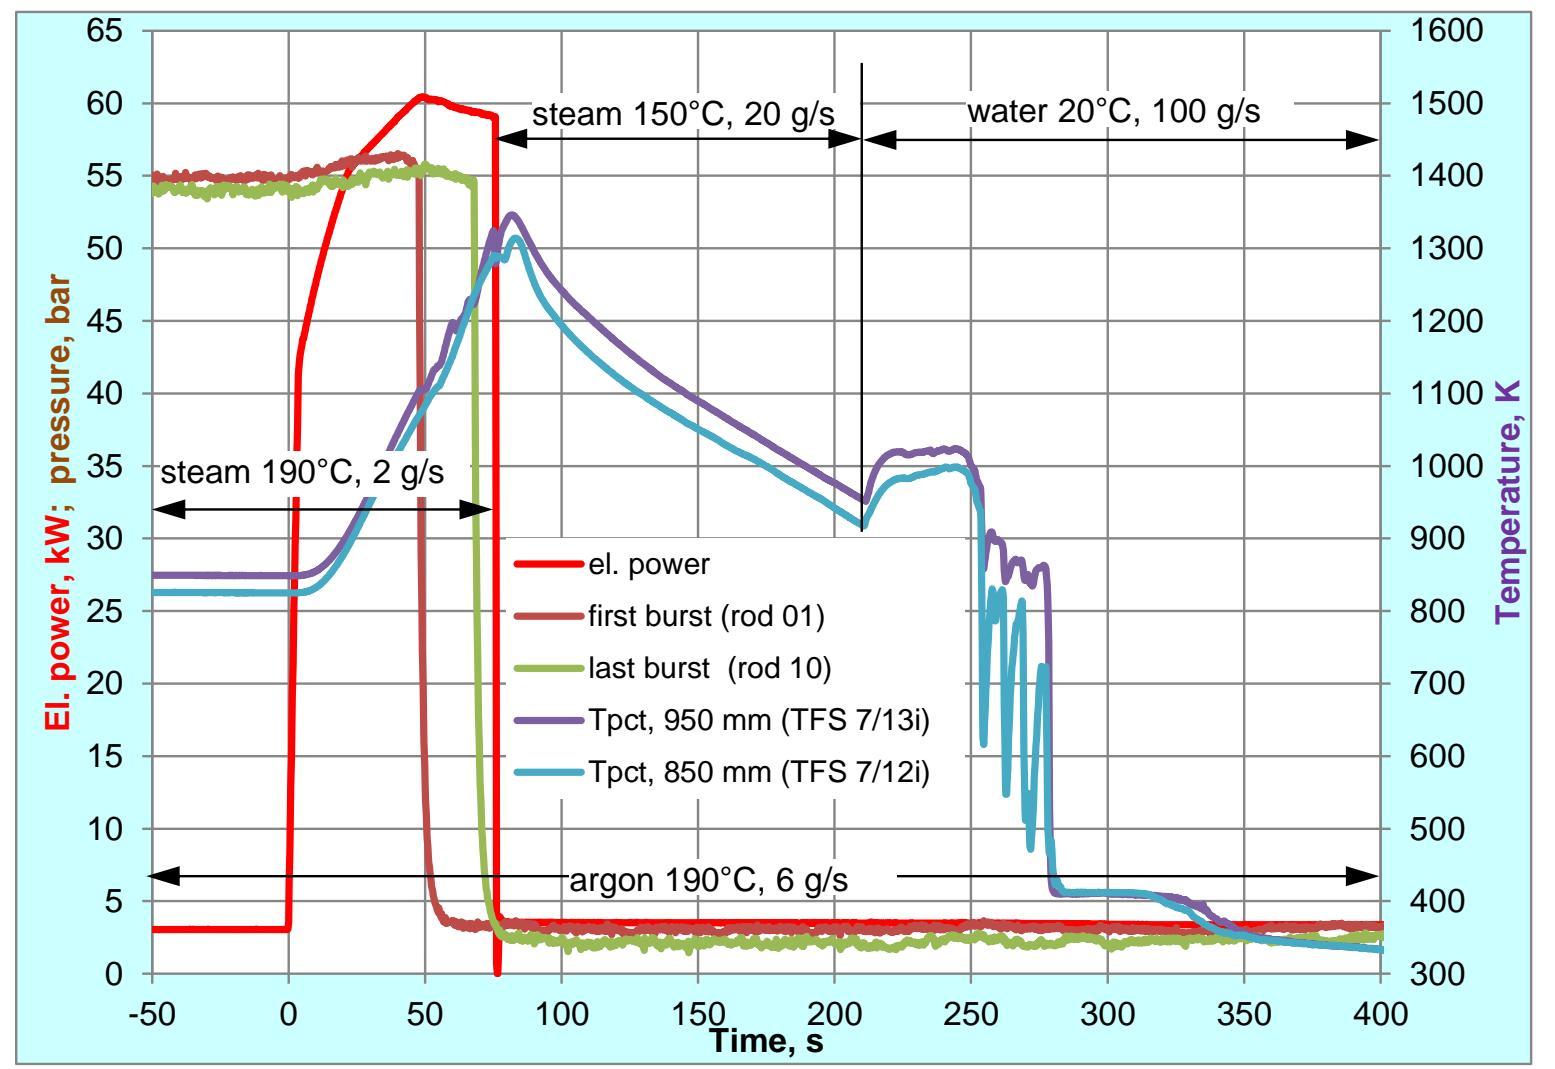
QUENCH-L3: test progress

Maximal cladding temperatures of internal rods in hottest region of QUENCH–L1 (Zry-4, reference test) and –L3 bundles (elevation 950 mm)

- Similar to QUENCH-LOCA-1, the maximum temperature of 1350 K was reached on the end of the heat-up phase at elevation 950 mm. Circumferential temperature gradient across a rod was up to 70 K on the burst onset.
