## Material migration and fuel retention studies during the JET carbon divertor campaigns

The first divertor was installed in the JET machine between 1992 and 1994 and was operated with carbon tiles and then beryllium tiles in 1994–5. Post-mortem studies after these first experiments demonstrated that most of the impurities deposited in the divertor originate in the main chamber, and that asymmetric deposition patterns generally favouring the inner divertor region result from drift in the scrape-off layer. A new monolithic divertor structure was installed in 1996 which produced heavy deposition at shadowed areas in the inner divertor corner, which is where the majority of the tritium was trapped by co-deposition during the deuterium-tritium experiment in 1997. Different divertor geometries have been tested since such as the Gas-Box and High-Delta divertors; a principle objective has been to predict plasma behaviour, transport and tritium retention in ITER. Transport modelling experiments were carried out at the end of four campaigns by puffing <sup>13</sup>C-labelled methane, and a range of diagnostics such as quartz-microbalance and rotating collectors have been installed to add

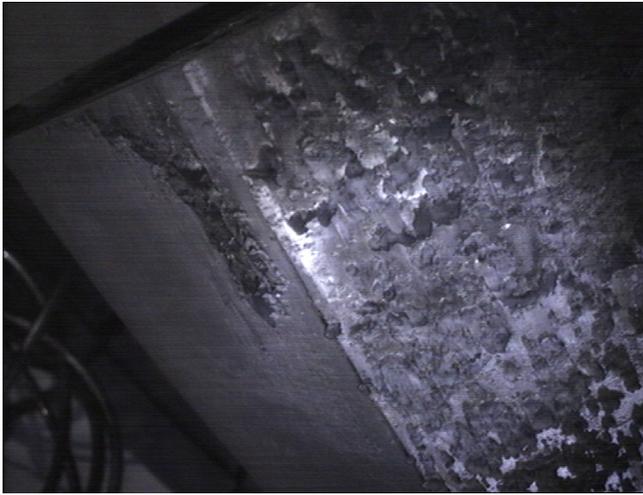
Fig. 45. View of part of the apron of a Tile 1 (right-hand side) and the upper front face of the tile (towards the left-hand side) during the 2007 JET shutdown inspection, showing spalling deposits. The tile had been exposed 1998–2007.

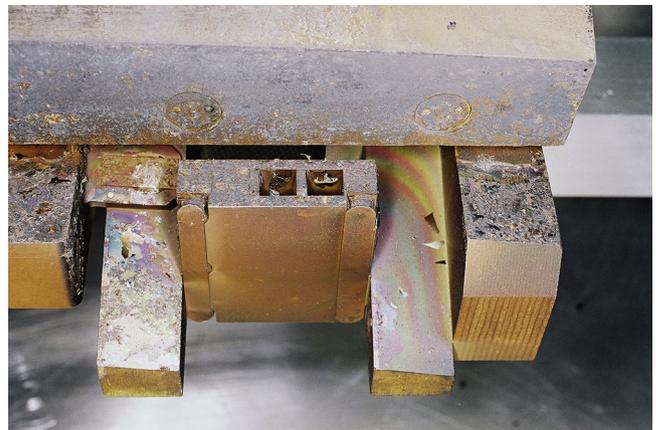
Fig. 50. Photograph of the inner carrier 2IN after removal in 2007. The bottom of Tile 3 is at the top of the picture. Surfaces are covered with a thick deposit, which is showing signs of spalling in certain places. The front face of the mirror test unit is so thickly coated that it is not possible to see where the third channel (with a sample flush to the face) is.
